# Stability evaluation of modernized bank protections in a culvert construction

**Abstract.** The paper presents stability evaluation of the banks of the Wilga River on a chosen stretch in Koźmice Wielkie, Małopolska Province. The examined stretch included the river bed upstream from the culvert on a district road. The culvert construction, built over four decades ago, was disassembled in 2014. The former construction, two pipes that were 1.4 m in diameter, was entirely removed. The investor decided to build a new construction in the form of insitu poured reinforced concrete with a 4 x 2 m cross section. Change of geometry and different location in relation to the river current caused increase in the flow velocity and, as a consequence, erosion of both protected and natural banks. Groundwater conditions were determined based on the geotechnical tests that were carried out on soil samples taken from the banks and the river bed. Stability calculations of natural slopes of the Wilga River and the ones protected with riprap indicate mistakes in the design project concerning construction of the river banks. The purpose of the study was to determine the stability of the Wilga River bank

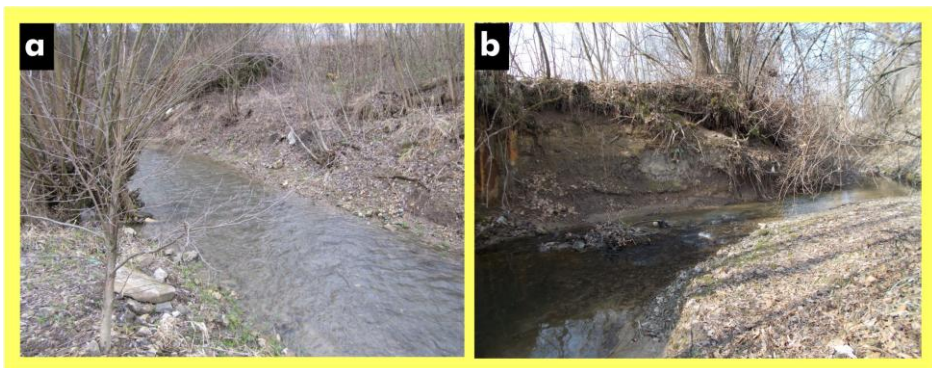
The source of the Wilga River is located in Pawlikowice (Wielicki Foothills). The river starts at the altitude of 370 m above sea level and after about 21 km it flows into the Vistula River at the altitude of 200 m above sea level. The beginning of the river meanders through stone formations and after that it flows only through finegrained cohesive soils (Fig. 1a). The outlet stretch was regulated and embankments were built so the urban area is protected against the backwater from the Vistula River. The Wilga River has an irregular flow. During floods it rises, the flow velocity increases and the river intensely erodes its bed creating often vertical slops that are 3 m high (Fig. 1b). When the water levels are low they do not exceed a few centimetres.

**Fig. 1.** Natural bed of the Wilga River a) upstream and b) downstream from the culvert.

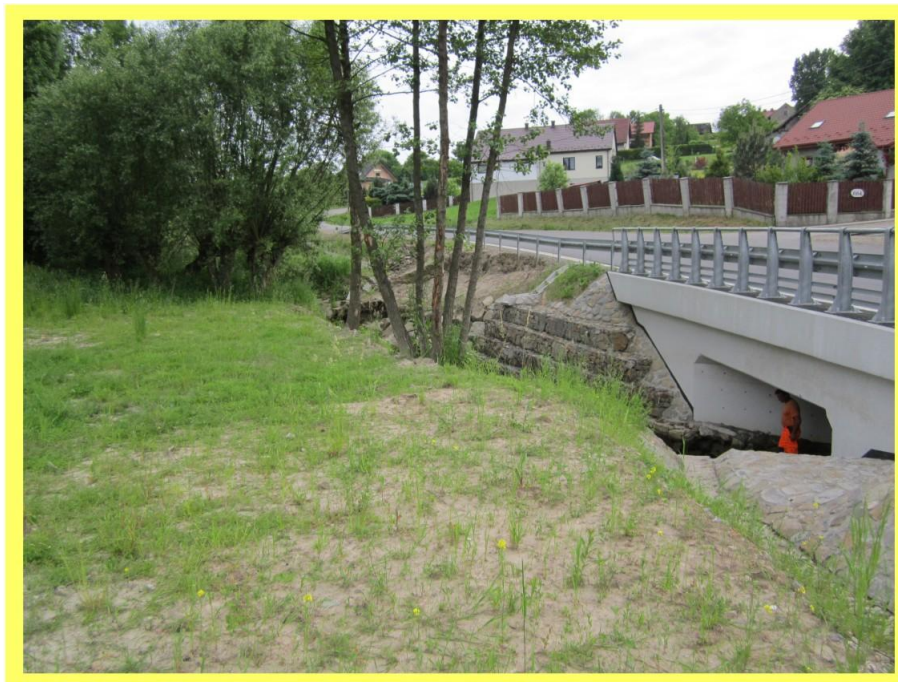
Former culvert pipe was entirely disassembled. On the ground level where geotechnical parameters were appropriate the base of a new culvert was built. It is a reinforced concrete culvert poured on site; it is a closed frame based directly on solid clayey soils. The front walls are situated parallel to the road axis. The total length of the construction is 11.74 m. The horizontal diameter is 4.00 m, the vertical 2.00 m (Fig. 3) and the total carriageway is 10.34 m wide.

**Fig. 3.** Culvert on the upstream side and the view of damages

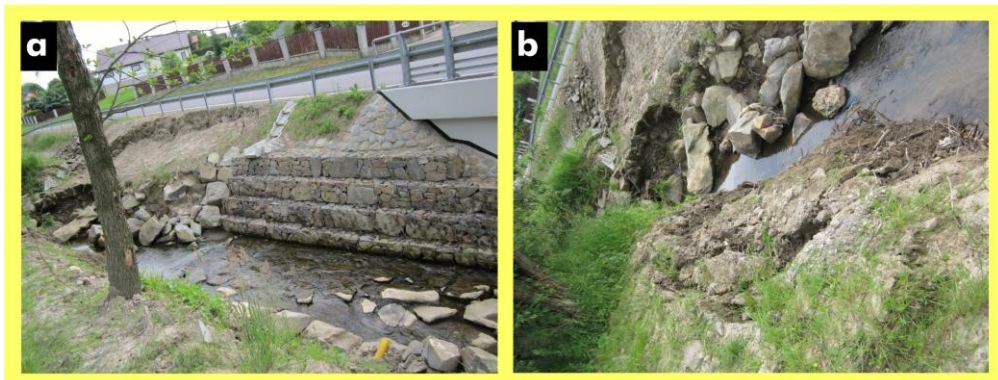
In the first year (2015) after the construction was finished the bank protection on the right side formed from riprap slid along with the soil from the slope fig. below.

**Fig. 4.** The view of damages that occurred after the first year of exploitation a) from the downstream side and b) upstream side
