Vertical Displacement of the Surface Area over the Leakage to the Transverse salt Mine in 1992–2012

Tomasz Lipecki^{1,*}

¹ AGH University Science and Technology, Faculty of Mining Surveying and Environmental Engineering, A. Mickiewicza Av. 30, 30-059 Krakow, Poland

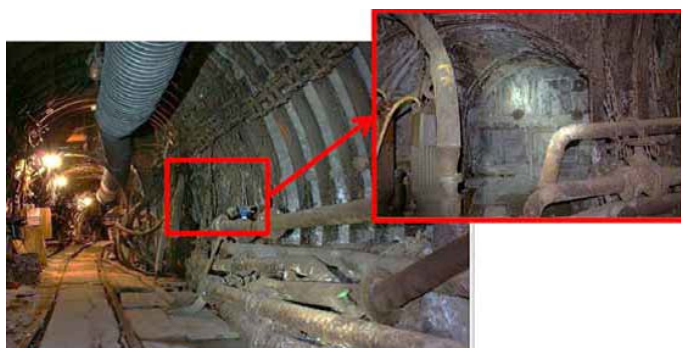
Fig. 2. Place of transverse leakage

Immediately, after the inflow was revealed, protective work was started, which was based not only on the execution of the dam but also on the drilling of wells [3, 5]. Observation wells and subsequent ones forming the so-anti-filter and injection barrier [4]. Due to the unsatisfactory effectiveness of these activities in 1993, the drainage holes of the dam were made and the rock injections were started by drilling around the transverse in the so-called. "Range". In total, 102 injection holes were drilled, including almost 2000 m³ of mortar ore. By the year 2000, the outflow stabilized at around 120 l/min, similarly saturated NaCl to about 3 g/l and insoluble (from 240 g/l to 10 g/l).

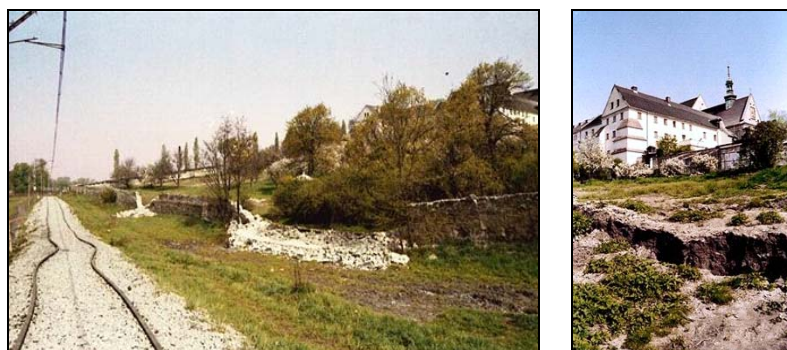
Fig. 3 Deformation of the track and destruction of the wall and cracking of the soil in the monastery's garden [4]

practically destroying level IX, which was eventually liquidated by flooding. Water flooding the mine also threatened the city located above the mine. As a result of the disaster, significant deformations occurred on the northern front of the mine, and after a spill in 1992, a subsidence of a 0.3 m drop was observed, which deepened at an extremely fast rate from day to day. The trough covered by its impact railways and threatened the buildings of the nearby monastery, eventually causing the wall to collapse. (Fig. 3). These spots are located north of the transverse front, which indicates the size of the area covered by the water inflow. Figure 4 shows the surface deformation in relation to the transverse run that is visible at the bottom of the picture.

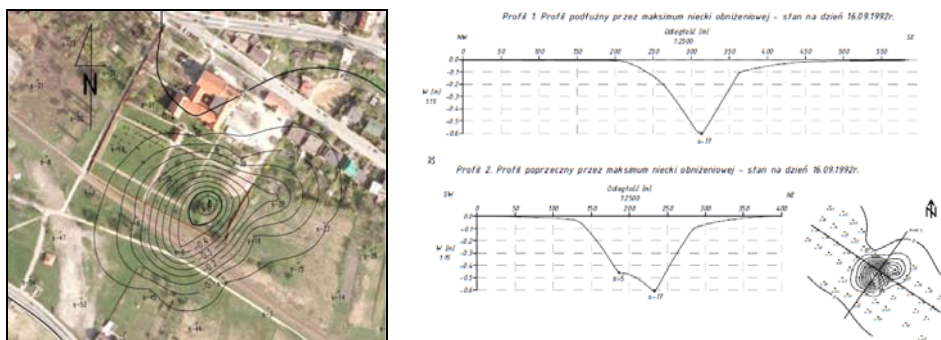
Initial measurements from June to September 1992 showed no significant changes in the surface area. Maximum reductions reached 22 mm in the two points of the observation network during that time. A sudden vertical displacement occurred at the beginning of September as a consequence of another rapid flooding of the water to the transverse, along with a large amount of rock material. The largest subsidence within 4 days reached almost 40 cm, and in the following week increased by another 21 cm. The situation of the depression formed at that time is shown in Figure 5. The reduction covered almost 3 ha and its volume amounted to over $3,800\text{ m}^3$, which gives an idea of the amount of material displaced in the transverse region.

Fig. 5. Subsidence basin –September 1992

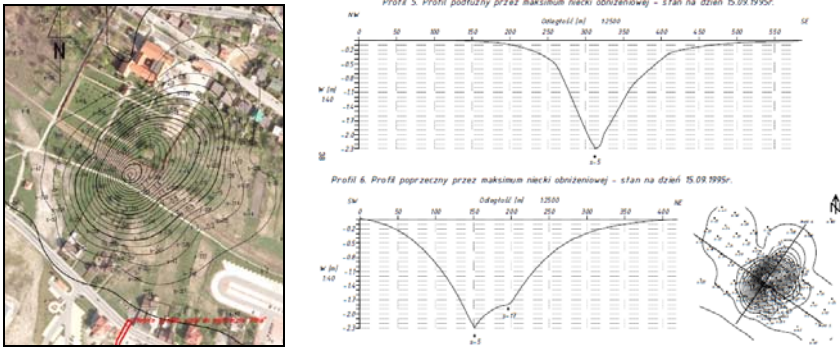
At the end of April 1993 there was another sudden spill, causing the trough to deepen to 2 m. After this incident the area was settling at an uneven speed until the end of 1994, when it was mastered and the leak was closed. The map below (Fig. 6) shows the state of deformation in 1995, after mastering the leakage. The trough covers an area of almost 8 hectares and its volume reaches 30000 m^3 . The largest decreases occur all the time at the same point of the observation network, reaching the value of 2.3 m. The comparison of the spatial shapes of the basin from 1992 and 1995, when recorded its greatest development, is presented in Figure 7.

Fig. 6. Subsidence basin – state for 1995, after mastering the leak

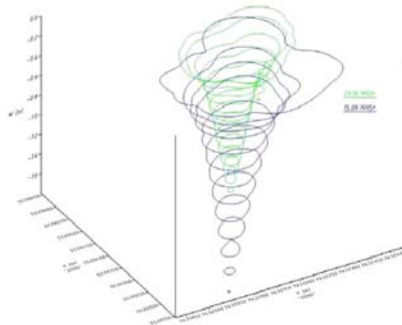
Fig. 7. The development of the subsidence basin in 1992–1995

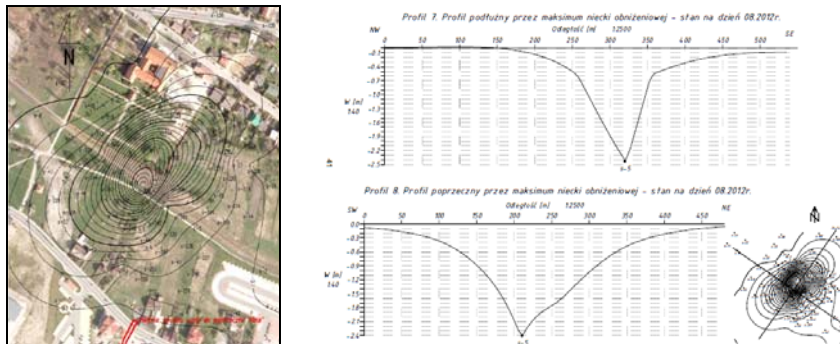
Figure 8 shows the state of the subsidence basins of the 2012 subsidence. Long-term and slow summation of the reductions has led to the expansion of the basin to more than 12.5 hectares and its volume has increased to almost 37,000 m³. The center of the basin has decreased by an estimate of about 2.4 m (unfortunately the point of the network has been damaged).

Fig. 8. Subsidence basin – August 2012

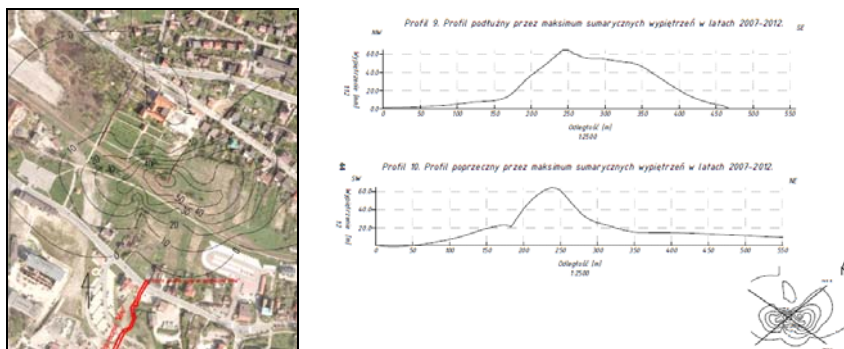
observations. It has been reported even in the years 2007–2008 that the uprising reached up to 20 mm. This is probably due to the rebuilding of the water column in the ground, after the water has completely stopped draining from the front of the transverse dam [9]. The following years of observations confirmed the revealed tendency to rise at an average of several mm per year in the discussed area. On the map shown in Figure 9, the summary uplifts from 2007 to 2012 are shown, reaching up to 50–70 mm, which suggests that the average annual value of the uplifts oscillates within 10 mm/year. The centers of reductions and uplifts initially overlapped, but later the maximum uplift shifted north.

Fig. 9. Uplifts recorded in the period 2007–2012

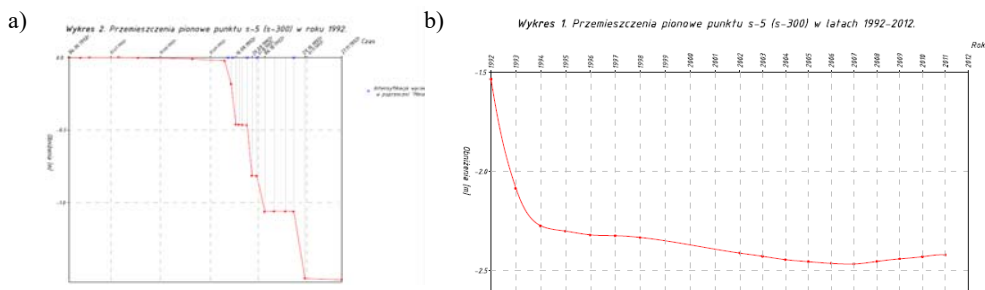
The nature of elevation changes can be shown not only on the basis of surface analysis. Very good dynamics of changes are reflected in the graphs, that show the behavior of individual points of the research network. The first period, when catastrophic changes occurred (1992), presents a graph of changes in the height of one of the points shown in Figure 10a, and 10b presents the reductions over the period of 20 years (1992–2012). On the first one, there is a visible, instantaneous process of revealed deformation, however after this period, the reductions take a character similar to the curve striving for, almost asymptotically, zero altitude changes. The end of this curve is again increasing and as mentioned before, it presents the process of upliftment, which as you can see, is not a random phenomenon.

Fig. 10. The dynamics of reduction points in 1992 (a) and during the period 1992 to 2012 (b)
