Damage Analysis of Moldboard Plow

Abstract. Moldboard plow is a tool used to cultivate the agricultural land. The material of the moldboard is a double layer where the outer layer is high carbon steel and the inside is a low carbon steel. The findings on the side edge of the moldboard plow are often damaged due to bent deformation and then broken. The study was conducted to determine the cause of the damage through simulation and testing laboratory. The simulation results show that the moldboard is overloaded by its material capability. This is shown also from the results of testing the chemical composition that this material is a low-alloy steel single layer without surface hardening. Hardness tests conducted using Rockwell C show that this steel has a tensile strength of only about 400 MPa. This is reinforced by the results of microstructural observations showing that more than 99% of the phases are ferrite.

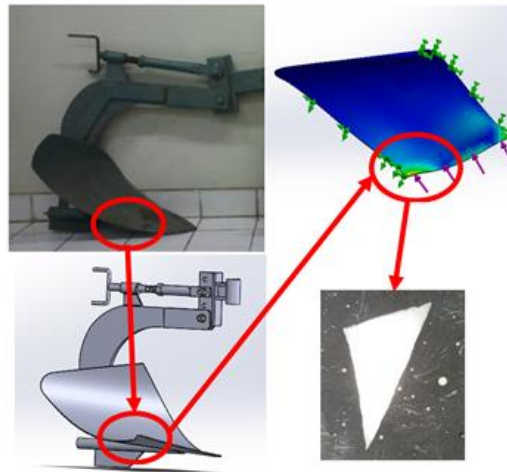
Fig. 5. The stress simulation of moldboard plow

From simulation shown that the critical area is at the edge tip in the corner. This area gets greater stress than other areas i.e. 713 MPa. While tensile strength material is 403 MPa.

The result of the stress analysis simulation is that the load received during the plowing process is greater than the tensile strength of the material. This suggests that the material is very susceptible to plastic deformation which will cause a deformation. Hence, moldboard material will easily experience cracks that cause damage.

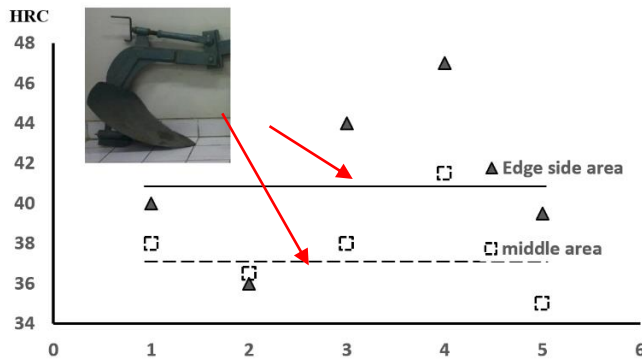
Fig. 6. Hardness graph by position tested

The graph in Figure 4 indicates that the average of the harness in the middle moldboard 37.8 HRC and in the edge side 41.3 HRC. The difference of the hardness value between that area is not very significant.

Hardness test by Rockwell C shows that material has low HRC value i.e. 35 to 47. It is mean that tensile strength moldboard material only around 400 MPa. This reality has shown that why the moldboard easy to be damaged.
