Ensuring safe operation of buildings and structures

Abstract. It is possible to ensure safety of the entire construction process as well as safe operation of buildings and structures in future by timely implementation of geotechnical monitoring. Geotechnical monitoring of buildings and structures is a complex research of “soil base – foundation – above ground structures of a building”. Geotechnical monitoring studies behaviour of buildings and structures during construction and operation and, safety measures to prevent hazardous situations in future are undertaken upon analysis of acquired results. Geotechnical monitoring comprises combination of works, including field observation for structures’ behaviour of a building under construction or renovation, its foundation, including soil body surrounding the structure under construction, and field observation for structures of surrounding buildings. Such monitoring allows us to timely detect and prevent non-reversible processes that occur in “soil base – foundation – above ground structures of a building” system. Considering task in hand to ensure safety and security of buildings and structures, list of geotechnical monitoring works c

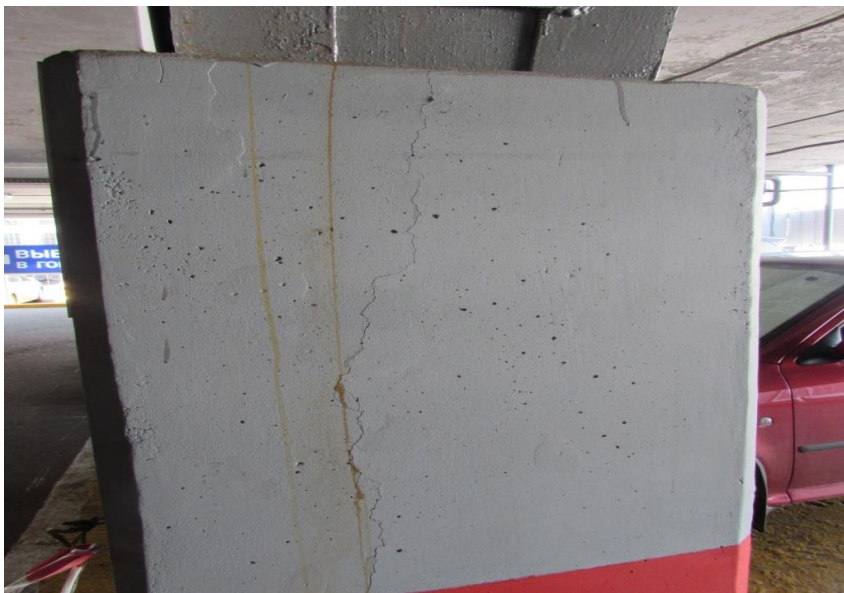
- Cracks in columns, due to corrosion of the reinforcement (Fig.3, 4);

Fig. 3. Parking No.1, 1st floor. Vertical column crack.

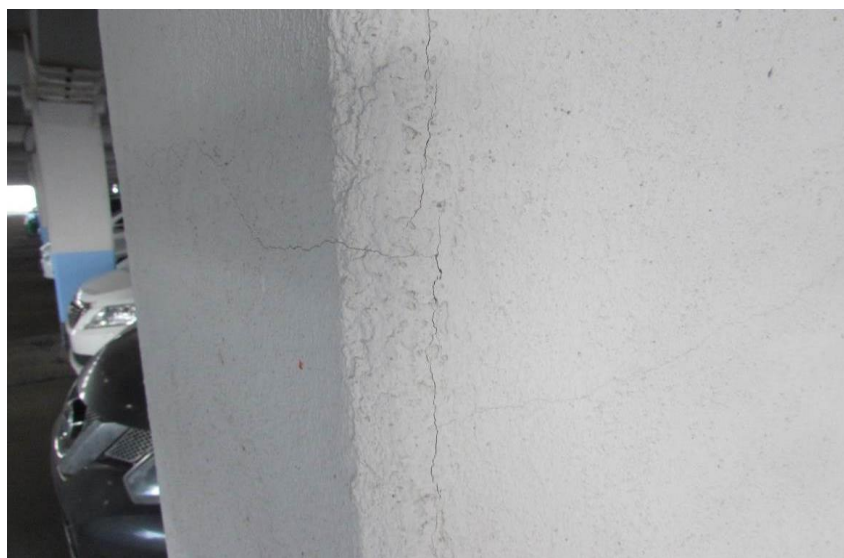
Fig. 4. Parking No.2, 1st floor. Vertical column crack.

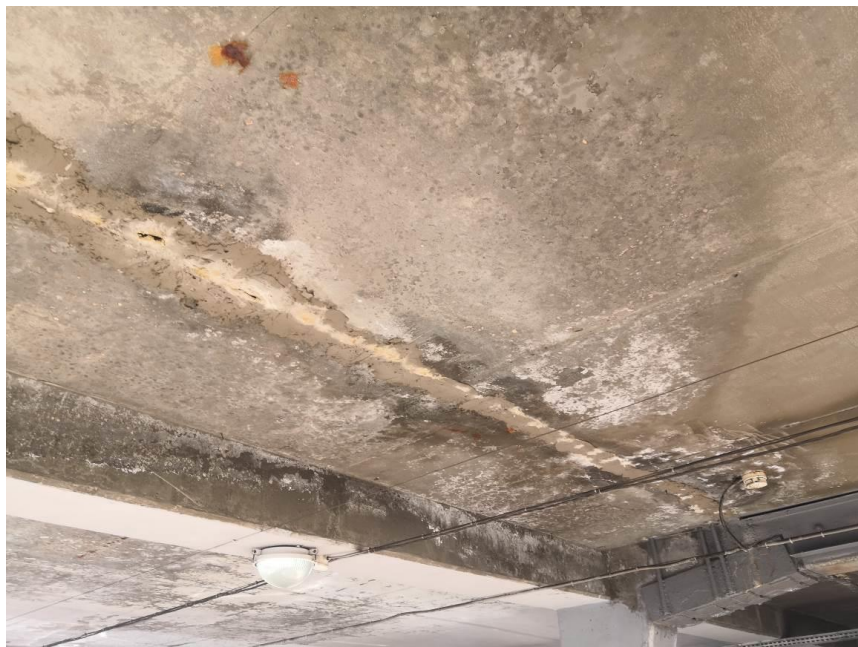
- Extended cracks on the lower surface of the floor slabs, with an opening width of more than 0.3 mm, with traces of rust and efflorescence (Fig.5, 6);

Fig. 5. Parking No.1, 3rd floor. Efflorescence on the slabs surface at the expansion joints

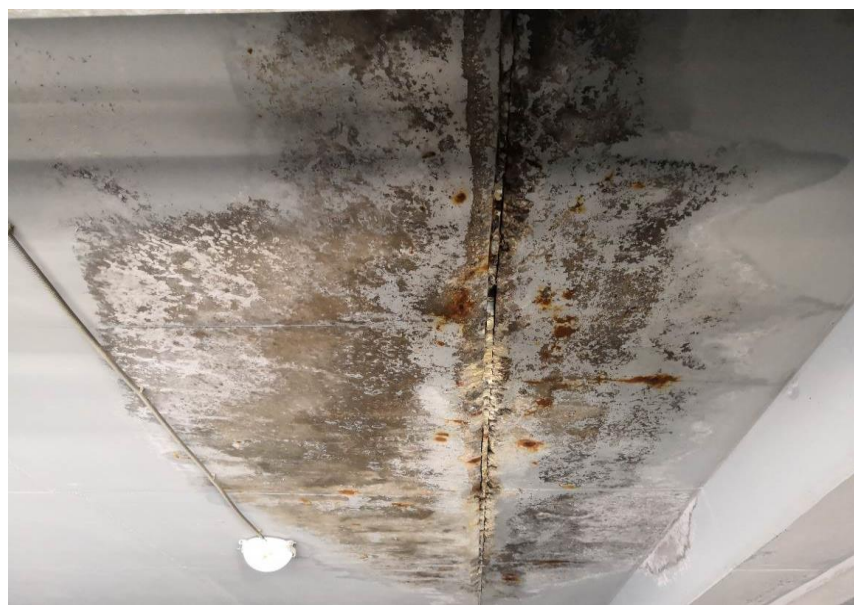
Fig. 6. Parking No.2, 2nd floor. Cracks in the slab with traces of efflorescence and corrosion of reinforcement

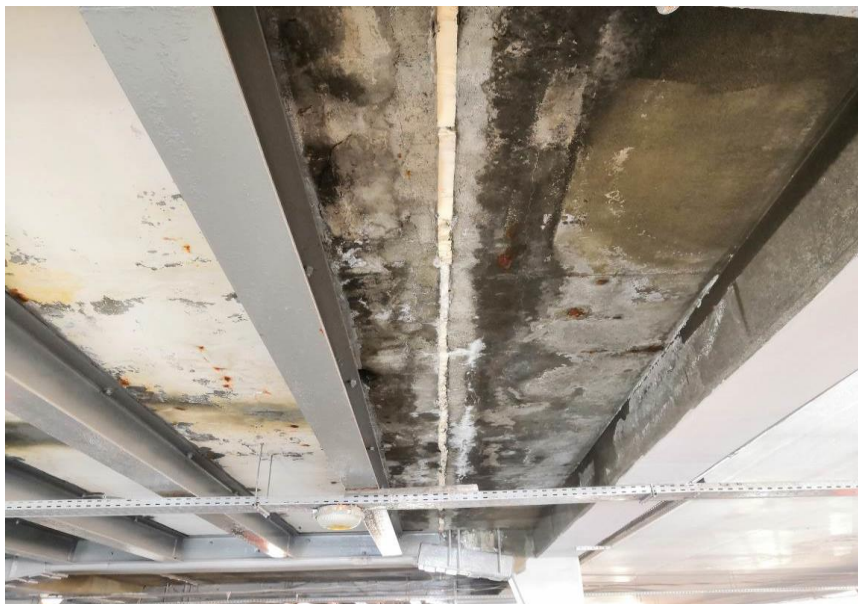
- Deflection of floor slab sections between expansion joints (Fig.7, 8).

Fig. 7. Parking No.1. Deflections and efflorescence on the floor slab surface between the expansion joints

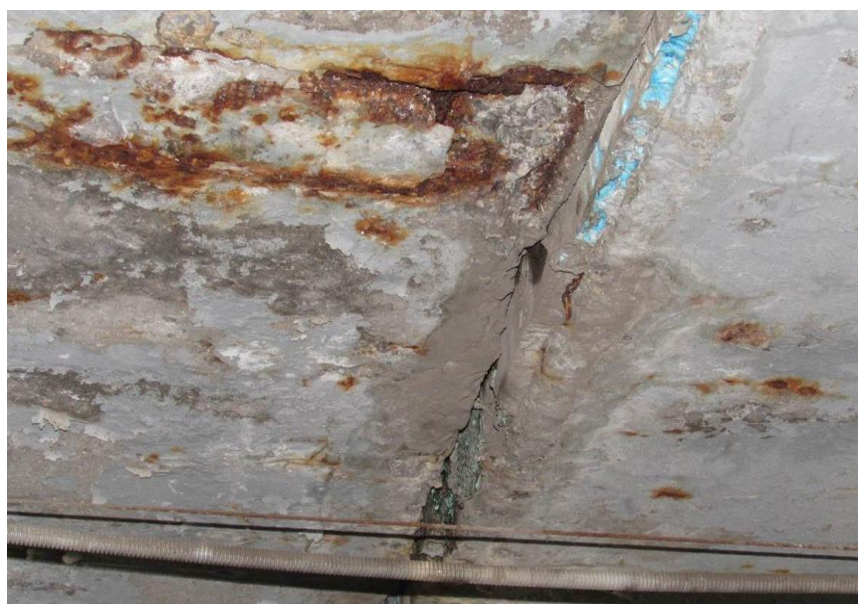
Fig. 8. Parking No.2. Deflections of floor slab sections between expansion joints. 1st floor

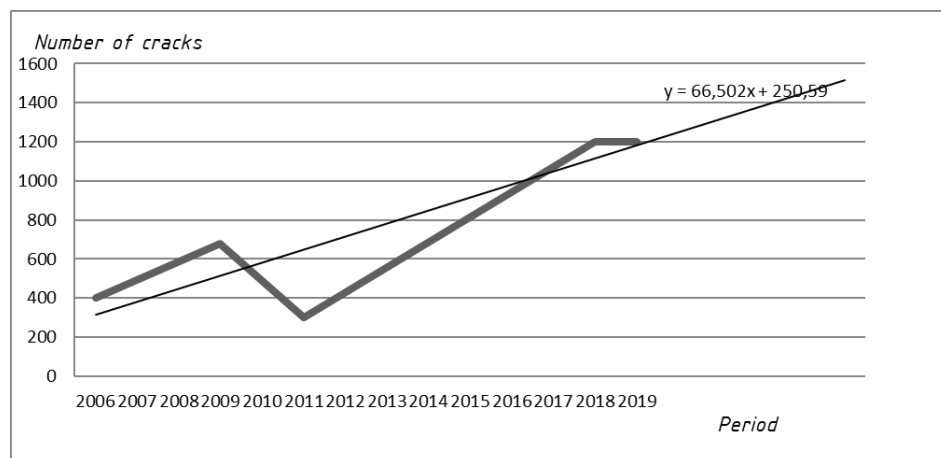
Fig. 9. Approximation of damage increment graph

Conducting object monitoring and comparing the results obtained with data from previous studies showed an increased number of cracks in the parking structures. The

dynamic of the crack number development over time in structures of both parking buildings for the period from 2005 to 2019 is shown in Fig.9.

From Fig.9 it follows that over time, there is a clearly pronounced tendency for defects growth in structures of the observed buildings. Moreover, main damage increment is observed in the winter-spring period of the year. According to the results of object monitoring, the state of parking No.1 is assessed as operational, and parking No.2 is assessed as limited in operation.

According to the data obtained over the course of monitoring, damageability of the structures was assessed according to the methodology [3] for assessing reliability of buildings and structures by external signs. Remaining operational life expectancy of parking No.1, i.e. projected period for repair works and strengthening of structures to extend service life is 2 years, at the same time remaining operational life expectancy for parking No.2 is absent. In this regard, parking No.2 requires full repair and strengthening of building structures.
