Considerable cracking in the foundation slab in a multi-storey underground garage

Marek Maj*, Tomasz Kowalik and Andrzej Ubysz

Wroclaw University of Science and Technology, Wybrzeże Wyspiańskiego 27, 50 370
Wrocław

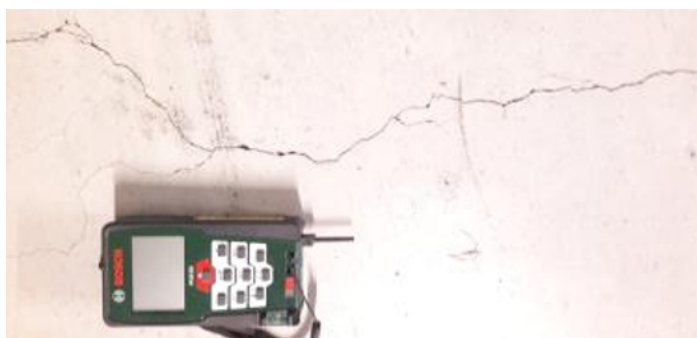
Fig. 1. Cracks in the parking slab with a width of over 0.6 mm

In addition, an ongoing process of crack propagation can be observed (according to the interview carried out with the user's representative); their number, width and aperture is gradually increasing. The distance between cracks, in places strongly outlined, the width of which is more than 0.1 mm, is on average 0.40 m.

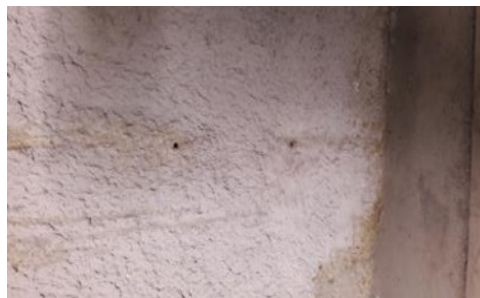
segments of the diaphragm wall. Local dampness is also observed at the connection points of the diaphragm wall with the foundation slab (Fig. 2). This means penetration of groundwater through some expander connections and through the walls. Leaks in the floor over the foundation slab are shown in Fig. 3. After every major atmospheric precipitation, it is necessary to perform injections in order to seal the walls in places of leaks.

Fig. 2. Dampness in the connection between the diaphragm wall to the foundation slab

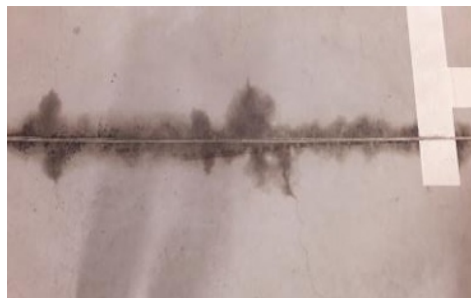
Fig. 3. Leaks in the floor over the foundation slab

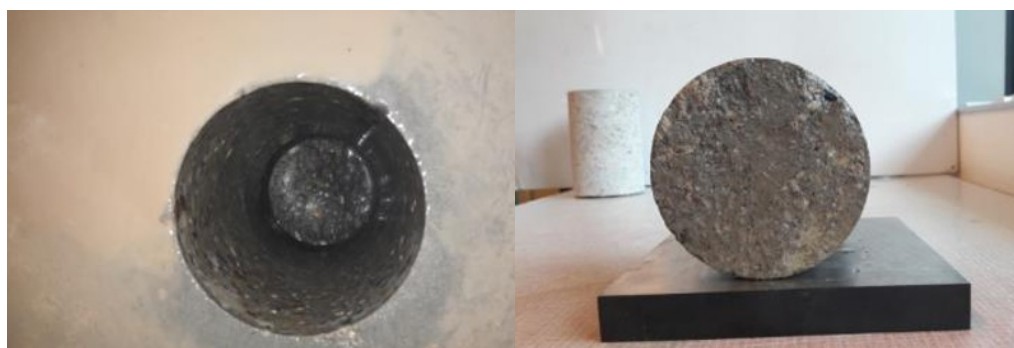
- In one of the samples, separation of the foundation slab from the floor was observed, which may indicate that the bonding layer had been cut.

Fig. 5. Place of borehole

Fig. 6. Sample cut from the concrete slab, bonding layer

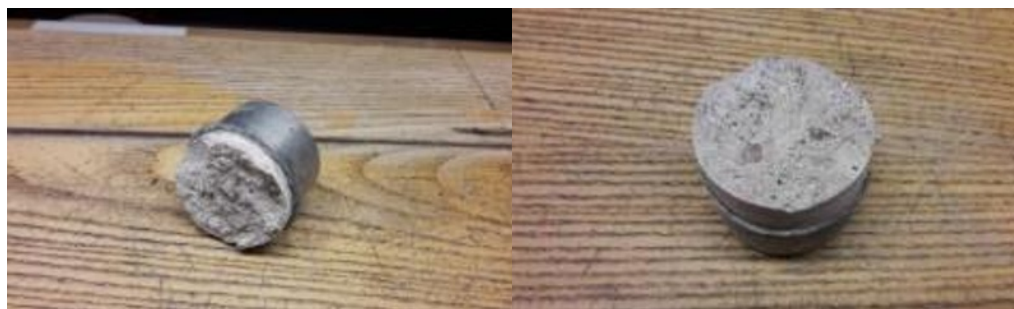
Fig. 7, 8. 'Pull off' samples for strength tests
