Sinkhole hazard in the post-mining area of Old Copper District, Lower Silesia, Poland

Abstract. This study discusses the occurrence of sinkholes and the removal of their effects in the territory of the Old Copper District in the municipality of Lubków, Warta Bolesławiecka, located in the voivodeship of Lower Silesia. Three sinkholes appeared more than 25 years after mining activities ceased with the closure of the “Konrad” Mine of KGHM Polska Miedź S.A. The sinkholes appeared in the former mining areas in the years 2017 – 2018: the first in the area of the Lubichów III shaft located in the municipality of Lubków – the downcast and transport shaft of the “Lubichów” and “Konrad” mines; the second in the area of Lubichów IVa in Lubków – the ventilation shaft of the “Lubichów” and “Konrad” mines; and the third in the area of the Lubichów IVa shaft - in the village of Lubków. The “Lubin” Mine of KGHM Polska Miedź S.A. commissioned development of projects to mitigate the risk and to secure the areas and remove the dangers.

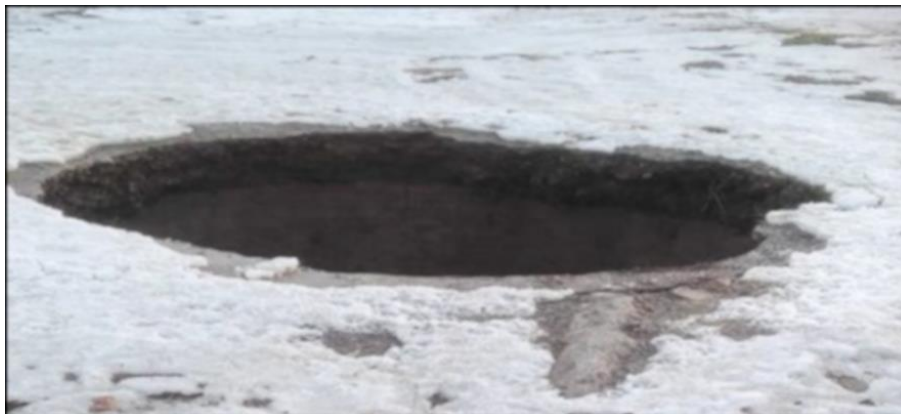
In the afternoon of 16 February 2017, in a private estate in the village of Lubków, in the area of the Lubichów III shaft, the emergence of mining damage in the form of a collapse of the terrain was observed in the former trunk part of the shaft (Fig. 1). The personnel of Lubin Mine took action on the same day by fencing the surrounding area, and securing the hole with a wooden structure until the form of removal of the resulting mining damage could be determined. The inhabited buildings were not damaged in any way, but the inhabitants of the building located approximately 10 m from the shaft (former building of the extraction machine) were relocated.

Fig. 2. Open part of the Lubichów III shaft on the day of the mining damage occurrence

The surveying services of "Lubin" Mine determined the size of the sinkhole using laser scanning. The diameter of the sinkhole was about 4.1 m and roughly corresponded to the diameter of the closed shaft. The gap after the shaft barrel was exposed in the sinkhole and the trunk part of the shaft was 0.45m below the ground. There were no deformations found in the ground around the shaft lining except for the bottom edge part of the shaft hole resulting from damage to its integrity on the edge of the cave-in. There was no depression of the surface outside the shaft, which indicates the stability of the orogen around the shaft barrel [16]. The following steps were taken to establish and document the ground-water conditions: core drilling of seven holes in the area from the bottom of the shaft to a depth of about 20 - 22 m; laboratory tests of the properties of the ground collected from the cores; and two tests by impact probing. The results indicated the physical and mechanical properties of the terrain in the area of the shaft; no basic groundwater level; absence of any cavities or hollow ground in the surveyed ground. This was a very important observation for the assessment of land stability around the shaft. A space in the shaft barrel unfilled with the filling material was exposed in the cave-in, with a water surface at a depth of about 39 m below the surface level.

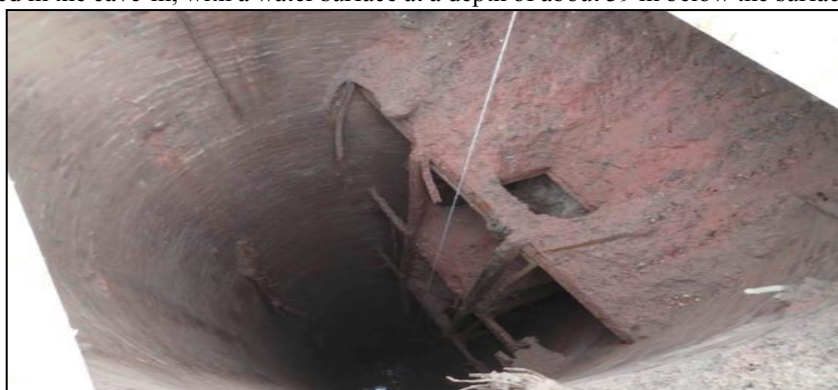
Fig. 3. The inside of the Lubichów III shaft – the entire shaft lining

On visiting the site, it was observed that the construction for the ladder compartment as well as the shaft girders and the hoisting shaft guides were built on the side of the ladder compartment. The presented section of the lining lacks beams that would separate the hoisting compartment. There was a visible overhang on the remains of construction of the ladder compartment which probably was a left-over after backfilling the shaft with rock material from the mining dump (Fig. 3).

This overhang prevented the identification of the integrity of the shaft inlet located at a depth of 6.0m under the ground level directly below the deck of the ladder compartment [16]. KGHM Cuprum performed indicative measurements of the level of the water mirror on 30 March 2017. They showed stabilisation at a depth of approximately 39 - 40m, with a test based on lowering the sinter below the mirror of the water at a depth of about 54m below the surface.

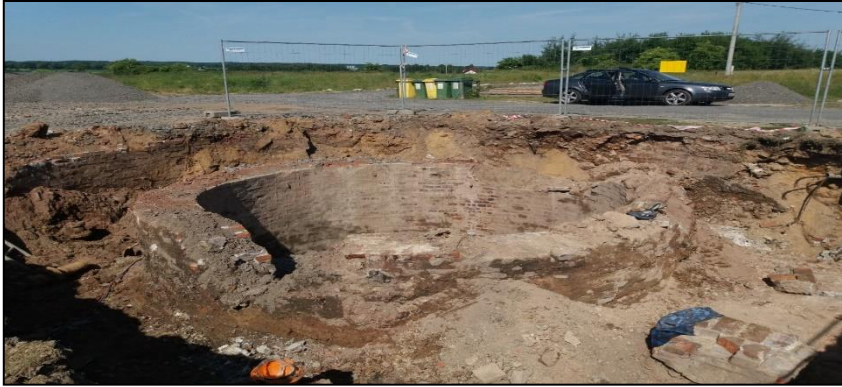
Fig. 4. Exposed Lubichów III shaft barrel.

The liquidation of the mining damage in the region of Lubichów III included the capping of the shaft inlet at its trunk and safeguarding the trunk part of the shaft with a reinforced concrete slab cap. This ensured full security of the shaft, both for the users of facilities located in its vicinity as well as for the environment. For the duration of the time needed to prepare the project fully and analyse the results obtained from the drilled holes, the shaft was fenced and secured with a wooden structure. The site was also monitored. The following actions were taken on the basis of the project to liquidate the collapsed Lubichów III shaft: uncovering of the shaft barrel (Fig. 4); filling the cavity in the shaft barrel; filling the interior of the shaft with crushed basalt stone to the depth of approximately 55m; making of a reinforced concrete slab of 7.5x7.5x0.5m in a central position above the shaft, including insulation and placing of an inspection hole (Fig. 5); to monitor the interior of the shaft, with an inspection planned for July 2019 to determine whether the filling material level has changed and requires further filling; covering of the reinforced concrete slab with soil and return of the land for use by the owner of the property.

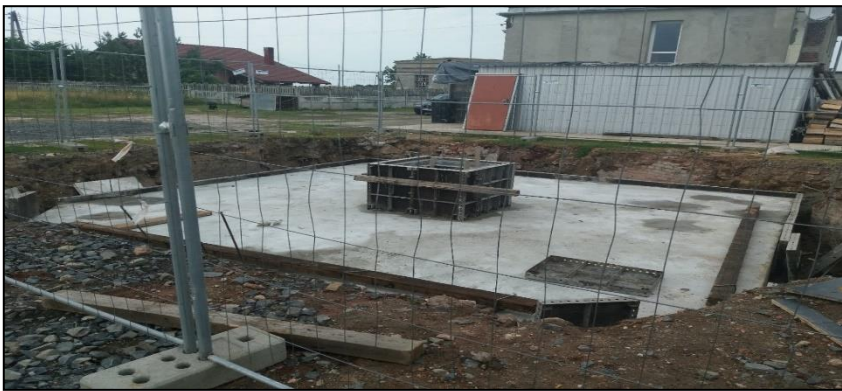
Fig. 5. Reinforced concrete slab with inspection hole securing the Lubichów III shaft barrel.

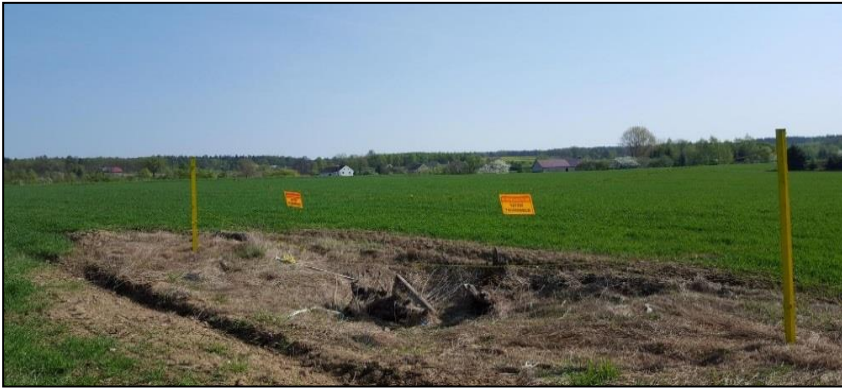
Mining damage in the form of a collapse of the terrain in the trunk part of the Lubichów IVa ventilation shaft (Fig. 6) was observed on private agricultural land in Lubkowo [17]. The exact date of its occurrence is unknown. The cave-in was reported by the owner of the parcel in April 2018 and a notification delivered concerning its location (Lubichów IVa shaft area).

The size of the sinkhole was determined by the "Lubin" Mine surveying services. The cave in is 0.74m in its deepest part with a diameter of approximately 4.0m. The trunk part of the shaft was invisible and the space of the shaft barrel remains covered. It was not possible to identify the material used to fill the shaft barrel [17]. The integrity of the ground on the edge of the deformation was unspoilt and there was no sedimentation of the surface in the area around the shaft. Due to the way the area was used the surface of the land was covered with vegetation, with dead shrubby vegetation visible in the sinkhole.

Fig. 6. The sinkhole in the trunk part of the Lubichów IVa shaft.

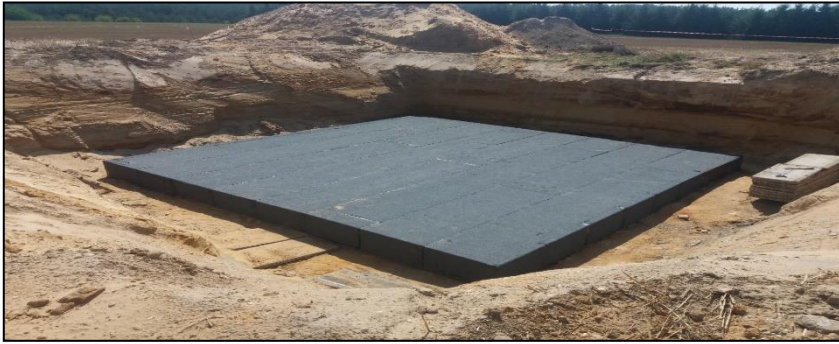
Fig. 7. Reinforced concrete slab approx. 3m under terrain level, dimensions: 7.0x7.0x0.5m

The site was monitored throughout the preparation of the project, for the time needed for the ground-penetrating radar survey (GPR) and the analysis of the results. The following actions were taken following the project: a 10.5m x 10.5m excavation (approx. 3 m deep) to uncover the shaft barrel which in turn was not found at the designated depth; it was decided not to continue the excavations after consulting the company implementing the project; at the level reached by excavation works a 7.0x7.0x0.5m reinforced concrete slab without a revision hole was placed in the central position over the shaft - the slab was insulated (Fig. 7); the cave-in was filled with sand of appropriate fraction and humus to restore the land for use by the owner of the parcel.

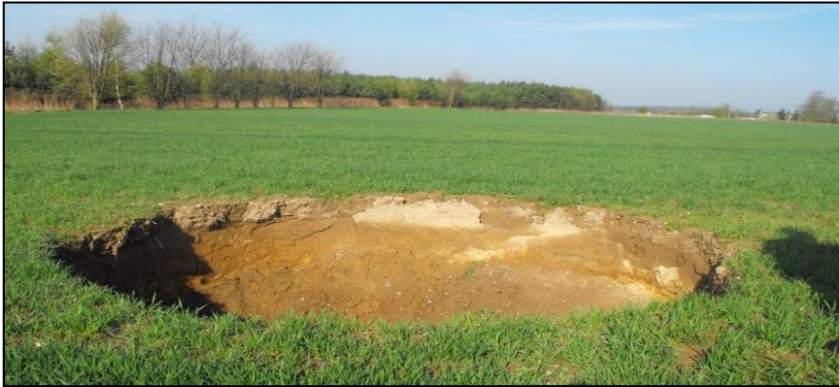
A non-continuous deformation of the area of unknown origin in the form of a rupture was revealed in April 2018 in the village of Lubków in the south-western part of the mining area "Lubichów". The sinkhole was created during field work using agricultural equipment. The deformation was about 60m south-west of the Lubichów IVa ventilation shaft. The elevation of the terrain near is at an altitude of about 216m above sea level. Measurements have shown that it has a circle shape of approximately 4.0m in diameter. The estimated depth of the sinkhole is approximately 2.0m [18].

Deformation was caused by the collapse of the terrain into the orogen to a depth of about 2m. It was a circular rupture due to the geometry in the horizontal section. The rupture walls were steep near the edge of the surface while the deeper part was shaped as a conical funnel (Fig. 8). The ground was damp and not covered with vegetation inside [18]. There was no subsidence of the terrain or other forms of deformation in the perimeter. The area around the sinkhole was secured by a ring-fence and signage (Fig. 9) the genesis of the sinkhole could not have been determined and it was impossible to confirm the stability of the soil.

It should be considered that the formation of non-continuous sinkhole is of anthropogenic origin due to its location and nature because, according to all available indications, it constitutes an unintentional side effect of the former mining activity of "Lubichów" Mine. All things considered, it can be assumed that the "Lubichów" sinkholes were mainly influenced by the following factors [18]: location in the shallow located drifts of "Lubichów" mine, including above all the ventilation drift pos. 52; insufficient thickness of the rock mass in the overcap for filling the void; the hydrogeological situation in the region related to the restoration of groundwater level; the activity of rainwater infiltrating into the ground; presence of the active fault in the area.

Fig. 8. The sinkhole in Lubichów IVa shaft area.

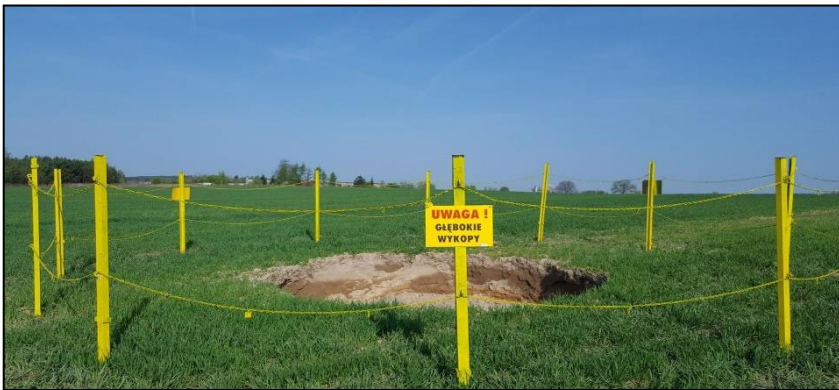
Fig. 9. Secured sinkhole in Lubichów IVa shaft area.

The site was monitored throughout the preparation of the project, for the time needed for the ground-penetrating radar survey (GPR) and the analysis of the results, the sinkhole was adequately secured. It was decided to secure the sinkhole by deepening it and filling with crushed basalt rock of the indicated fraction (Fig. 10) and to build a fence around about 0.10 hectares of the parcel (Fig. 11) in order to monitor the position of the level of the upper surface of the filling for a period of three years until 06 September 2021 based on part II of

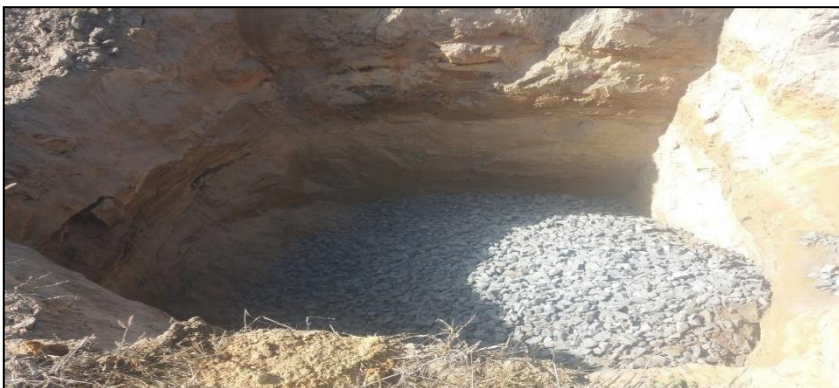
Fig. 10. The filling of the landslide located in the area of the Lubichów IVa shaft.

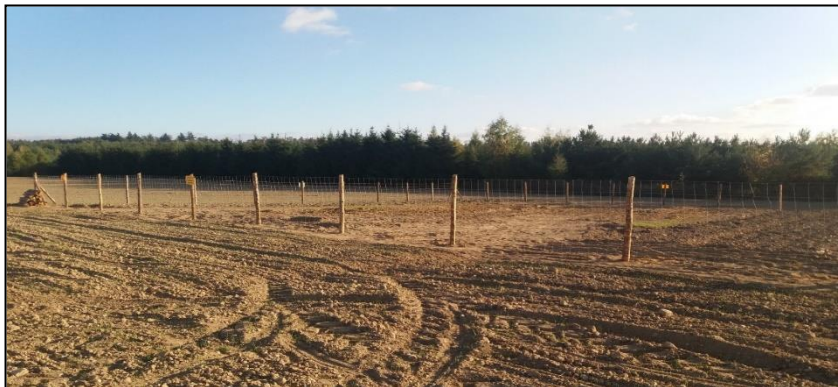
Fig. 11. The fence around the area of the landslide under surveillance.

Mining damage can become apparent in the mining areas of the Old Copper Belt although the mines there have long been excluded from exploitation, the mines have been closed for years and the mining sites have been liquidated. Phenomena that are described in the paper may occur. The damage caused in the Lubichów III and Lubichów IVa shafts protected by crushed basalt rock backfilling and covered on top with reinforced concrete slab ensures that the damage of this kind in this place will not happen again. Treatment of the non-continuous deformation (sinkhole) in the Lubichów IVa shaft area by backfilling with crushed basalt rock does not mean the damage will not reoccur. Hence, the decision to put a fence around the sinkhole site and constant monitoring of the site for three years seems appropriate.
