Analysis of the displacement of road embankments and bridges located in areas prone to landslides

Cracow University of Technology, Faculty of Civil Engineering, Cracow, Poland

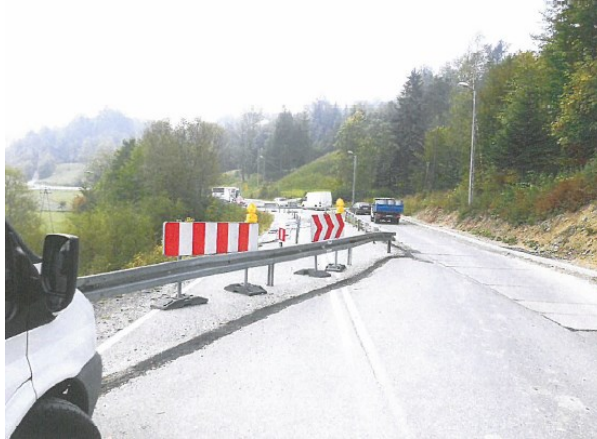
The landslide became active in 2007 and 2010. At that time, along the eastern side of the road, protection in the form of micropiles topped with a cap was applied [5,6]. This protection slowed down gravitational movements and protected the road from breaking completely. In 2014, as a result of rainfall, the landslide reactivated once again. A road fault with a height of 6-8cm was created on the road at the border of the active landslide (Fig. 2). Due to the danger of using the damaged section of the road, a temporary road was constructed using concrete slabs on the west side and a temporary barrier was installed to prevent access to the damaged section of the road. Within the active landslide and near the landslide, there were many fresh intra-landslide slopes, thresholds, crevices, cracks, water exudation, and uneven terrain.

Fig.2. Road surface damage [5].

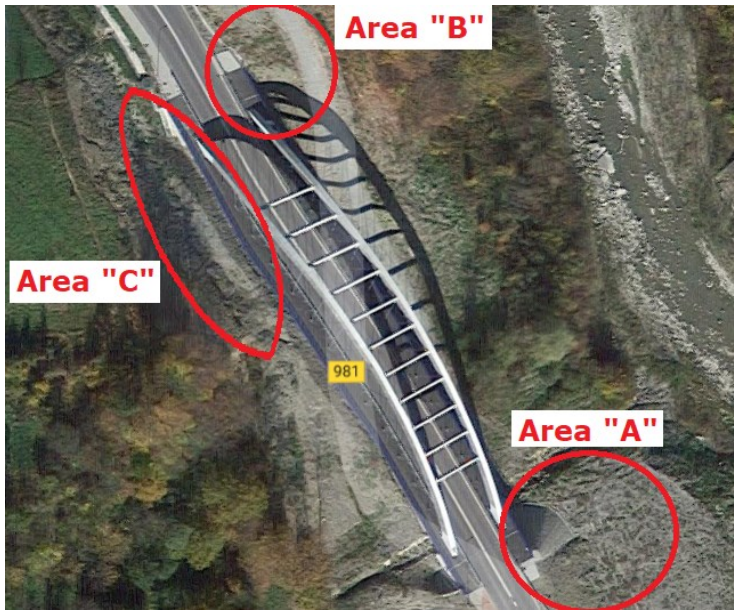
The three areas most threatened by damage to road No. 981 were adopted for analysis (Fig. 4). The areas “A” and “B” include the surroundings of the abutments at the site of the previous active landslide. Area “C” includes a slope located on the west side of the object, in its immediate environs.

Fig. 4. Areas of research adopted for differential analysis with a terrestrial laser scanner.
