# Analysis of school damage due to Lombok earthquake on August 2018

**Abstract.** The Lombok earthquakes on 5 and 19 August, 2018 have caused fatality and damage buildings including houses and schools. It was reported that the Lombok earthquake had caused damage to at least 606 schools in West Nusa Tenggara. Following the earthquake, the field survey was carried out in a few days to collecting data of damaged schools in Lombok. The global positions of surveyed schools were recorded during the survey to identify the geological and seismicity condition surrounding area. The data were analyzed to understand the cause of the damaged. The damage pattern of the schools is also analyzed and then compared to the other related studies. The damage on the schools in Lombok Island generally has a result of insufficient quality of the building materials. Further, understanding the earthquake resistant building for earthquake prone areas is the most basic knowledge to be informed to the Local Government who has authority to manage the schools. This study suggests for establish Local formal rule of related to minimal requirement for earthquake resistant school building following the microzonatio

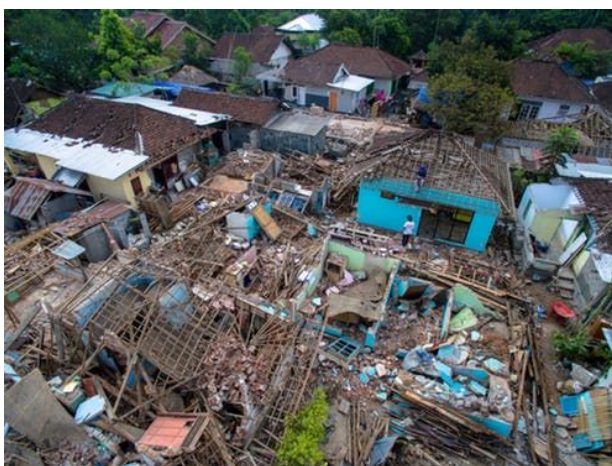
**Fig. 1.** The Damage in Lombok earthquake 2018 [2].

The damage caused by the earthquakes was in the form of collapsed building and houses, cracked soil, and liquefaction. The main recent damage and collapse of buildings due to earthquakes occurred generally due to the weakness of the buildings for anticipating the ground motion.

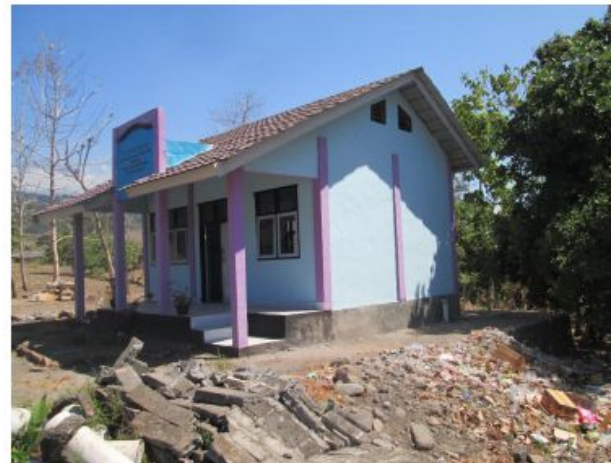
**Fig. 5.** The general structure of SD 02 Obel-obel

The main structure of observed building of SD Negeri 02 Obel-obel (Fig. 4) is made of brick masonry wall. This building is used for reading class. The main structure of the building may also be categorized as confined wall (Fig. 5).

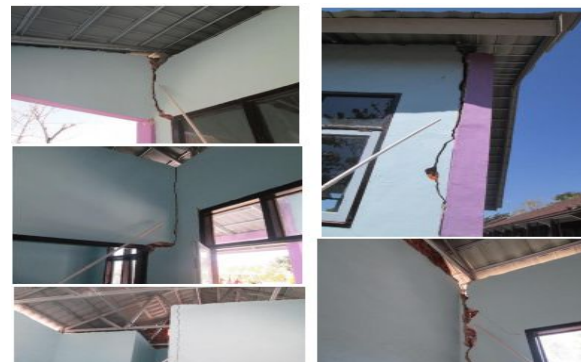
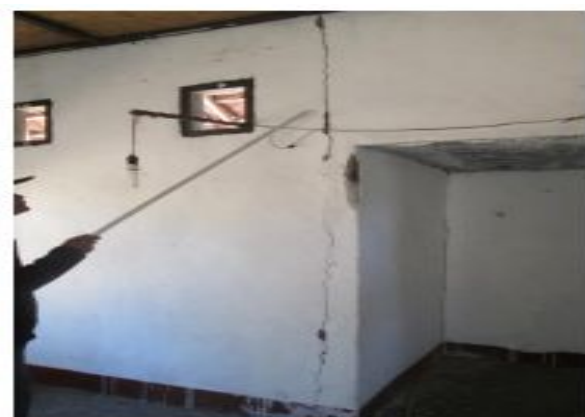
**Fig. 6.** The Damage type of SD 02 Obel-obel

This building is still firmly standing but it suffered from detail damage. It can be categorized as light to medium damage. First, the connection between the wall and the confining reinforce (RC) concrete was cracked (Fig. 6). It seems there is not enough steel bar to connect the walls and the main RC columns. Second, the overlaps main steel bar is to short. It is at least 40 time of the main bar diameter. Since then, the joints of perimeter beam and column was pulled out during the earthquake.

(a) Reading Room

(b) Praying Room

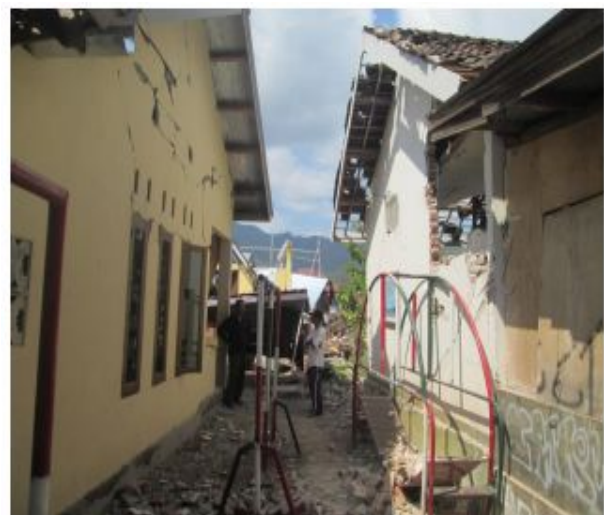
**Fig. 9.** The Heavy Damage type of Paud Terpadu PB

Second building, there are many cracks on the wall connected to the confining reinforce (RC) concrete (Fig. 9). It indicates there is not good enough connection between the walls and the main RC concrete. Since the crack also existed in horizontal direction where generally no need connected bar, it shows the material of the building is not in good quality. Moreover, the roofs of the buildings are made of burned clay which may have a relatively weight compared to the metal roofs.

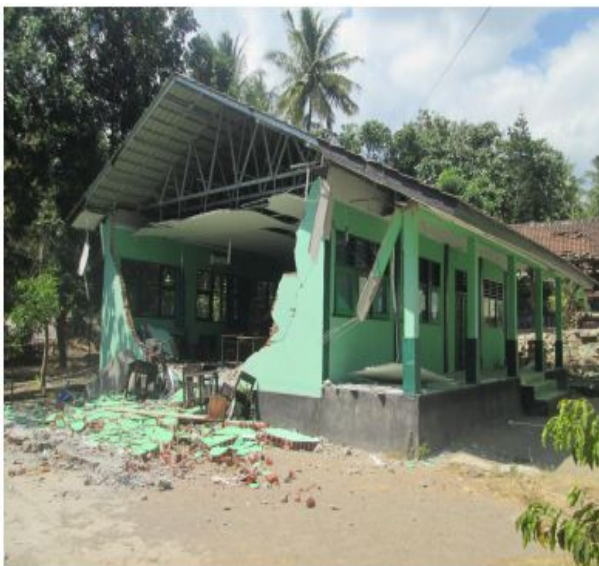
**Fig. 11.** The damage of SMP N 01 Pemenang.

The structure of observed building of SMP Negeri 1 Pemenang (Fig. 10) is made of confined brick masonry wall. The building is used for learning classes. The building collapse badly in one side (Fig. 11). The rest of the building can be said still firmly standing even it suffered from small detail damage. This building relatively new building which can be seen from the

material used. It uses the light formed steel for roof construction and uses light metal roof material as well. The side damage indicates the low quality of material and its connection. The wall - roof connection just only 'simple touch' each other. Structurally it is considered to be No Connection at all.
