Possible in-service damages of steam generators at VVER-1000 and VVER-1200 NPP units and their impact on long-term operation

Abstract. Specific features of corrosion-mechanical damages of primary circuit header to steam generator vessel branch welds at VVER-1000 NPPs and their impact on safety and economic efficiency during long-term operation are analysed. Measures to avoid the damages for similar zones of VVER-1200 steam generators are discussed.

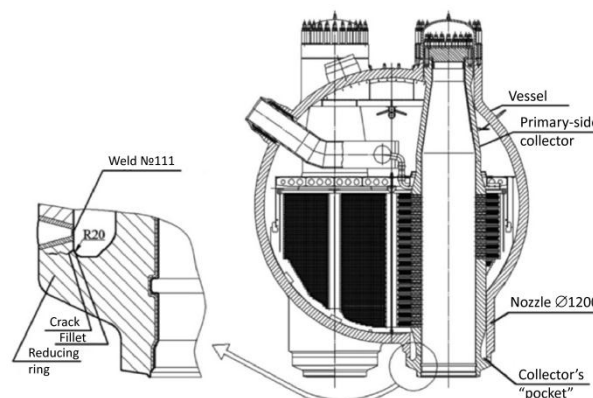
Specific design features of SS-111 zones under consideration are shown in Fig.1 [2]. SG branches connected to headers are oblique ones having long and short forming lines. A typical view of the SS-111 zone "pocket" is shown in the right part of Fig.1.

Fig.1. Steam generator PGV-1000M [2]

Damage of SS-111 starts on the inner surface from the "pockets" under corrosion impact of the secondary circuit coolant. Water chemistry parameters inside the "pockets" (Fig.1) may differ for the worse with accumulation of corrosion products and increased content of impurities.

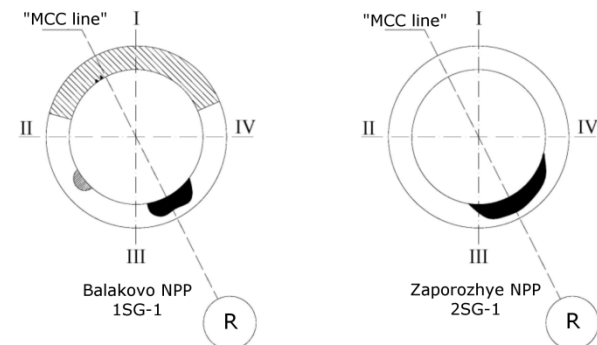
The results are consistent with the hypothesis that there is a directed mechanical impact of the MCC piping on the SS-111 zones, which should be considered as the main factor in the formation and growth of primary cracks in the direction of the "MCC line" (Fig.4-6). Fig.4 shows caption comments that are common to Fig.4-6.

- - primary damage (1st repair)
- ▨ - secondary damage (2nd and other repairs)
- ⊙ (R) - reactor

- I - long forming line (FL) of the Ø1200 SG branch
- II - FL of the Ø1200 SG branch near SG "cold" bottom (Figure 4)
- III - short FL of the Ø1200 SG branch
- IV - FL of the Ø1200 SG branch near SG "hot" bottom (Figure 4)
- "MCC line" connects centers of reactor and each SG header

Fig.4. Zones of primary and repeated defects in SS-111 of VVER NPP Units of the project V-320 ([2])

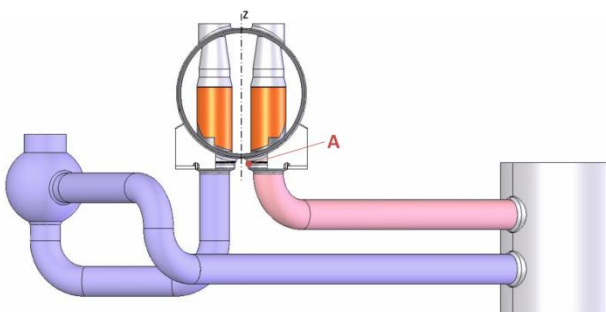
Fig.7. Layout of MCC piping of VVER NPP Units of "small" series ("hot" MCC piping in rose color)

Points A (Fig.7) and B (Fig.8) show maximum loaded zones located near short forming line of SG branches and "MCC line" (Fig.3).

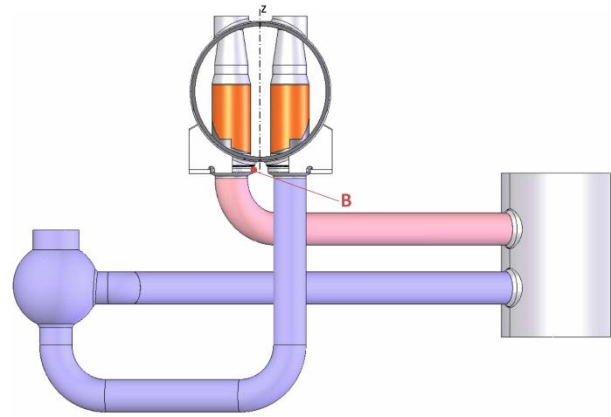
Fig.8. Layout of MCC piping of VVER NPP Units of the project V-320 series ("hot" MCC piping in rose color)
