# Research on Metal Supervision and Inspection Standards for Gas-steam Combined Cycle Units

**Abstract.** Domestic gas-steam combined cycle units start and stop frequently, and the load changes greatly, which accelerate the expansion of defects, such as fatigue, cracks, and organizational deterioration of metal components. In view of the problems caused by the material selection characteristics of gas-steam combined cycle units and the daily shutdown mode, several common typical cases of gas-steam combined cycle units are analyzed, such as compressor blade fatigue fracture, main steam combined valve body fatigue cracks, pipeline and pressure vessel weld fatigue cracks. As well, the gas-steam combined cycle unit metal supervision content and inspection emphasis are studied and supplemented.

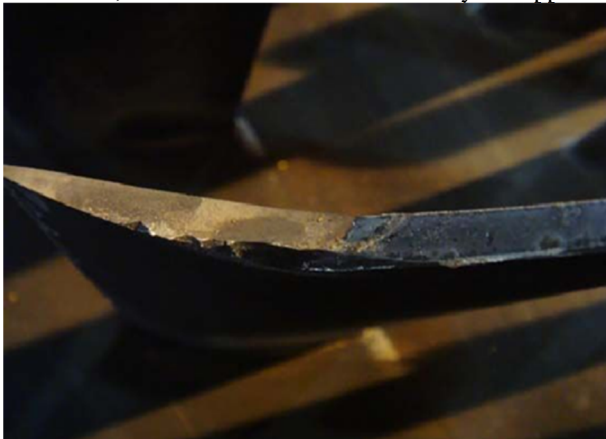
equipment hidden dangers like .... These accidents and hidden dangers were found to be related to frequent peak shaving or daily shutdown [7]. Figure 1 and Figure 2 show the fracture morphology and damage degree of the compressor S1 of a certain S109FA gas-steam combined cycle unit respectively. The fracture morphology shows obvious high-cycle fatigue fracture. Through the analysis, the vibration of the shaft system near the critical speeds of 1, 2, and 3 gradually increases when the unit speeds up and the compressor may have resonance when the speed changes every time the unit is started and stopped for the low resonance margin of the static blade of the compressor. Hence, after a long period of frequent daily start and stop operation, metal fatigue and dynamic and static friction would occur on the compressor blade under multiple resonances, and blade fracture is more likely to happen.

Fig1. Sectional appearance of compressor blade

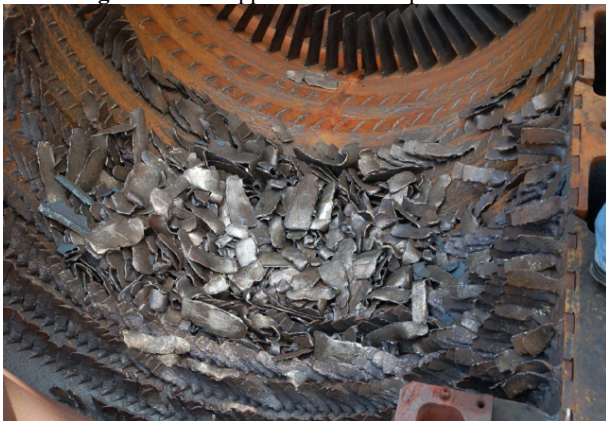
Fig2. Damage degree of compressor blade

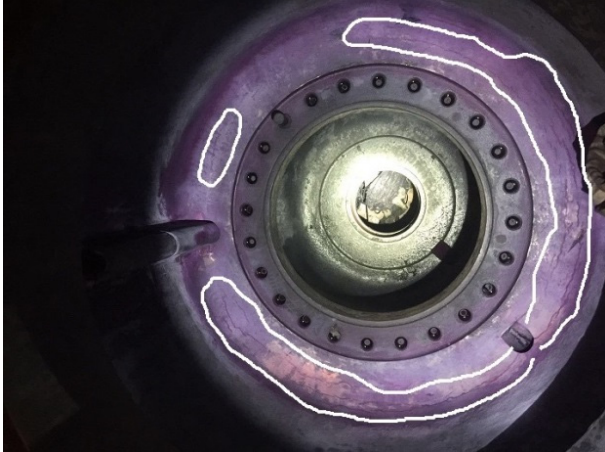
A certain S109FA gas-steam combined cycle unit with a D10 standard steam turbine (GE) was selected to demonstrate the fatigue crack, and it is a single-shaft, three-pressure, reheat, two-cylinder, impulse condensing combined cycle steam turbine. By November 2018, the unit had been operated for a total of 42,528 hours and started and stopped 1,561 times. Cracks were found by endoscopy in the body of the high-pressure main steam union valve, which was made of GE brand B50A224B, equivalent to ASTM A356 Gr9 class, and the composition was 1 Cr1Mo V, namely ZG15Cr1Mo1V. As shown in Figure 3, multiple cracks were revealed by the color

penetration test of the bottom joint surface of the high-pressure main steam combined valve casing. The oxide scale around the crack was polished and then colored and penetrated again. It was clearly found that the crack surrounded the valve casing and the length reached about 4/5 of the inner circumference of the valve casing. Further inspection showed that the crack starting point was located in the trap hole, as shown in Figure 4. Subsequently, the endoscope was used to detect the cracks inside the hydrophobic hole, and it was found that the cracks extended 4mm along the hydrophobic hole.

The analysis shows that the drain flows backward into the valve from the trap of the valve seat and is deposited on the side of the trap. Generally, when the unit starts, steam flows through the valve seat, and the valve seat expands with heat. However, due to water accumulation in the trap side of the valve seat, the temperature rise on the trap side of the valve seat is obviously slower and the expansion is smaller than that on the sealing surface, resulting the tensile stress on the sealing surface. Conversely, when the unit is shut down, the sealing surface side shrinks relatively faster than the drainage hole side. Hence, the sealing surface side is subjected to additional compressive stress, and such alternate stress changes eventually lead to the cracking of the sealing surface. In all, the reasonable drainage pipe layout of the valve seat and timely drainage is of great significance for the long-time range stable operation. or combined cycle [8-9].

**Fig3.** Cracks at the bottom of the valve casing.

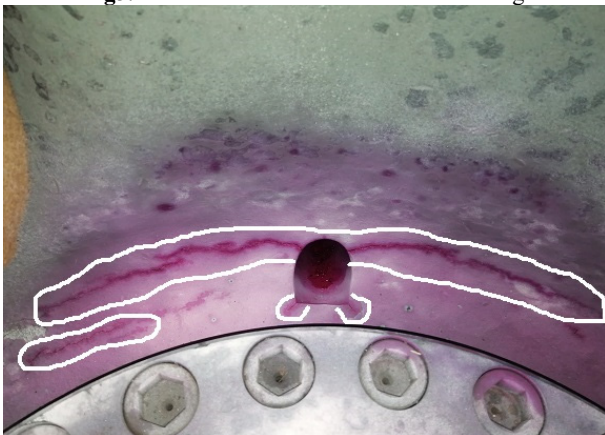
**Fig4.** Cracks on the hydrophobic port location.

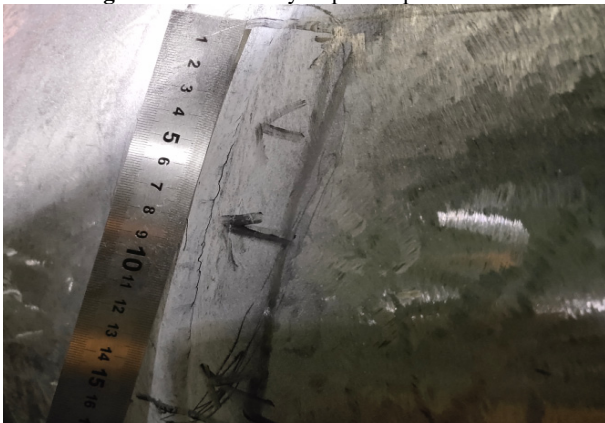
A 9F gas-steam combined cycle generator set was put into production in 2013. It adopts a single-shaft combined cycle type and consists of a PG9351FA gas turbine, a dual-cylinder dual-flow steam turbine with a D10 three-pressure reheat system, a 390H hydrogen-cooled generator, and a three-pressure reheating system. During the maintenance period in April 2019, the metal supervisory inspection of the butt joint girth weld was carried out, and it was found that there was a pipe weld fusion line. The crack defect is about 150 mm long and the depth is about 10 mm. Typical defects are shown in Figure 5.

According to the survey data, the unit has been in operation for about 10,500 hours, and started and stopped 675 times, which frequently participates in peak-shaving variable load operation. In addition, the desuperheater often sprays water to adjust the high-pressure steam parameters. Frequent and drastic changes in temperature have brought great challenges to the service materials of the unit, causing multiple high-parameter steam leaks in the pipes, which has brought great harm to the safe and stable operation of the unit.

**Fig5.** Cracks on weld fusion line of the high voltage bypass desuperheater pipe.

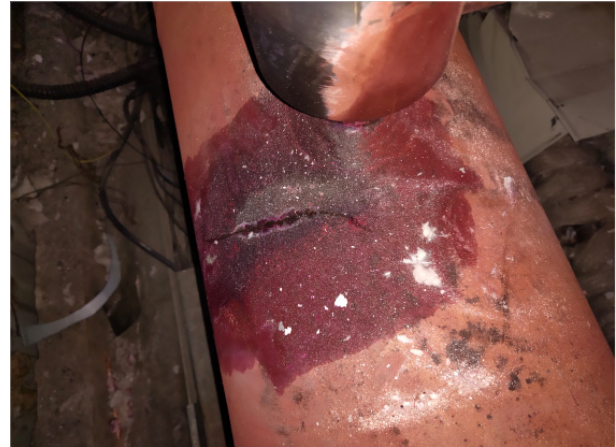
Figure 6 shows a SGT5-2000E cogeneration unit of a Siemens company. During operation, it was discovered that there was steam leakage in the pipe of the high-pressure heat supply desuperheating and pressure reducer. The pipe material was 12Cr1MoVG and the specification was  $\Phi 273 \times 14$ mm. According to the shutdown inspection, circumferential cracks and through cracks were found in

the pipe base material, and these cracks were located at the rear end of the nozzle head in the desuperheating water 150 mm. It can be seen that, in view of the characteristics that gas units frequently start and stop to participate in peak adjustment operation, the metal inspection cycle of complex stressed parts of high-parameter pipelines, such as elbow weld, tee, temperature reducer, pipe base fillet weld and other key positions, should be shortened and special inspection of high-temperature and high-pressure steam pipelines should be carried out.

**Fig6.** Circumferential cracking of the base material of heating and desuperheating pressure reducer pipe.
