Predicting remaining life of lattice steel transmission tower based on condition assessment and corrosion hazard data

Fathoni Usman^{1*} and Nor Hazwani Nor Khalid²

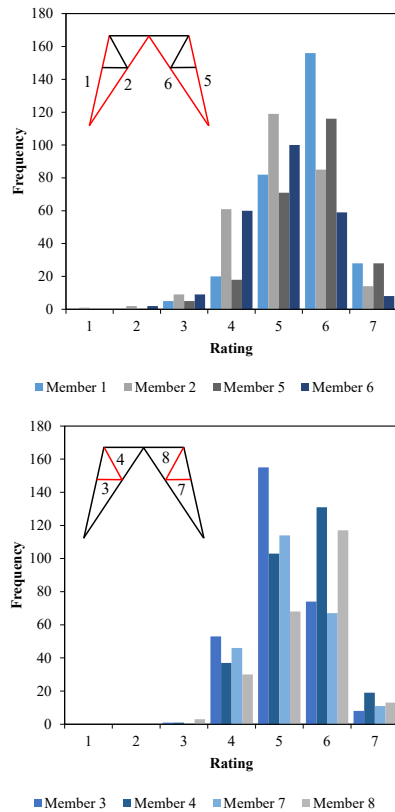
Corrosion was the common sign of deterioration observed during the assessment. The corrosion was on the galvanized coating with no significant further corrosion to the carbon steel member. The galvanized Zink coating observed has more than 100 microns of thickness. Figure 2 shows the distribution of corrosion on tower members. It shows that corrosion is observed more often on redundant members with less slanted or flat-oriented members. There is 25% soil with high and highly corrosivity conditions recorded and affecting the concrete condition. Figure 3 shows the Partial correlation graph of soil corrosivity and concrete condition.

Fig. 2. Corrosion rating distribution for main member and bracing.

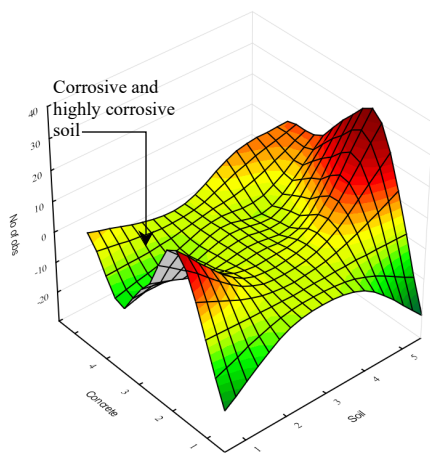
Fig. 3. Partial correlation graph of soil corrosivity and concrete condition.

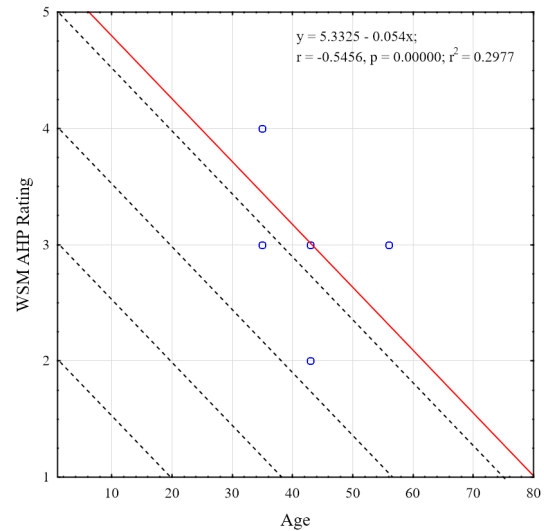
The multi-criterion decision analysis with AHP produced weighing for each sub-component with 19.5%, 22.5%, 21.2%, 23.1%, 13.7% and the *CI* of $0.084 < 0.1$. Figure 4 shows the linear fitting curve for the tower condition rating and age of the tower. It is found that the predicted age of a tower from this study can reach more than 70 years when it has a condition rating of 5 with an *r*-value of 0.5465. The predicted life of a tower will gradually reduce by about 20 years for each decrease of the tower condition rating.

Fig. 4. Linear fitting of brushed data of condition rating and age of the tower.

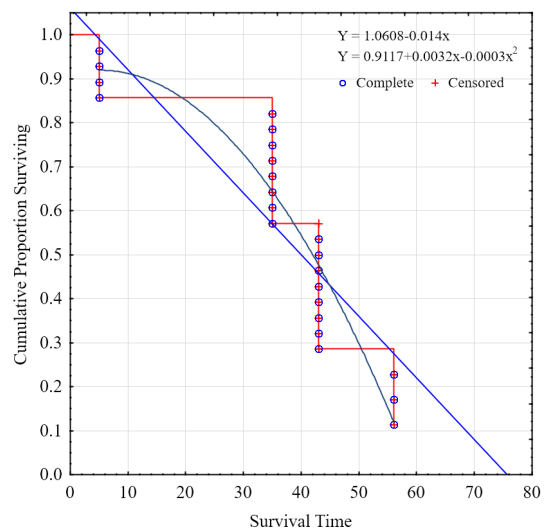
The predictive remaining life of the lattice steel transmission tower in this study uses Kaplan-Meier survival analysis. The Kaplan-Meier model is based on estimating conditional probabilities at each time point when an event occurs to estimate the survival rate at each point in time. In the survival study, the tower condition rating and the age at which each rating is applied as the condition changes through time. Figure 5 shows the survival function plotted as a step function with the fitting curve of linear and quadratic mode. Visually, the range of predicted life of the tower from the survival function seems to be a good approximation of 60 to 78 years.

Fig. 5. The survival function plotted as a step function with fitting curve of linear and quadratic mode.
