Analysis of Leakage Cause of L415M Spiral Submerged Arc Welding Pipe

Abstract. The causes of longitudinal crack in gas pipeline during pressure were analyzed by means of mechanical property test, microstructure analysis, sem analysis and energy spectrum analysis. The results show that the leakage of L415M spiral submerged arc welded pipe is caused by the contact between the base material of steel pipe and low-melting copper alloy in the process of high temperature, resulting in the brittleness of liquid metal. Specifically, when the leakage site of the steel pipe is heated at an abnormal high temperature, copper penetration along the grain boundary causes embrittlement, strength reduction and crack along the grain boundary, finally leading to the crack and leak of the steel pipe.

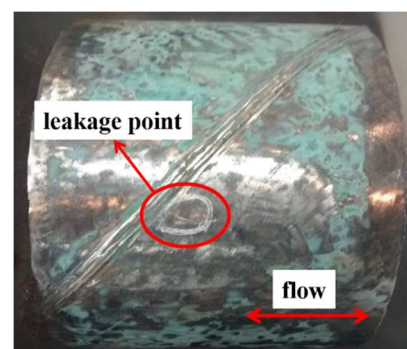
(a) Morphology of steel tube outer wall

The sample is the pipe section at the leakage site cut by a flame, and the leakage point is about one meter from the nearest pipe end. The morphology of the steel pipe after stripping the external coating is shown in Fig. 1. There are obvious cracks in the inner and outer walls of the steel pipe at the leakage point, and the cracks are distributed

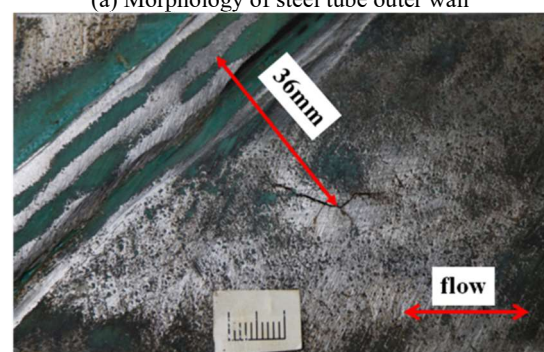
(b) Morphology of steel tube outer wall leakage point

along the longitudinal direction of the pipe body. The crack center is 36 mm away from the center of the spiral weld, as shown in Fig. 1(b).

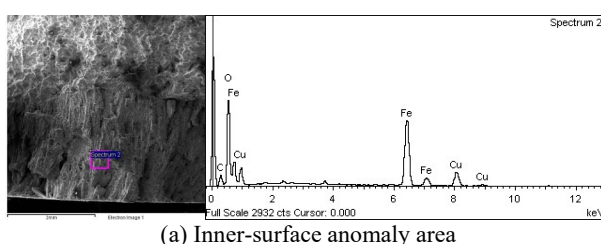
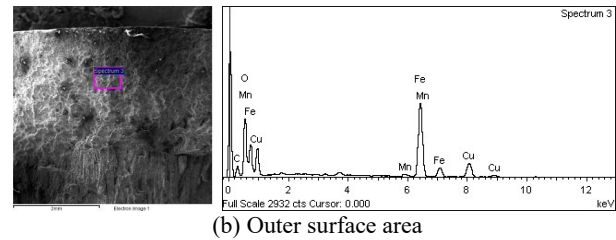
Fig 10. T3 fracture surface energy spectrum analysis

The energy spectrum analysis of the inner and outer layers of the T3 fracture surface is carried out. The results are shown in Fig. 10. There are Cu elements in the abnormal area of the inner layer and the outer layer of the fracture surface, indicating that Cu elements are enriched in the crack area.
