Understanding of subsurface conditions controlling flow liquefaction occurrence during the 2018 Palu earthquake based on resistivity profiles

Abstract. The 7.4 Mw earthquake on 28th September 2018 in Palu City triggered a flow liquefaction phenomenon in the Balaroa and Petobo areas, contributing to significant casualties and building damage. This paper presents the results of a liquefaction study to map subsurface conditions in these areas using the multi-electrode resistivity method with the dipole-dipole configuration. The objective of this study is to understand factors controlling the flow liquefaction phenomenon. Based on the interpretation of 2-D resistivity images, the liquefied soil layers are characterized by lower resistivity values than the non-liquefied layers. These contrasts of resistivity values form a gently sloping boundary between the liquefied and non-liquefied soil layers. The resistivity image perpendicular to the flow direction indicates the presence of a subsurface basal morphology in the Balaroa area, suggesting that a shallow groundwater zone is present within the liquefiable soil layer. Thus, the subsurface topographical condition is the main governing fa

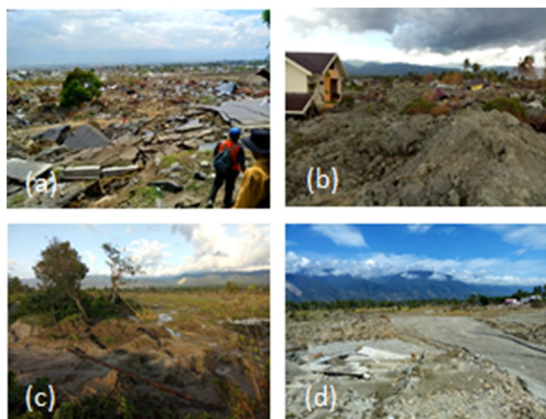
Fig. 1. Flow liquefaction phenomena in (a) Balaroa, (b) Petobo, (c) Ojo Oge and (d) South Sibalaya.

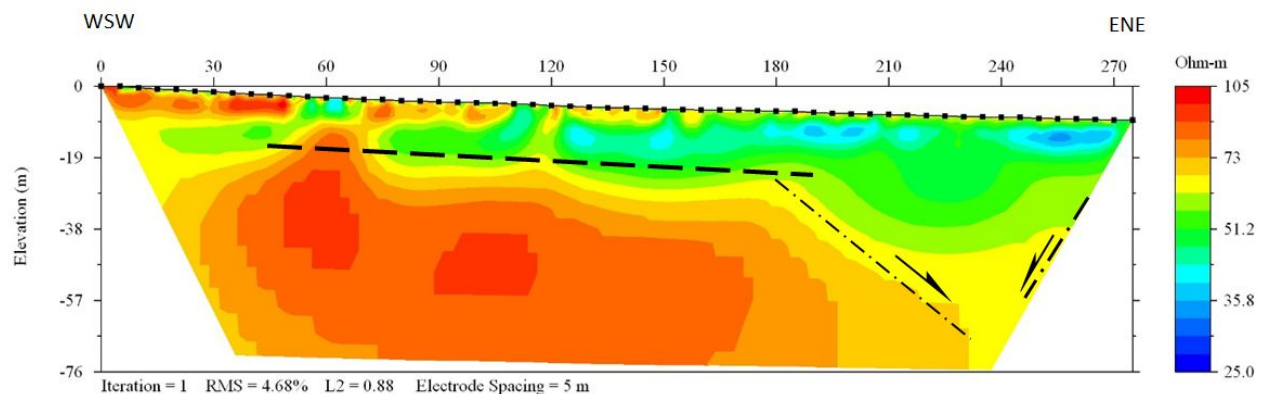
Fig. 5. Resistivity profile for WSW-ENE direction at the Balaroa site. The black dotted line indicates the inclined plane at the boundary between the soil layer with low resistivity and the soil/rock layer with high resistivity. Dashed-dotted lines and arrows indicate the normal faulting. The profile map view is shown on Fig. 4a.

As shown in Fig. 5, the boundary between alluvial deposits and the old alluvial fan layer forms an inclined plane at a very gentle angle from west to east. Thus, this subsurface topography is likely to govern the initiation of movement of liquefied soil mass to turn into flow liquefaction during the earthquake. Fig. 5 also indicates the thickening of alluvial deposits to the east due to the existence of a basinal structure associated with the normal

faulting component of the Palu-Koro Fault. [18] also found this basin geometry from the analysis of microtremor measurement data in this area.

Furthermore, the examination of Fig. 5 and 6 clearly shows that the boundaries between alluvial deposits and alluvial fan deposits are still intact after the flow liquefaction event. It implies that the flow liquefaction only involved the alluvial deposits. The presence of high

resistivity layers at the ground surface is associated with the remnants of alluvial fan deposits being displaced during the earthquake.

It is also evident that the alluvial deposits indicated by low resistivity of less than 30 Ωm at a depth of shallower than 10 m were locally developed after the liquefaction event. This finding suggests that the highly saturated soil layers are still present within the liquefied soils. Hence, the area is still prone to a liquefaction hazard in the future.

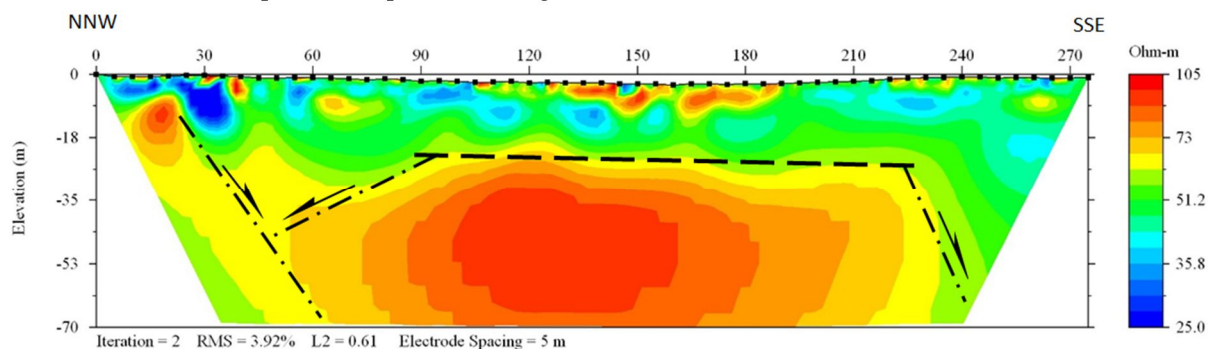
Meanwhile, Fig. 6 indicates that the boundary between low and high resistivity seems to form a basin geometry associated with normal faulting components of the Palu-Koro Fault. This basin geometry will control groundwater flow to this liquefied area. Consequently, shallow

groundwater levels will easily develop in this area to cause the soil mass to liquefy during the earthquake. The old alluvial fan deposits seem to disappear, and the alluvial deposits become thicker in the southeast direction. Consequently, this area experienced less intense flow liquefaction than the main area during the earthquake, as evidenced in Fig. 4(a).

Fig. 6. Resistivity profile for NNW-SSE direction at the Balaroa site. The black dotted line indicates the inclined plane at the boundary between the soil layer with low resistivity and the soil/rock layer with high resistivity. Dashed-dotted lines and arrows indicate the normal faulting. The profile map view is shown on Fig. 4a.

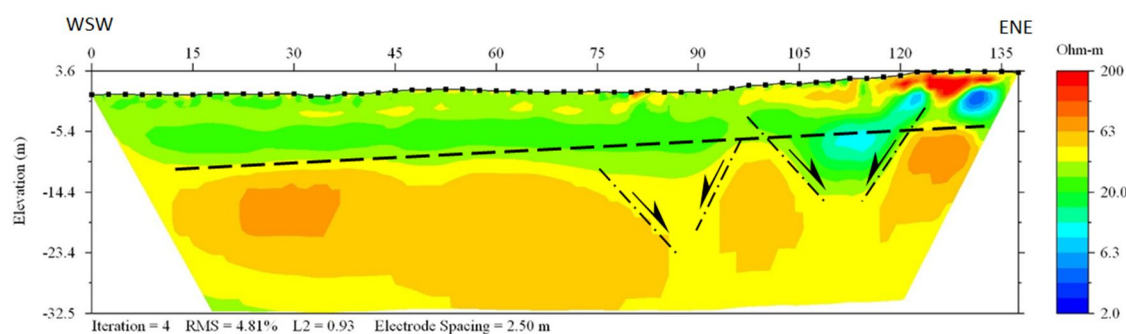
Fig. 7 presents the results of the geoelectric survey for the east-west direction at the flow liquefaction location in the Petobo area. The resistivity profile shows that the resistivity values range between 2 and 200 Ωm with a coverage depth of 36 m. The soil layer with a low resistivity profile (less than 40 Ωm) is probably associated with the alluvial deposits. In contrast, the high resistivity layers (>40 Ωm) are probably associated with the old alluvial fan deposits. Some fragments of alluvial fan deposits can also be found near the surface, as indicated by higher resistivity values, in most parts of the slope profile. The boundary between these different deposits forms an inclined plane at a gentle angle from east to west that controls the generation of flow liquefaction. Close

examination of Fig 5 and 7 suggests that the inclined boundary in the Petobo site is steeper than in the Balaroa site. Consequently, the liquefied soils in the former flowed at a greater distance than in the latter.

Fig. 7 also shows the presence of basinal structures within the alluvial fan deposits, probably due to normal faulting associated with the movement of the Palu-Koro Fault. This basin geometry may control groundwater accumulation within the alluvial deposits, which leads this sediment mass to be highly saturated, and thus, highly liquefiable during the earthquake. Localized very low resistivity layers are still detected within the alluvial deposits, indicating saturated alluvial deposits are still present near the ground surface in the upper part of the slope profile. These pieces of evidence indicate that the Petobo liquefied area is still prone to flow liquefaction in the presence of a strong earthquake in the future.

Fig. 7. Resistivity profile for WSW-ENE direction at the Petobo site. The black dotted line indicates the inclined plane at the boundary between the soil layer with low resistivity and the soil/rock layer with high resistivity. Dashed-dotted lines and arrows indicate the normal faulting. The profile map view is shown on Fig. 4b.
