Implementation of earthquake mitigation at the engineering faculty, university of mataram

Teti Zubaidah^{1,2*}, Rosmaliati^{1,2}, Cipta Ramadhani^{1,2}, and Dwi Ratnasari^{1,2}

Abstract. After the 2018 Lombok earthquakes, buildings within the Engineering Faculty of the University of Mataram (FT Unram), were severely damaged and there have been no comprehensive treatments. Facilities to support earthquake mitigation, such as signs for evacuation routes and assembly points (temporary evacuation sites), are still minimal, and even if they are available many of them are not designed and placed properly. Some parts of the buildings have been partially renovated, meanwhile, there are new buildings constructions that have not been investigated related to disaster mitigation. Anticipating the re-occurrence of big earthquakes in Lombok, it is very necessary to carry out activities for implementing earthquake mitigation at FT Unram. The activities are divided into three stages, namely *first*: conducting direct reviews for inventory and documentation of all vulnerable points, followed by making of maps and building plans; *second*: determining the proper locations of assembly points, creat

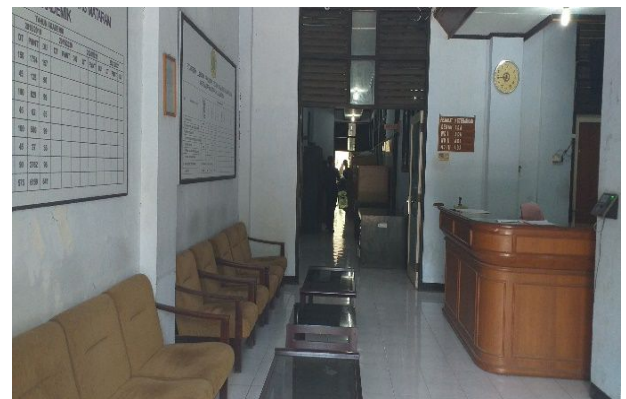
Fig. 3 shows the atmosphere on the 1st floor, where a corridor is narrow and blocked with several piles of goods because there is a warehouse at the end of the

Fig. 3. Daily situations of the 1st floor of Building A.

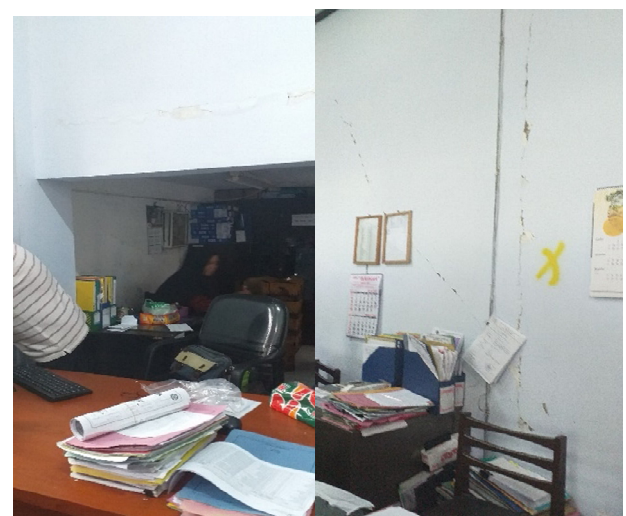
corridor. In Fig. 4 some staff occupied a narrow place under the stair, due to the lack of available spaces, while the condition of the walls in that room was quite dangerous. Fig. 5 shows the library with several reading shelves (some of them are made of glasses) are placed very closely together. Fig. 6 shows some cracks in the outside walls of the 3rd floor of the building. Since current renovations are only inside the building, these cracks will not be treated, because they can only be observed by seeing carefully through a window in the corner of the 3rd floor.

Fig. 4. Staff is working on a narrow place under stairs, and conditions of walls on the 1st floor of Building A.

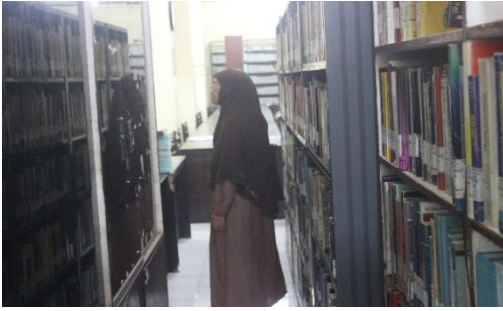
Fig. 5. The library with several reading shelves (some of them are made of glasses) is placed very closely together on the 2nd floor of Building A.

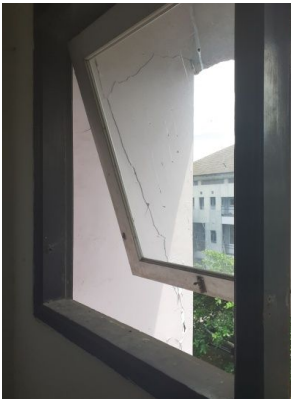
Fig. 6. Cracks in the outside walls of the 3rd floor of Building A.

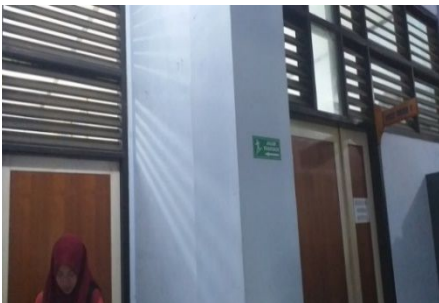
Fig. 7. For an example of a misplaced and misused evacuation symbol on Building A, here a ladder symbol was used on a straight path.

In this building, there were evacuation signs, but often installations and the symbols used are not correct. Fig. 7 is an example of an evacuation sign with a ladder symbol was placed, even though what is meant is only going straight. Fig. 8 shows a symbol that commonly resembles an evacuation sign, even though what is meant is showing the direction to reach the Informatic Engineering study program. In a panic situation, this sign might be misinterpreted. The placements of these evacuation signs are higher than the standard, which should be between 120 – 160 cm above the level [6].

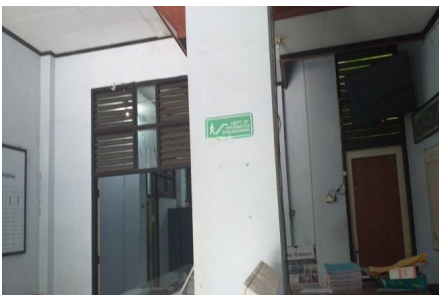
Fig. 8. Example of a misused symbol on Building A, here the same symbol as evacuation one was used to give information of direction to a study program, which on a panic situation it might be misinterpreted as an evacuation route.

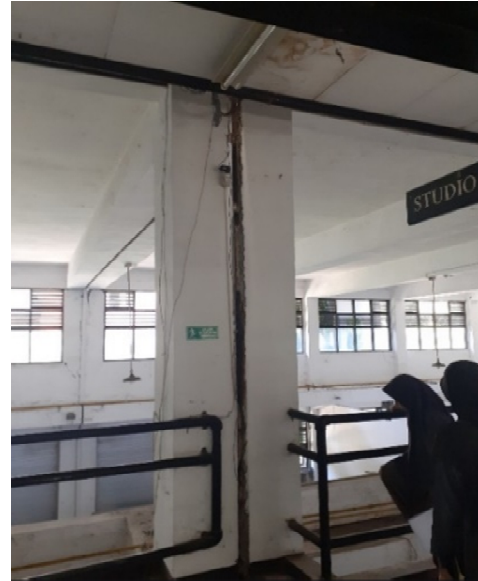
Fig. 9. A large crack between two columns was observed from the 2nd floor of Building B; the crack is initially from the ground floor.

This building is the administration room, lecture rooms, and laboratories of Mechanical Engineering and Electrical Engineering study programs. There are quite a large number of damages on this building, including heavy damage on the 1st, 2nd, and 3rd floors. Fig. 9 shows a large crack that can be observed on the 2nd floor. It is a connection between two columns, that are heavily fractured already from the ground floor. Some of the walls including one beside the hanging stair Fig. 10 had large cracks, and the ceiling of the laboratory on the 3rd floor was also broken in Fig. 11.

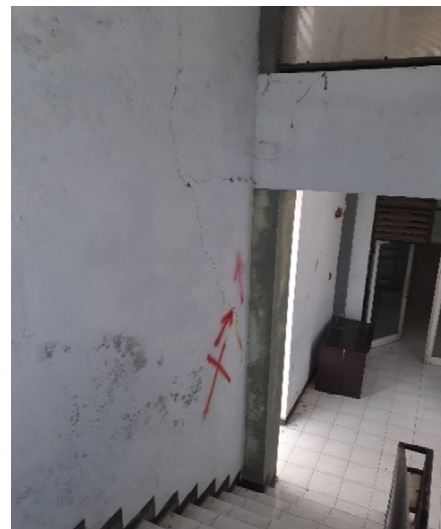
Fig. 10. A large crack in the wall beside the hanging stair, connecting the 2nd and the 3rd floor of Building B.

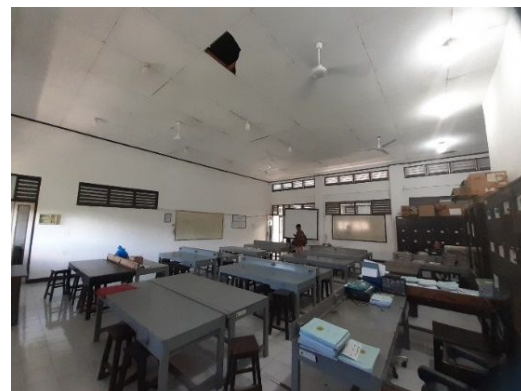
Fig. 11. A large crack on the ceiling of the electrical laboratory on the 3rd floor of Building B.

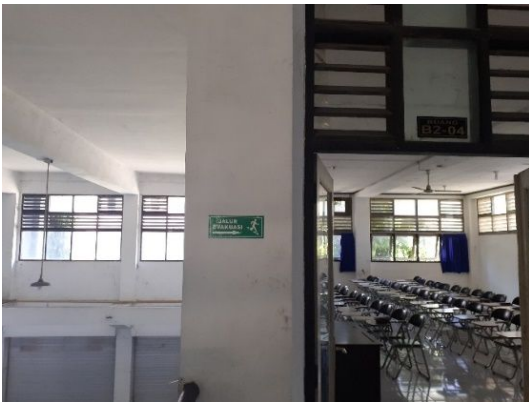
Fig. 12. Example of a misplaced evacuation symbol on Building B, which is quite impossible to be seen by the people who come out from the classroom.

Many evacuation symbols are installed incorrectly, for example, it placed on the wall in the direction of the classroom door in Fig. 12, which is quite impossible for the people who come out of the room to see the sign. Several symbols are placed on the glass windows or glass doors in Fig. 13, which will most probably be broken firstly on a large earthquake.

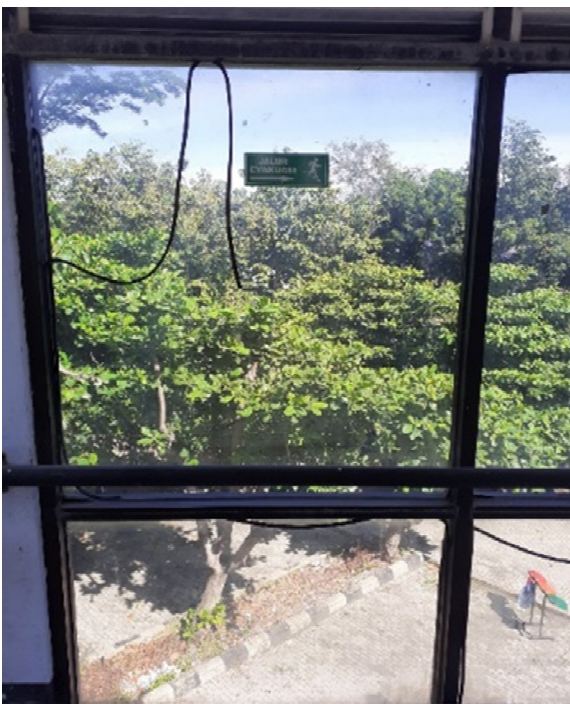
Fig. 13. An example of a misplaced evacuation symbol on Building B, placed on a glass window which is most probably broken firstly on a large earthquake.

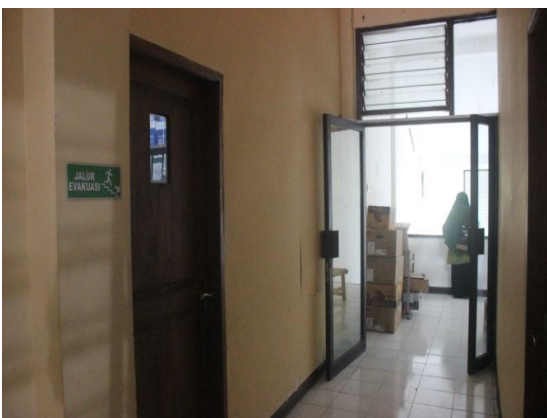
Fig. 14. A misplaced evacuation symbol on Building C1 might be misunderstood there is a staircase behind the door.

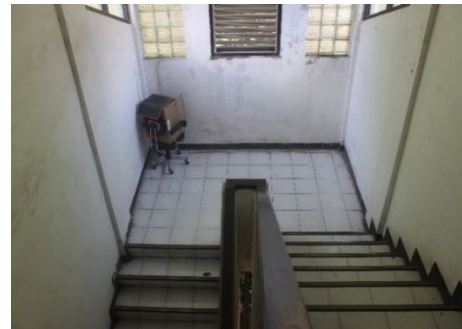
Fig. 15. Inaccessible evacuation route in Building C1, some items are placed in the stair and the next door is locked.

Compared to the other two previous buildings, damage to this building was quite minimal, especially in Building C1. While in Buildings C2 dan C3 there were some minor damages on the 2nd floor; but the exact number of vulnerabilities could not be identified yet. The evacuation symbols are also in good availability in all important places. However, there was a misplaced symbol as depicted in Fig. 14. The symbol with ladder sign placed next to a closed glass door, which might be misunderstood that there is a staircase behind the door by guests; even though what is meant is an evacuation route and the stair is in the next position route (just after a large glass door). If we try to follow the route through the stair, it was inaccessible because the next door was locked and there were some items placed in the middle of the stairs, as depicted in Fig. 15.

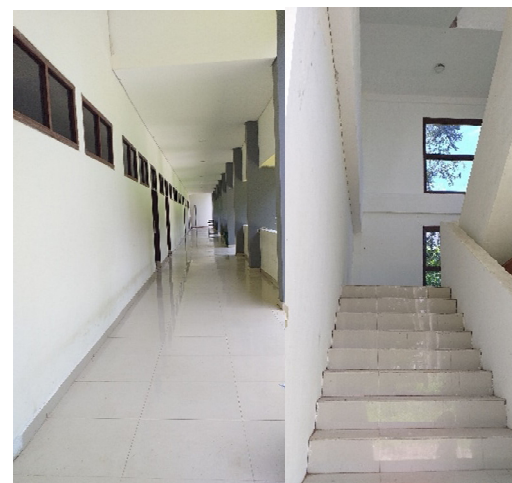
Fig. 17. Site plan of FT Unram with Buildings under investigation (A, B, C1, C2, C3, and D).

In this building damages are not so visible, because the finished construction before the 2018 Lombok earthquakes was only for the 1st floor; and the rest three floors were only completed in the middle year of 2021. However, the condition of the corridors and stairs is very narrow (Fig. 17), which raises difficulties for people to evacuate. The wooden doors of some classrooms (Fig. 18) are difficult to open, which might cause some other vulnerabilities. Careful inspections on this building construction during the last few months show that there seems to be a slight slope in the concrete columns starting from the 2nd floor. Because of this, we must continue more detailed investigations.

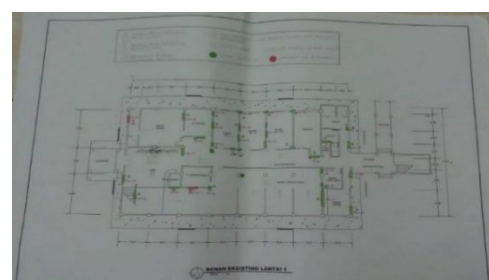
Fig. 18. Sketch of Building A, showing all vulnerable points.

Fig. 18 is an example of a building sketch that shows all vulnerable points and levels of vulnerability in detail. This drawing is equipped with point codes and an accompanying document that describe the vulnerability of each point, also documentation in the form of photos and videos of each vulnerable point.
