Assessment and retrofitting of nursing faculty building of Andalas University, Padang, Indonesia

Abstract. The Faculty of Nursing building is one of the administrative buildings at Andalas University. This building was designed by a planning consultant and began construction in 2013. However, during the construction period, it was found that the concrete quality was very low, that is $f_c'=14.32$ MPa, so that the construction could not be continued because it was not in accordance with the planning quality, $f_c' =22.39$ MPa. Therefore, it is necessary to evaluate the feasibility of the building structure before the construction is continued. In the structural analysis, the loads applied are dead loads, live loads, and earthquake loads. The analysis was carried out using the application (*software*) ETABS. Based on the analysis results, it was found that the capacity of columns and beams of the building are not strong enough to withstand the loads acting on the structure. The inter story drift also does not meet the permit limit requirements according to the New Indonesian Earthquake Code, SNI 1726:2019. Therefore, it is necessary to retrofit (strengthen) the structure of the Nurs

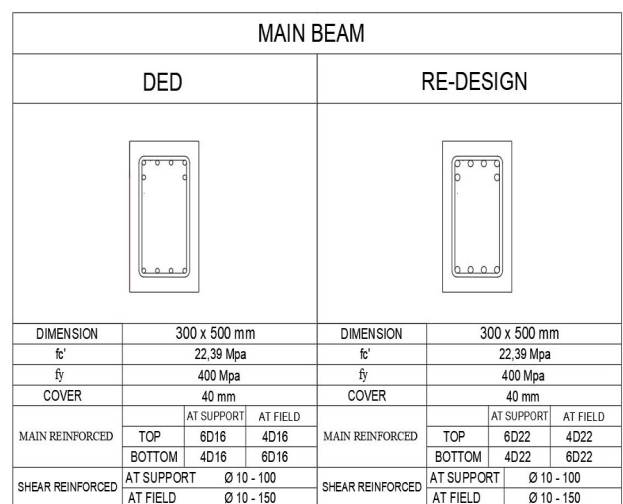
Fig. 9. Comparison of the Main Beam Details between the DED (Initial Design) and the Re-design

Re-design of beams was carried out on the structure of the main and secondary beams of the building. The re-design was carried out because the beams from the initial design (DED) could not withstand the loads acting on the structure [4,8].
