# Unsaturated modelling, testing and monitoring towards the rehabilitation of a slope on National Route 3, KwaZulu-Natal, South Africa

**Abstract.** The stability of over-steep road embankments often worsens with time. In many cases the slope deterioration can be ascribed to continual downslope creep of a surficial layer of soil that has been affected by infiltration of rainfall. Such infiltration reduces the suction in the surficial layer interacting with the environment. With every season the surficial layer moves further downslope, often resulting in cracks in the slow lane and placing structures constructed at the crest of fill slopes in potential jeopardy. A slope on the National Route 3 (N3), in the South African Province of KwaZulu-Natal, constructed at roughly 40° from the horizontal showed signs of distress in the slow lane many years after construction. The rehabilitation of this slope required stabilisation design using unsaturated soil testing, modelling, and in-situ suction measurement. The slope was stabilised using soil nails, a high-tensile steel mesh, and a suction measurement system was installed. An overview of the emergency works design, subsequent investigatio

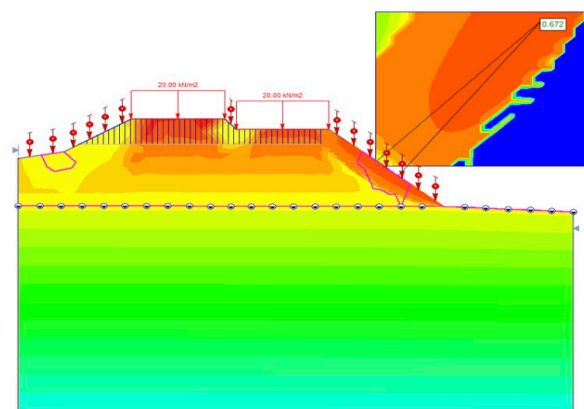
The slope had a FoS of 1.3 prior to the simulated rainfall event due to increased strength from matric suction. After the fourth day of rainfall the FoS over the crest reduced to below unity for all the failure planes showed in Figure 2. The negative pore pressures varied between 0 and -30kPa over the entire depth above the groundwater table. The model showed that the rainfall event had weakened the surficial layers which had previously been stable in their original conditions. While no such exceptional rainfall event occurred before the slope in question experienced translational failure, the net rainfall surplus area the slope is located in means that successive rainfall events will cause water to accumulate in the surficial areas of the slope without enough evaporation to remove infiltrated water. Over time this will lead to the same low suction conditions found by the model.

**Fig. 2:** Transient slope stability analysis simulating rainfall infiltration

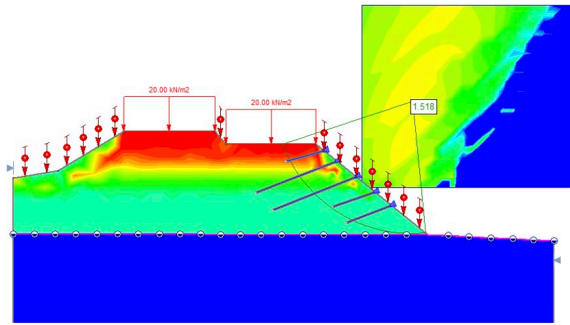
**Fig. 3:** Transient slope stability analysis simulating rainfall infiltration with slope stabilisation measures

The inclusion of passive soil nails to intercept the failure plane enhanced the sliding resistance. The model was therefore adjusted to include for passive soil nails until an  $FoS > 1.5$  was achieved after the simulated rainfall event. This is shown in Figure 3 below.

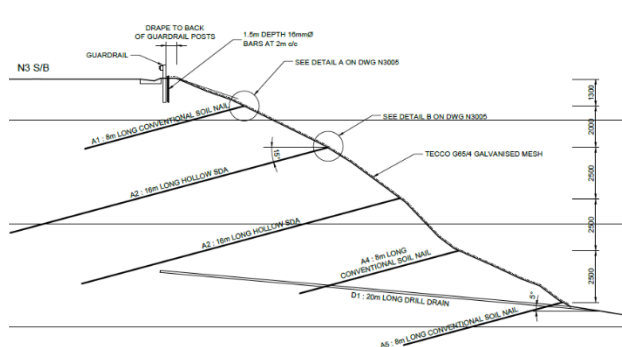
**Fig. 4:** Cross-section of implemented stabilisation works

As a result of the transient slope stability analysis three rows of conventional soil nails, and two rows of self-drilling anchors were installed. Sub-horizontal drains were included at the toe of the slope to provide dewatering, and tension cracks at the crest were sealed with an impermeable clayey infill to prevent further ingress of water. A schematic of the stabilisation works is presented in Figure 4.

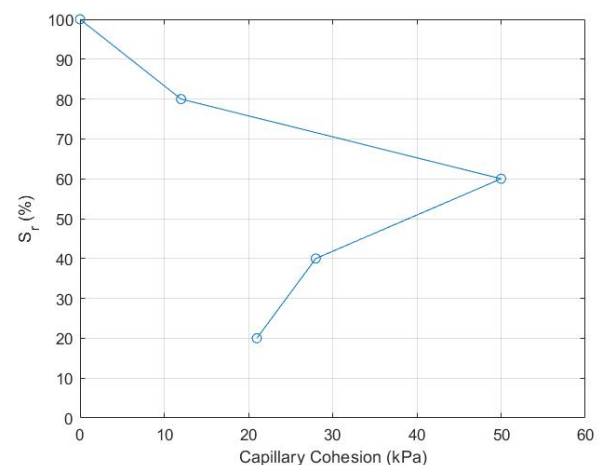
The derived capillary cohesion values (effective cohesion subtracted) are provided in Figure 5.

**Fig. 5:** Capillary cohesion from unsaturated shearbox test

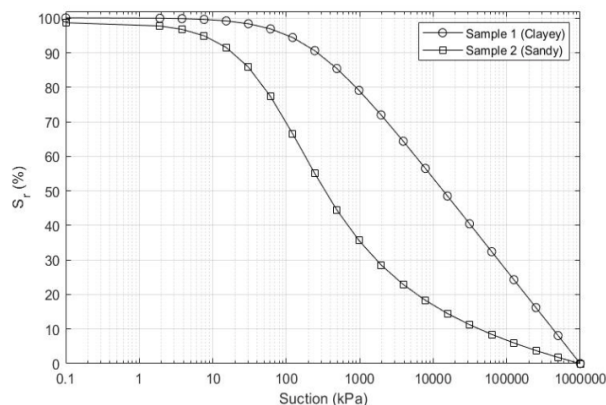
**Fig. 6:** SWRC's between 4.95 – 5.45m [7]

The difference in the two measured curves is likely due to the fact that the Shelby sample was retrieved at an interface between two different grades of fill (clayey sand above and silty clay below). The two samples tested were taken from the top and bottom of the Shelby sample respectively.

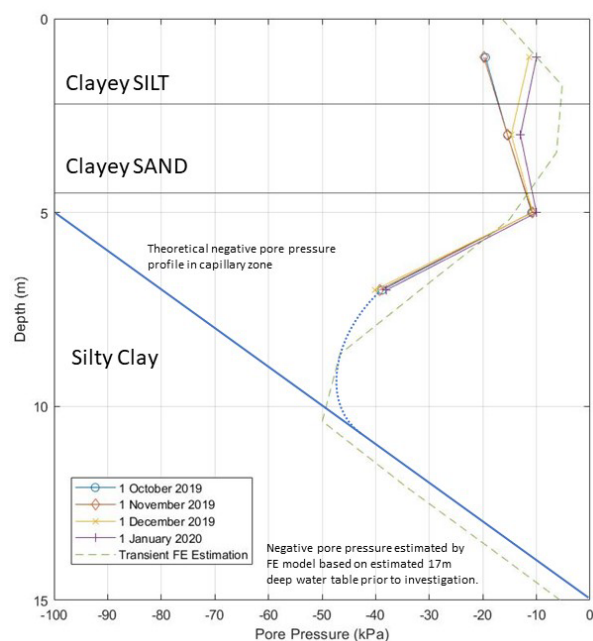
The estimated suction profiles match the measured data well, validating the use of the transient FE model in the emergency works design. In terms of infiltration influence with depth, the following observations can be made from Figure 7:

- The measured data shows seasonal suction fluctuations were mostly limited to the top 3m of profile, with some minor changes down to 6m.
- Minor suctions (<20 kPa) are present over the top 6m of the profile. This differs from the AS2870 [3] design suction depth of 3m.
- The net rainfall surplus has influenced suctions down to approximately 10m below the crest, after which the suctions from the water table's capillary zone become dominant.

**Fig. 7:** Measured suction profile with depth against profile estimated by FE transient analysis (adapted from [7])
