# Characterization of the geological and geotechnical conditions at the village of Monsanto

**Abstract.** The stability of slopes and hillsides involving rock or soil masses depends crucially on the occurring geological and geotechnical conditions. The village of Monsanto, municipality of Idanha-a-Nova, is located on a granitic inselberg. The tourist interest of the village lies largely in the fusion of the granitic rock mass with the man-made constructions and in the aesthetics of several granitic boulders scattered throughout the village. In the present work the geological and geotechnical characterization of the rock mass has been carried out, namely by the field survey of the entire intervention area and by a set of laboratory tests on samples collected in the field (ultrasound propagation velocity and the uniaxial compression test). Based on this information, the shear strength of the discontinuities was estimated and a kinematic analysis was performed using the Dips 7.0 commercial software, with the objective of defining the predominant sets of joints and identifying the most probable failure mechanisms in each hillside.

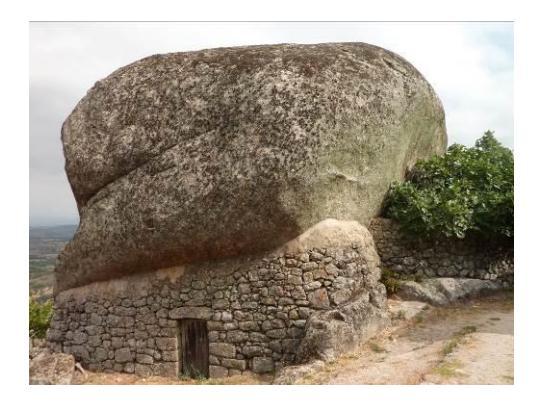
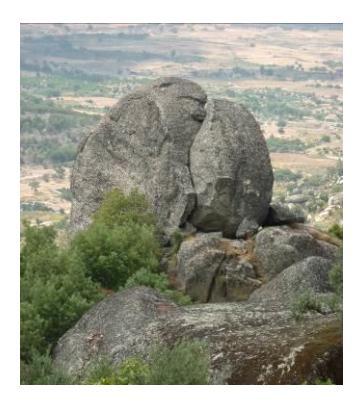
Fig. 1. Some rock blocks and boulders in Monsanto village. The boulders form the roofing and/or the walls of some houses and, outside the urban area, the rock mass forms blocky outcrops of moderately weathered to highly weathered granite.

The rock blocks show a coating over the surface that might be whitish to dark in colour due to the presence of lichens, the colour varying with the exposure conditions. The blocks exhibit a yellowish coloration due to weathering, being classified as  $W_3$ , sometimes  $W_4$  [9]. Locally they can present reddish coloration and evidence of oxidation. On the walls of the joints, in particular of sub-horizontal joints, it is common to observe quartz crystals standing out in relation to the rock matrix that has been eroded due to chemical and physical weathering. The blocks and boulders have large dimensions and show rounded edges and faces due to erosion. Frequently the contacts between blocks, or between the blocks and the supporting ground, are fully weathered, occurring as a sandy residual soil, and the contact area is very limited. In the NW area, the blocks are mainly prismatic with the larger dimension close to the vertical; conversely, in the East area the blocks are tabular and rest on sub-horizontal joints.

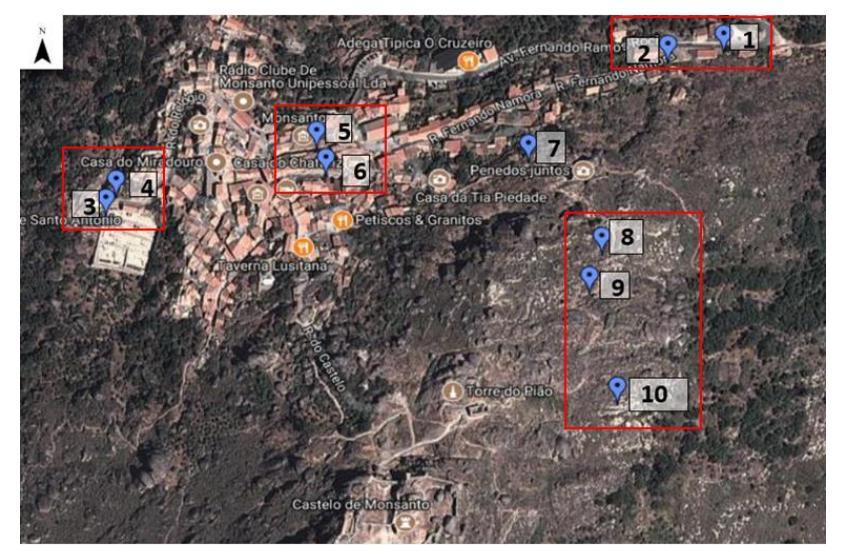
**Fig. 3**. Map of the intervention area with indication of survey locations for study of the joints sets. In general terms, it is found predominant subvertical joints with orientation NNE-SSW to NNW-SSE and ENE-WSW to ESE-WNW. The sub-horizontal joints show more scatter but dip predominantly to north.

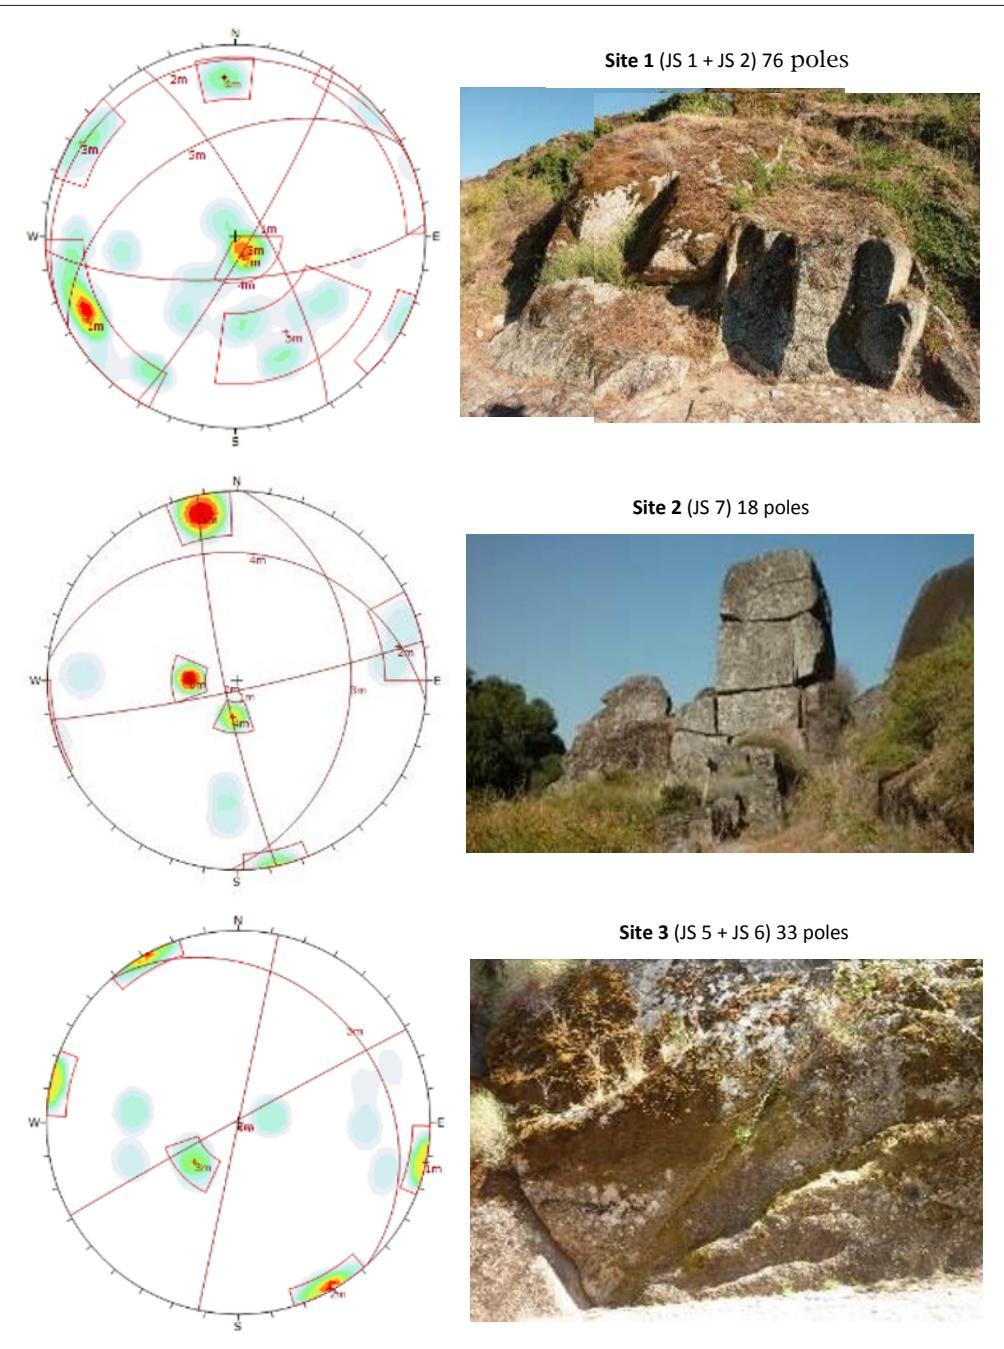
**Fig. 4.** Contour diagrams representing the orientation of the main sets of joints in Sites 1, 2 and 3 plotted on an equal-area net. (JS- joint station).

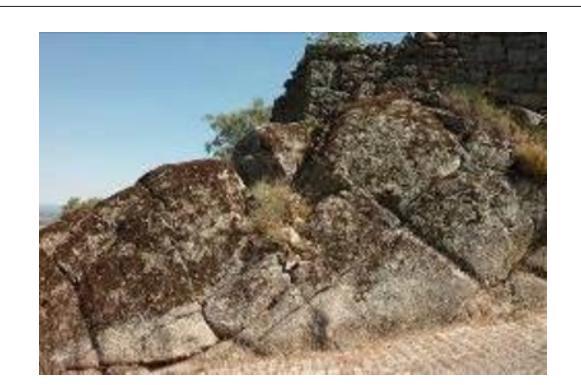
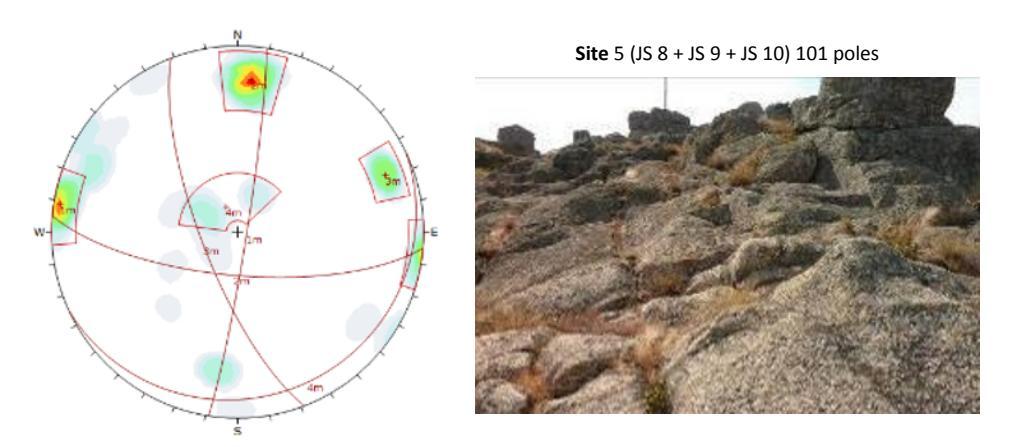
**Fig. 5.** Contour diagrams representing the orientation of the main sets of joints in Sites 3, 4 and 5 plotted on an equal-area net. (JS – joint station).
