Seismic capacity evaluation of the damaged reinforced concrete building during Palu earthquake 2018

Fajar Nugroho^{1,2*}

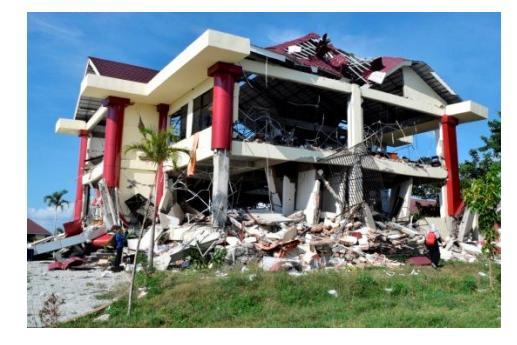
Observation was done by examining reinforced concrete structures in Fisip Dean buildings (Fig. 4). The strength of the existing concrete is obtained by conducting nondestructive testing using the hammer test Reinforcement bars used in the damaged structure are measured in the diameter of the reinforcement used, the type of reinforcement, and the length of the dispensing. The stirrups of reinforcement bar is measurement in the distance between the stirrups and the large angle and the length of the curve in the stirrups. The Dean building has a soft story. The building was originally 3 floors, and after the earthquake changed to 2 floors, the ground floor was totally collapsed.

Fig. 4. The Dean Building of the Faculty of Social and Political Science (FISIP) of Tadulako University in Post-Earthquake 2018

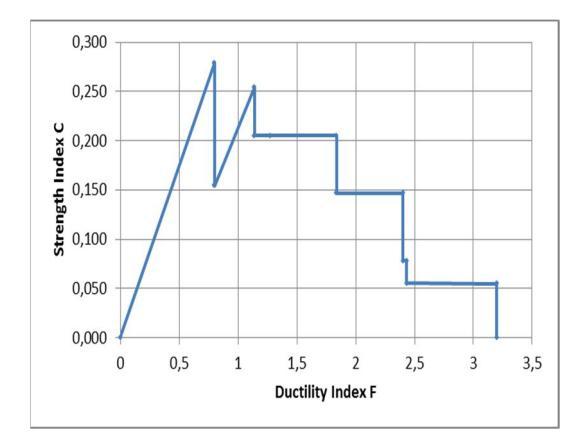
a. C and F Relations North-South

Fig. 6.a shows the phase collapse of the North-South direction column. The building has a total strength index of 0.379. At the index of ductility 0.8, the building suffered the collapse of the column before the plastic boundary by reducing the strength index by 0.125. The collapsed column in the 0.8 ductility index is a sliding column. This column has a sliding collapse because there is a brick wall that curbs so that it is a short column with a net height of 1.8 meters. The collapse of this column caused the building to drastically decrease its strength index so that the building's strength index became 0.154. The decline in this strength index is likely the reason why it collapsed when it was shaken by the massive earthquake. Furthermore, on the index of ductility 1.14, the building again underwent a collapse

of the column by reducing the strength index to 0.205. Furthermore, the building's 1.84 ductility index underwent a collapse of the column by reducing the strength index to 0.147. The building continues to experience the collapse of the column until all the columns collapse on the ductility limit of 3.2.

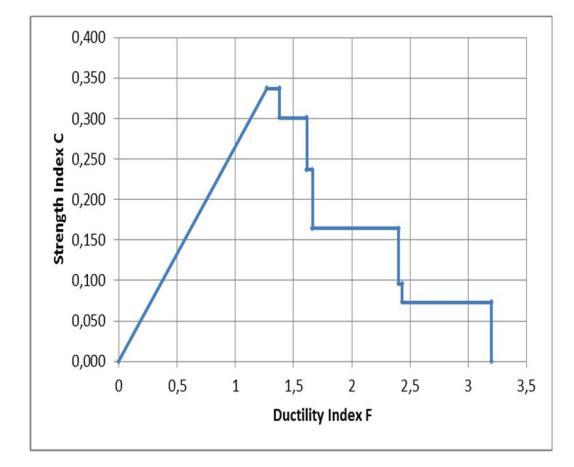
b. C and F Relations East-West

Fig. 6.b shows the phase of collapse of the column east-west direction. The building has a total strength index of 0.337. At the index of ductility 1.38, the building suffered a collapse of the column by reducing the strength index to 0.301. The type collapse column is a bending collapse. Most of the columns on the east-west are experiencing bending collapse. At the next ductility index, the building continues to experience the collapse of the column until all the columns collapse at the index limit of the ductility 3.2.

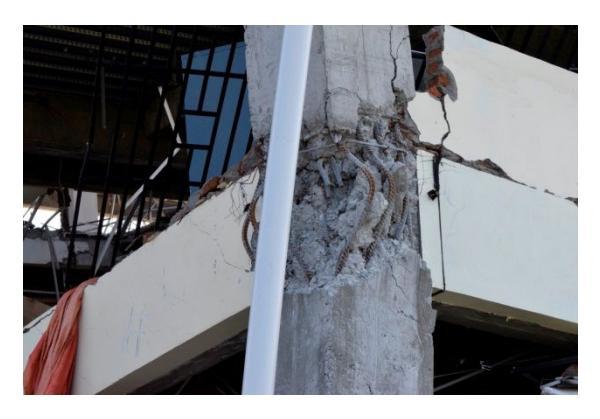
Fig. 7. The Damage in The Column Beam Connection

Fig. 7 shown that the consequences of not being properly installed at the join of beams and columns resulted in the main reinforcement of the column experiencing bent (broken). The size of the existing stirrups and curve is insufficient. The width dimensions of the beam should be designed smaller than the column, and column dimensions should be designed more strongly than beams. It is aimed at the main reinforcement of the beam to be restrained by the main reinforcement of the column. Also, the column beam join should be mounted in the field as the main reinforcement of the column to avoid damage after receiving the earthquake load. Based on the floor plan, the Dean Building of the Faculty of Social and Political Science of Tadulako University has a large column spacing of 9 m and 8 m.

In the earthquake-prone area for reinforced concrete buildings is recommended to use in minimum diameter 10mm for reinforcement bar (D10) and the quality of concrete K-300 (fc' 25 MPa). Rainwater drain pipes should not be entered into the column because it will reduce the column cross-section so that the column strength will also decrease. Based on SNI 2847:2013 [10], the length of the main reinforcement of the beam to the column is 12d with a curvature of 90°. Overlapping distance on a major reinforcement connection is 40d. The length of the stirrups latch is 6d, with a curve of 135° [10]. The distance between the columns in the building should not be too large for the building to become more rigid, so it is expected to withstand the earthquake load.
