Experimental stand for investigation of fluid flow in heat exchangers with cross-flow arrangement

Abstract. The operation analysis of high-performance heat exchanger with tubes elliptical indicated that the heat exchangers can be subject to damage. The reason for this is probably improper distribution of working fluid in tubular space of heat exchanger. Therefore, a part of the tubes may be improperly cooled and subject to compressible stresses. The paper presents an experimental stand allowing to confirm the given assumption. The experimental investigation enables to examine the mass flow rate in heat exchanger tubes. Also, it is possible to assess the impact of the construction of inlet, intermediate and outlet chambers on the flow distribution within the heat exchanger tubes.

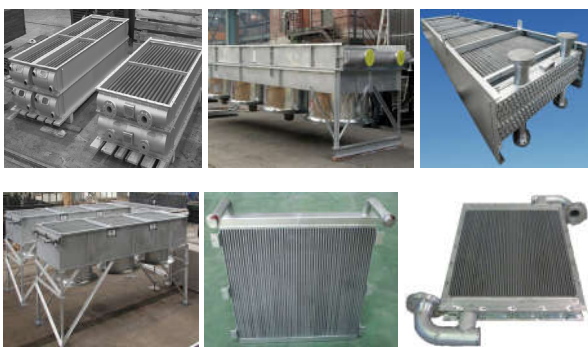
Fig. 1. Examples of construction of high-performance heat exchangers heater/cooler

The operation of the high-performance heat exchanger with finned elliptical tubes in cross-flow working fluid arrangement (e.g. flue gas-water), indicates a possibility of failure. This situation occurs mainly in the case when a large difference between the working fluid temperatures exists. The failure can be seen as a certain deformation of tubes in the form of buckling, or as a tube rupture. Examples of the construction of heat exchangers which are mentioned here, often refer to high-performance heat exchangers are shown in Fig. 1 [1, 2]. Figure 2 shows a structure (the basic elements) and the principle of operation.
