Materials, used in historical buildings, analysis methods and solutions proposals

M.Sami Döndüren¹, and Ozlem Şişik¹

3.2 Timurtaş (Demirtaş) Mosque

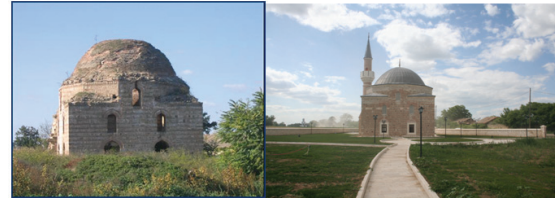
Fig. 1. Photographs before and after restoration of the Timurtaş(Demirtaş) Mosque (2007-2008).

In this section informations given was taken from the restoration,pre- restoration and restoration reports prepared for the Timurtaş (Demirtaş) Mosque of Edirne foundation general in 2007 prior to restoration of the building. Figs. 1-3 show the pictures of the tomb before and after repair.

The material decrement on the groud form walls have been completed according to the original material and mesh system. Filling the capillary cracks in the structure with epoxy plaster, 4 cm wide cracks are stitched with iron plates and they are filled with epoxy again. For cracks larger than 4 cm, it is recommended that the perimeter be disinfected and filled in accordance with the original material and mesh system. Except base of the minaret, the mosque was destroyed. Since the old photo about the minaret could not be found, it was completed with the guidance of periodical analyzes. As a suggested at the restitutions projects, the rostrum with alternated had been built of bricks. Transition from the ground form to the base was made with triangles. As a result of the periodical analyzes, this decision was made (Saruca Pasha

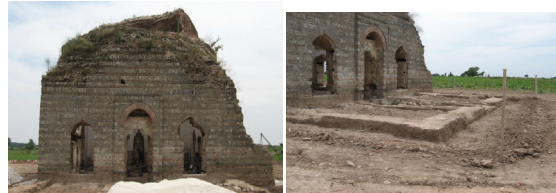
Fig. 2. Photographs before and after restoration of the Timurtaş(Demirtaş) Mosque (2007).

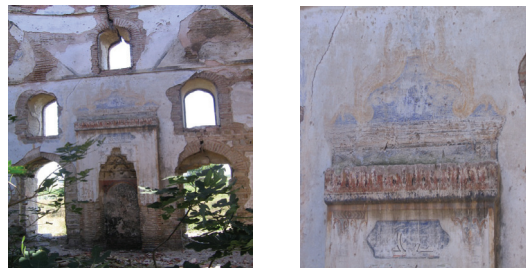
Fig. 3. Photographs before and after restoration of the Timurtaş(Demirtaş) Mosque (2007).

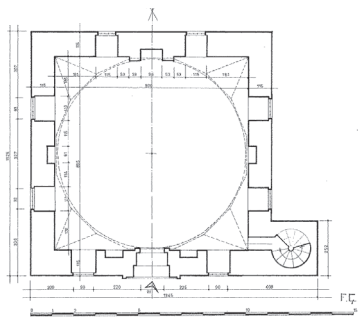
Fig. 4. Sketches of the plan of the Timurtaş (Demirtaş) Mosque.

SAP 2000 V18 finite element program is used for modeling. The building walls consist mainly of at least three main materials, stone, brick and mortar (plaster). However, since the general behavior of the structure in the model is concerned, it is assumed that the carrier elements are formed from a single material and the related unit volume weight, modulus of elasticity and Poisson's rate are used Sketches of the plan of the structure is given in Fig. 4.

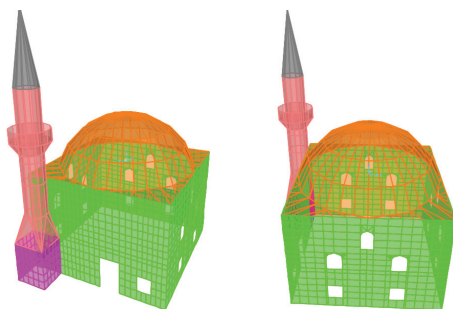
Based on the build-up relay project, in the numerical model, the wall thickness is defined as 1.1 m, and the thickness of the cove is defined as 0.25 m. Material properties are defined; The material of the wall and minaret is stone, the material of the dome is brick. The carrier elements of the structure are modeled as shells. 559 shells (area) were created using 558 knot points in the prepared structure model. 51 fixed supports are defined in the points that are transferred to the ground. The structural modeling is given in Fig. 5.

Fig. 5. Timurtaş (Demirtaş) Mosque structural modeling.

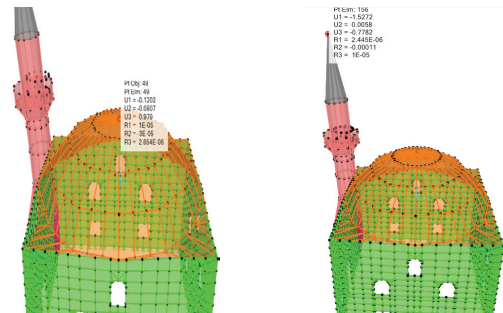
Under G force, the greatest displacement in the structure is about 0.979 mm in the vertical direction at the top of the dome. $R = 2$ is used in this analysis, the elastic displacement should be calculated as $0.979 \text{ mm} \times 2 = 1.958 \text{ mm}$ (Fig. 6). It is about 1.53 mm in the vertical direction at the top of Minaret. $R = 2$ is used in this analysis, the elastic displacement should be calculated as $1.53 \text{ mm} \times 2 = 3.06 \text{ mm}$.

Fig. 6. Under G force, the greatest displacement in the Timurtaş (Demirtaş) Mosque (mm).

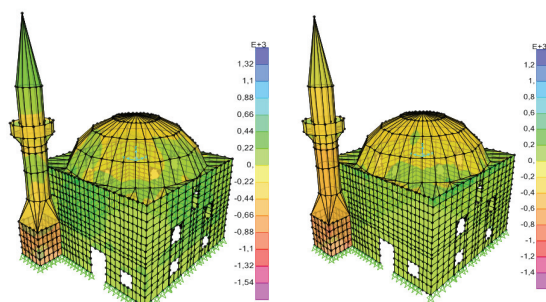
The behaviour of the structure according to the G force acting, prepared separately S22 and S11 (tensile and compressive) stress value graph (Fig. 7).

Fig. 7. Under G force, S11 and S22 Stresses in the Timurtaş (Demirtaş) Mosque (KN/m²).

The most unfavourable compressive stresses calculated were 1.54 MPa from S11 Graph and the most unfavorable tensile stresses were also found to be 1.32 MPa on S11 graph (Fig. 8). However, it should be kept in mind that the values of the strain distributions in the graphs S11 and S22 are very close to one another. Both values exceed the safety stress values of the stone walls given in Table. The maximum shear strain determined from the S12 graph is 0.630 MPa. This value is also above the safe dislocation stress value.

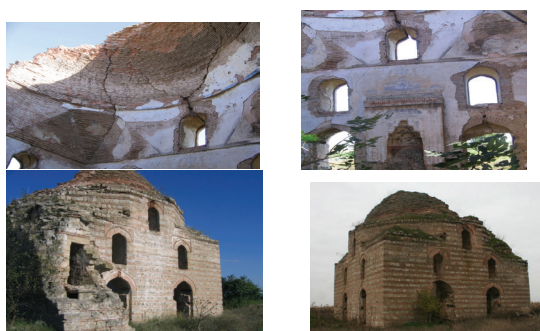
As a results under G force when the effects of structural analysis are examined, on the carrier walls of the structure. In the Turkish Earthquake Regulation, it has been observed that the compression tension and dislocation stress values proposed for masonry structures are exceeded. As a matter of fact, the size of the dome of the structure and the cracks formed is an indication that the structure is not stable (Fig. 9).

Fig. 9. Timurtaş (Demirtaş) Mosque prior to the restoration of damaged photos.

- Timurtaş (Demirtaş) Mosque: The maximum compressive stress at the construction is calculated as 1.1 MPa, which exceeds the pressure safety tensile strength of 0.3 MPa. The tensile stresses determined at 2.16 MPa exceed the tensile safety stress and reinforcement is required. The calculated maximum displaced stress was 0.99 MPa. This value exceeds the safe displaced stress value is calculated as 0.175 MPa. As of January 2017, the current situation has been examined and it has been determined that there are spills and dissociations in

the stones forming the body walls in particular. Despite the high stresses in the finished element model, there are no large and risky cracks in the areas where the cowbag merges with the body walls and in the window and door openings. This can be interpreted to mean that the structure still retains its stability. However, maintenance of the damaged stones and filling of the gap between the joints will be favorable for the continuation of the stable condition of the building. When the analysis results are evaluated, it is observed that there are great stresses in the walls forming the main building, in the dome, in the doors, in the window spaces and in the minaret. Especially for historic buildings built with materials that are inadequate for tensile strength, these high values of stress have a considerable risk. It is a necessity to improve these stresses if a child of the works studied in the study is thought to have collapsed the upper body walls of the dome without the dome before the restoration. Static problems that need to be solved with minimal intervention, while remaining faithful to historical structures, require the development of new methods. Otherwise, the historical buildings can not be kept up for a long time just by cleaning and repairing works.

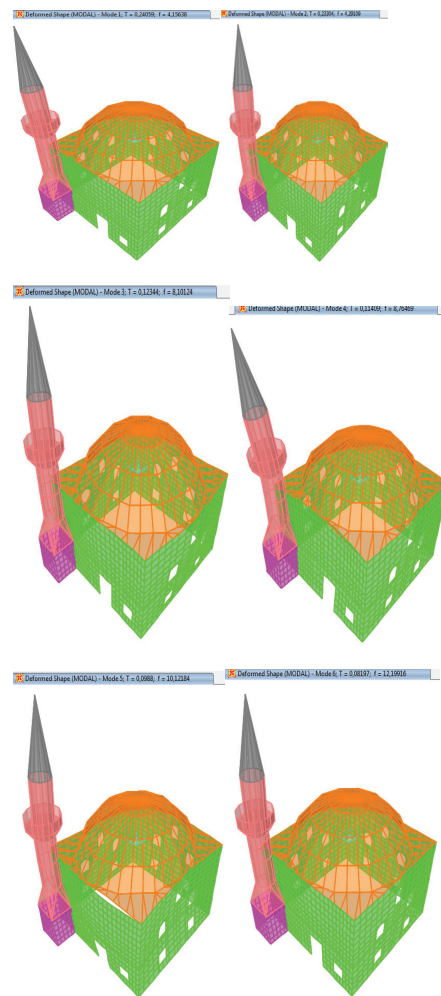
In Fig. 10, the first 6 mode graphs of the structure are given.

Fig. 10. The first 6 mode graphs of the Timurtaş (Demirtaş) Mosque.

structure system. Mode shapes and periods are obtained. The mass participation rate of the fourth mode showing the lateral displacement movement of the main mass in the X direction is calculated as 54% and the mass participation rate of the third mode showing the lateral displacement movement in the Y direction is calculated 56%. Since the structure is symmetrical, the mass participation rates give almost the same value. The highest natural vibration period already obtained is 0.24 and the building is very rigid.

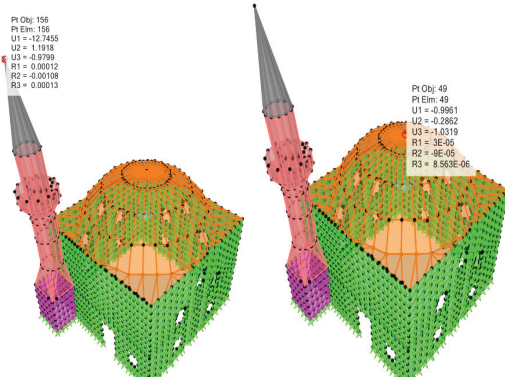
G+E_x: The earthquake loading brings a lateral displacement of 12.75 mm in the X direction, 1.19 mm in the Y direction, 0.98 mm in the Z direction,

Fig. 11. Under $G+E_x$ force, the greatest displacement in the Timurtaş (Demirtaş) Mosque (mm).

and 0.999 mm in the X direction and 0.29 in the Y direction and 1.03 mm in the Z direction.

Shape changes occurring in the modal spectral analysis resultant structure under earthquake load reduction (R = 2) and earthquake loads acting in the direction of X and Y with dead load are given in Figs. 11 and 12.

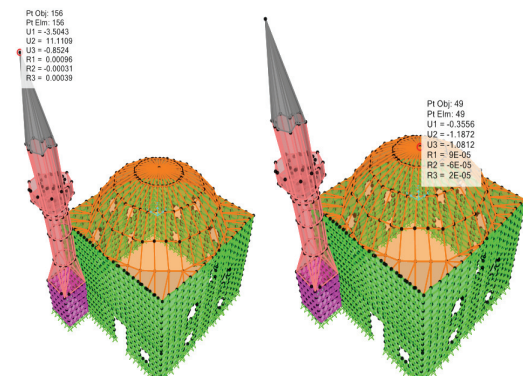
G+E_y: The minaret in the X direction is 3.51 mm in the direction of the earthquake, 11.11 mm in the Y direction, 0.85 mm in the Z direction and 0.36 mm in the X direction, 1.19 in the Y direction and 1.08 mm in the Z direction.

Fig. 12. Under $G+E_y$ force, the greatest displacement in the Timurtaş (Demirtaş) Mosque (mm).

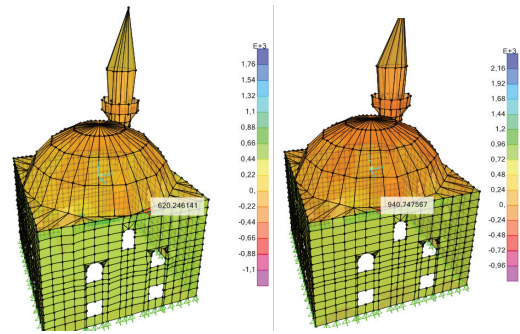
G+Ex ve G+E_y: It is seen that in the case of earthquake loading, the regions, where the stresses of S11 (Fig. 13) and S22 (Fig. 14) in the structure are unfavorable there are at the corner points of the dome and wall joints and windows and door gaps. The greatest compressive stress in the structure is calculated as 1.1 MPa, which exceeds the pressure safety stress of 0.3 MPa. The tensile stresses determined at 2.16 MPa in the construction exceed the tensile safety stress and reinforcement is require.

Fig. 13. Under $G+E_x$ and $G+E_y$ forces, S11 Stresses in the Timurtaş (Demirtaş) Mosque (KN/m^2).

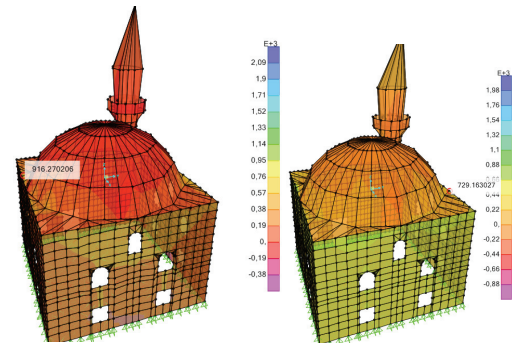
Fig. 14. Under $G+E_x$ and $G+E_y$ forces, S22 Stresses in the Timurtaş (Demirtaş) Mosque (KN/m^2).

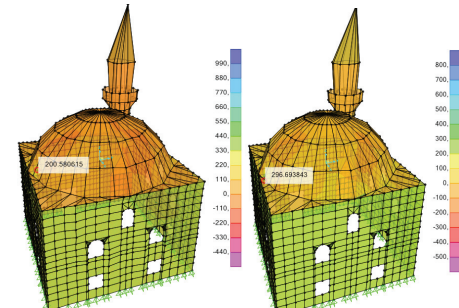
The calculated maximum displaced stresses were $G+E_x$ ve $G+E_y$ (Fig.15.) At 0.99 MPa. This value has exceeded the value of safe shear stress calculated as 0.175 MPa.

Fig. 15. Under $G+E_x$ and $G+E_y$ forces, S12 Stresses in the Timurtaş (Demirtaş) Mosque (KN/m^2).
