# The consequences of the inappropriate use of ventilation systems operating in indoor swimming pool conditions - analysis

**Abstract.** Increasingly more leisure facilities, such as water parks or indoor swimming pools are being built in Poland nowadays. In order to ensure the air quality required by standards for such leisure facilities it is necessary to fit them with effectively functioning ventilation. For the removal of excess humidity, as well as chlorine ions occurring as a result of the disinfection of water as well as the carbon dioxide emitted by people using the facility, the ventilation system needs to be appropriately designed and efficient. For this reason, studies into the air quality in such facilities were undertaken. The paper presents the causes and consequences of the inappropriate operation and maintenance of ventilation systems in swimming pools. The study found that the causes of deterioration in the technical condition of the system which was operated in an environment with chlorine ions were: an inappropriate manufacture of its components and the wrong choice of construction materials for the given environment of operation. Furthermore, failure to follow

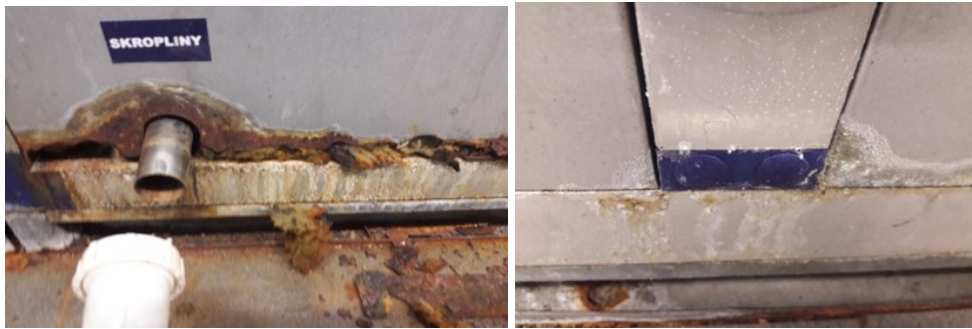
The studies assessed the state of the air handling units. A visual inspection of available internal and external structural elements of both ventilation units showed significant corrosion damage, which negatively affects both the quality of air entering the pool hall and the life cycle of the installation itself [7]. Heavy surface damage and material losses were observed at the bottom of the cover panels made of aluzinc-coated metal sheet. White (corrosion of zinc) and red corrosion products were present on the surface of the cover panels-degradation of the coating (Fig. 1-2).

**Fig. 1.** View of the external cover panels of the air handling unit (air handling unit 1).

Appropriate anti-corrosion protection of the parts of swimming pool installations operating in conditions of high humidity and an aggressive medium is a key factor allowing an increase in their life cycle and failure-free operation. The increased corrosion resistance of parts can be achieved by: painting with wet epoxy paints or powder surface protection with chemicals-cataphoresis process, the application of polymer coatings in the form of polyester, polyamide or epoxy resins (electrostatic or fluidizing).

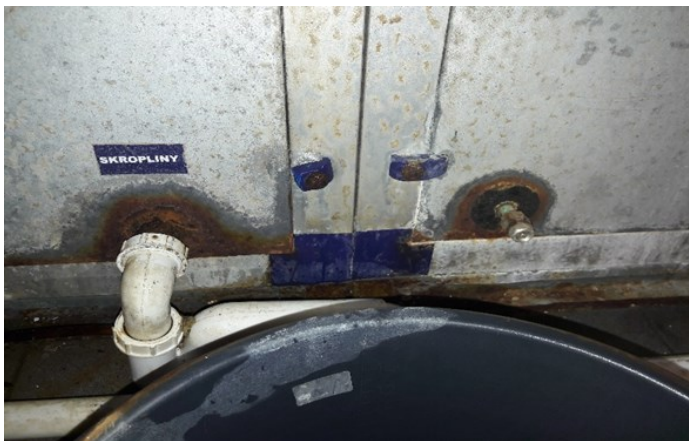
**Fig. 2.** View of the external cover panels of the air handling unit (air handling unit 2).

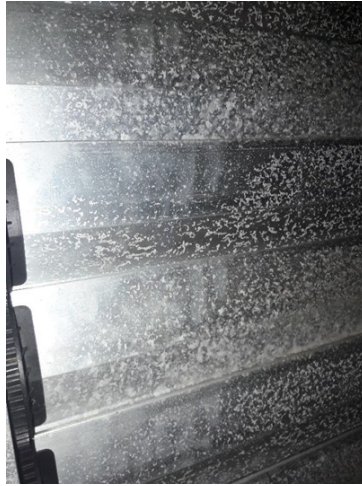
Corrosive damage and products of the corrosive process taking place were also observed on the side panels of the unit (Fig. 3) and floor panels made of X5CrNi18-10 sheets (corrosion pits) in various sections of the units (Fig. 4). Damper blades (Fig. 5), droplet separator (Fig. 6) and aluminum guides (Fig. 7) were also subject to corrosion.

**Fig. 5.** View of the damper blades' surfaces made of aluminum in unit 1.

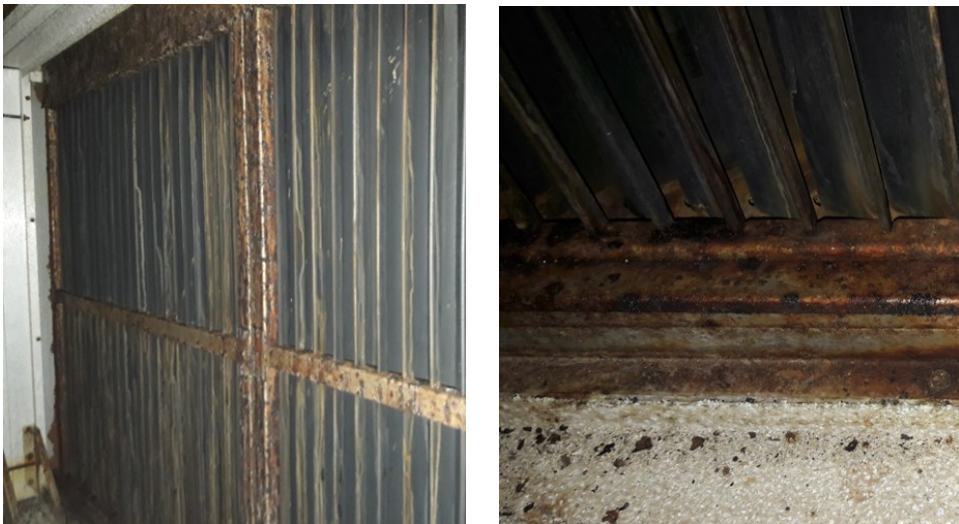
**Fig. 6.** View of the evaporator area in unit 1.
