# Stability analysis of the Kosciuszko Mound using terrestrial laser scanner and numerical modelling

**Abstract.** Landslides which form in anthropogenic soils are complicated from a geological engineering and geotechnical point of view. Each case requires a detailed investigation and the selection of effective reinforcements is a difficult project issue. The study presents the problem of the stability analysis of landslides occurring in the anthropogenic soils of the Kosciuszko Mound in Cracow. The previously performed protections are discussed to highlight their ineffectiveness and the current technical condition of the mound is also presented. By overlapping the results of displacement measurements made with a terrestrial laser scanner, a differential model of the terrain was created which made it possible to determine the size and direction of the deformation of the slopes of the mound and the tendencies for the development of landslide movements in this area. A cross-section, selected on the basis of the model, was numerically analysed using the finite element method (FEM) in the Midas GTS NX program. As a result of the analysis, the values of the displacements and strains oc

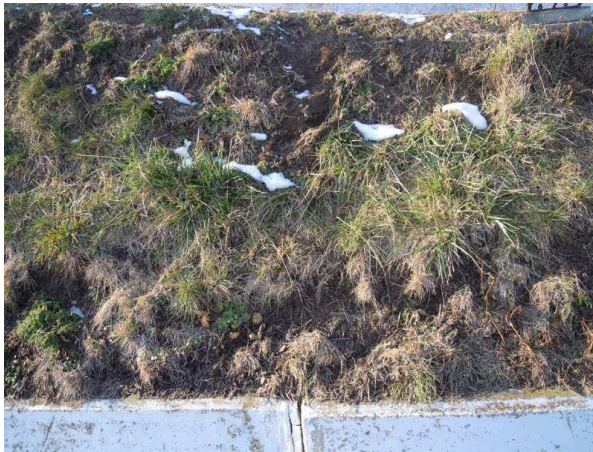
There are visible cracks in the balustrades surrounding the observation platform at the top of the Mound [phot.2]. There are cracks and other damage on the wall surrounding the Mound in the eastern part [phot.1]. On the northern side of the wall, there is a visible white coating on the bricks, in some places the bricks are slightly darker, which may be a sign of the increased humidity of the soil zones.

**Phot. 1.** Fragment of the landslide on the eastern slope of the Kosciuszko Mound [phot. K. Tomasziewicz].

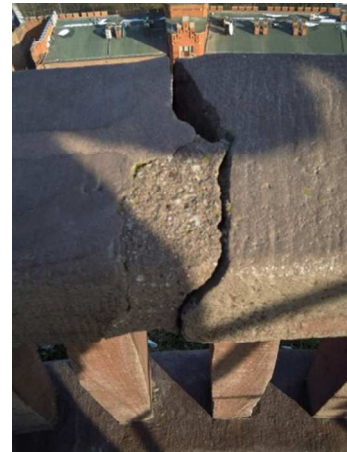
**Phot. 2.** Balustrade damage of the viewing platform of the Kosciuszko Mound [phot. K. Tomasziewicz].

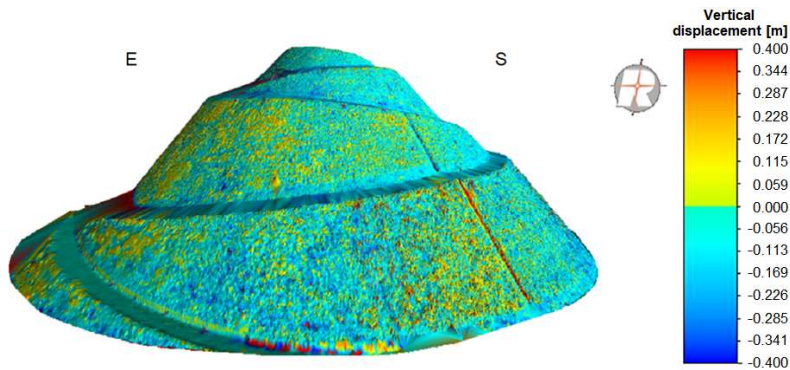
**Fig. 1.** Laser scanning differential model of the Kosciuszko Mound - vertical displacements of the south-west slope [14].

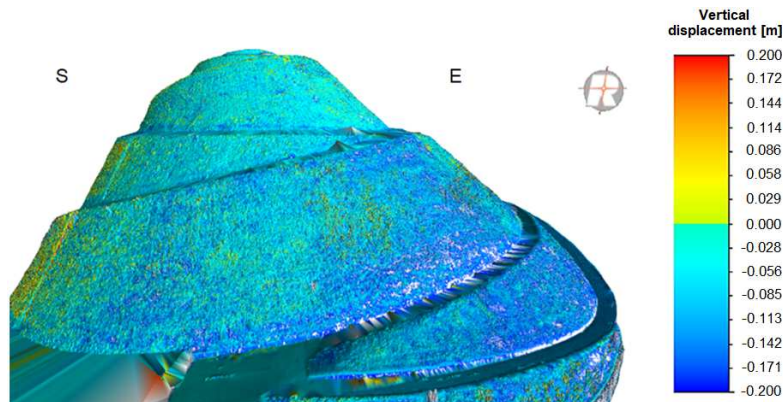
The slope is mainly deformed on the eastern side, which is slipping (displacement differences range from -400 mm to +400 mm, the bottom part of the slope has deformed the most). On the south-eastern side, the largest displacements (-200 mm) occur near the lowest walking path and over the retaining walls. Slope increments on the southern side are on average 50 mm, and in the lower part they vary from -200 mm locally to even +130 mm. Large displacements may be observed near the drainage system - displacements even reach up to +200 mm. The Northeast, North and West sides are dominated by displacement increments of +100 mm. The part of the Mound below the top of the observation platform is the least deformed, local surface displacements occur only in the northern part (within +80 mm). Slope displacements increase as you approach the base of the embankment.

**Fig. 2.** Laser scanning differential model of the Kosciuszko Mound - vertical displacements of the south-eastern slope [14].

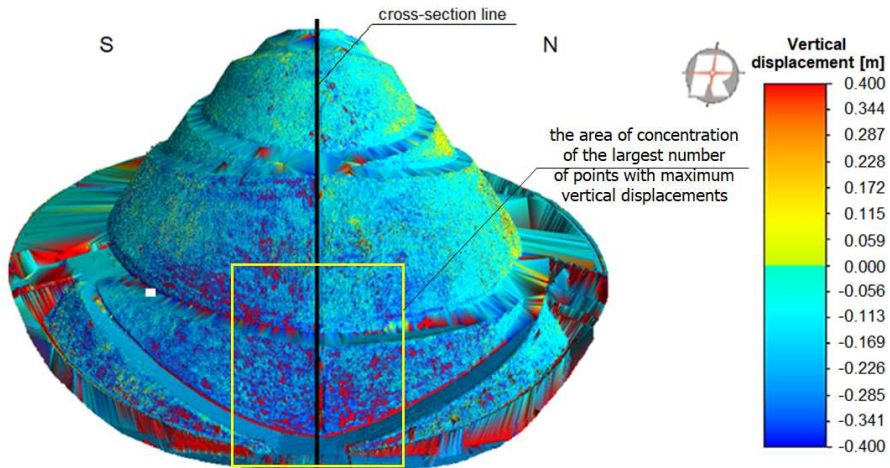
**Fig. 3.** Laser scanning differential model of the Kosciuszko Mound - vertical displacements of the eastern slope with a selection of the cross-sections adopted for numerical analysis (black line) [14].

In order to determine the stability of the Kosciuszko Mound's embankment, numerical modelling was carried out [14]. A cross-section on the east-west line (Fig.3) was selected for the model. It was selected on the basis of the results of terrestrial laser scanner measurements, covering the most deformed areas (Fig. 3).

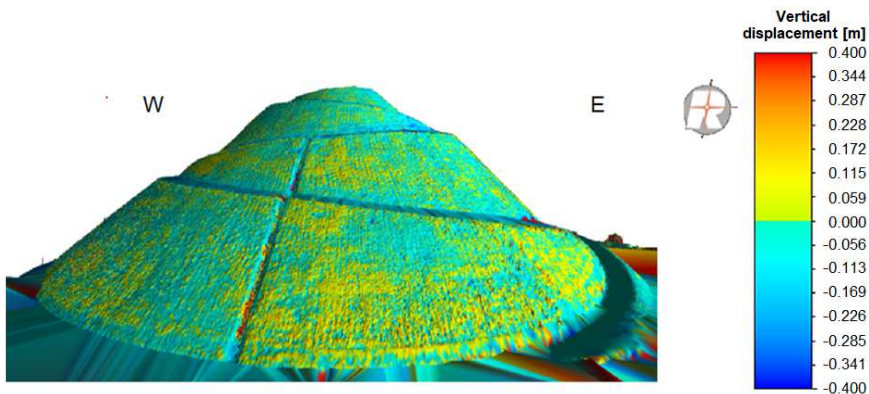
**Fig. 4.** Laser scanning differential model of the Kosciuszko Mound - deformations of the north slope [14].

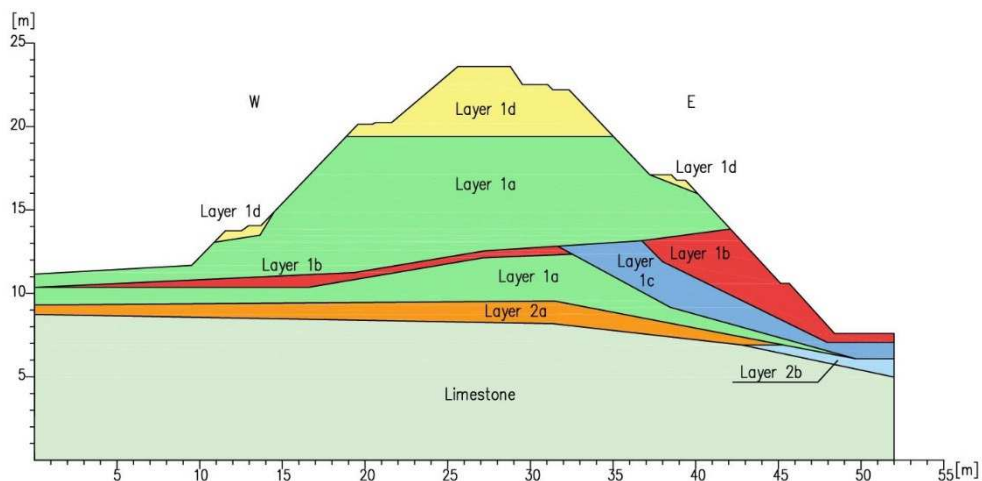
**Fig. 5.** Layout of W-E cross-sections adopted for the numerical model.

The width of the model is 52 m, and the height of 23.5 m (at the highest point). The layers marked 1a-1d are anthropogenic soils and layers 2a and 2b are original soils. The upper part of the Mound is made of non-cohesive soils in the form of medium sand, medium sand with gravel, medium or fine sand with dust, sand with dust and gravel, gravel with sand and dust, gravel with sand. The lower part of the embankment is made of cohesive soils in the form of dusts, dusts with loams, clay with dust and sand, dust with clay and sand. The whole structure is based on limestone.

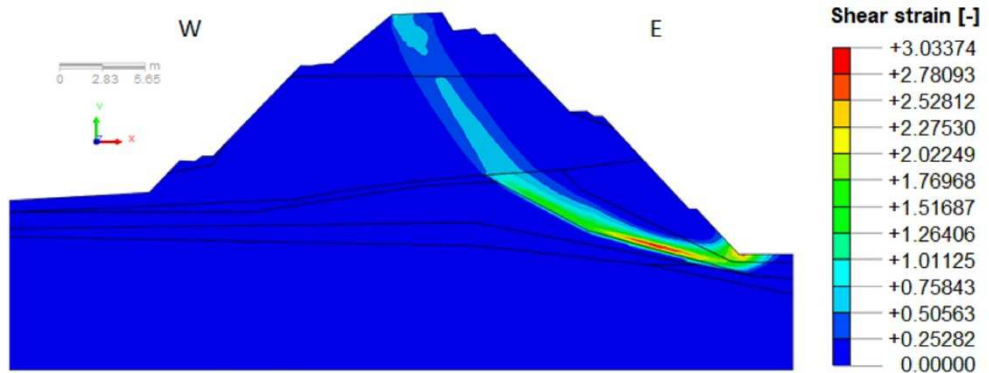
The results of the presented analysis refer to a situation with a critical stability. An analysis of slope stability with MIDAS GTS NX showed that the total factor of safety is 1.08. The factor of safety is slightly greater than 1, nevertheless this value is close to the critical value 1.00 (meaning the loss of stability) therefore it is necessary to control the development of landslide movements in this area.

The process of slope destruction starts in the lower part of the slope and then proceeds towards the top on the eastern side. The shear plane is clearly developed (fig. 6). The most

serious damage to the slopes is in the lower part and decreases towards its top. The area covered by the occurrence of landslide movements and the direction of their development obtained on the basis of the analysis coincide with results of monitoring by a terrestrial laser scanner [16].

**Fig. 6.** Maximum shear strain for the WE cross section through the Kosciuszko Mound [14].
