Effect of Near-Wave Field Mining Tremors on the Rock Bolt Support Behaviour within Stress Domain

Witold Pytel^{1,*}, Krzysztof Fuławka¹, and Piotr Mertuszka¹

¹KGHM CUPRUM Ltd. Research & Development Centre, 2-8 Sikorskiego, 53-659 Wrocław, Poland

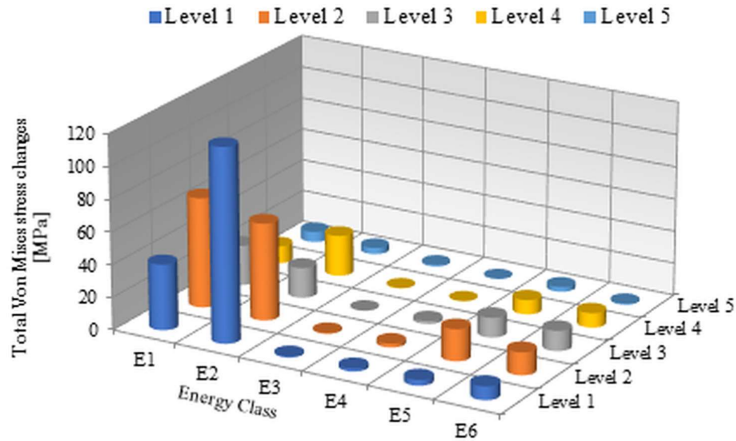
Fig. 16. Total changes of reduced stresses in bolt rod no. 2.

The largest stresses in bolt no. 2 were recorded at the first and second measurement level (Fig. 16). Changes of forces acting in the roof strata were triggered by events with low energy, i.e. E1 and E2 classes. It can therefore be assumed that such a high impact of tremors representing low energy classes is related to their genesis. Sudden increase of stresses in the area of measuring points after low-energy tremors indicates that they could have been caused by cracking or sudden spalling of rock stratum located directly above the immediate roof level. This confirms the increase in stresses at the first two measurement levels. Cracked rock layers, due to their low thickness, do not release energy great enough to determine their exact location during cracking. However, after partial detachment, they hang on the roof support generating high axial stresses.
