Groundwater Flooding due to Tropical Cyclone Cempaka in Ngreneng Karst Window, Gunungsewu Karst Area, Indonesia

Keywords: Tropical Cyclone Cempaka; Groundwater Flooding; Ngreneng Karst Window; Gunungsewu Karst Area.

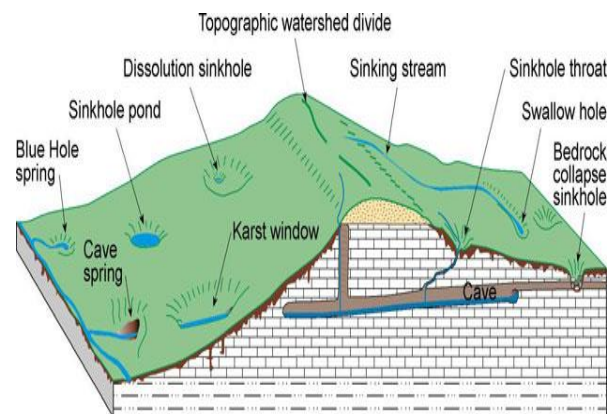
Fig. 5. The Scheme of the Landscape Overview in Karst Area

As seen from the geomorphological features, Ngreneng Cave is a "karst window". The karst window (Figure 5) is a natural form in karst region developed from the collapse of underground rivers, exposing part of the underground river to the surface at the base of karst valley (doline). Some experts call it *estavelle*, which is a term derived from Dinarik Karst in Europe [9]. However, some of the features do not meet the conditions of an *estavelle*. *Estavelle* is characterized by an intermittent spring—which periodically ceases to flow—due to changes in the water table (the dominance of diffuse/intergranular flow) and, at a certain time, it functions as a sinkhole [10]. These properties do not accurately represent Ngreneng even though this cave also acts as water drainage (sinkhole). Ngreneng has continuous flow all the year and is dominated by underground river flow (conduit).

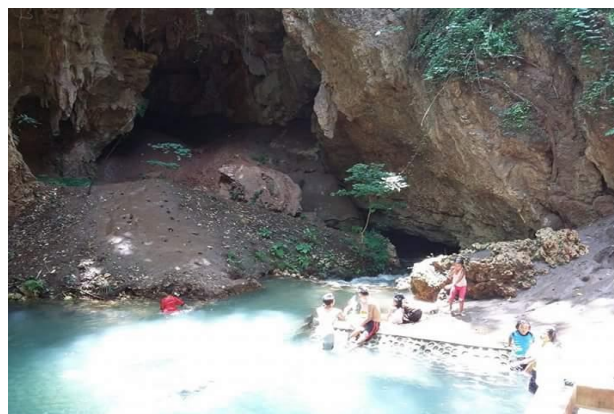
Fig. 6. The Small Drainage Tunnel of Ngreneng Cave (Photo was taken in the dry season of 2011, by Ahmad Cahyadi)

The main cause of overflow in Ngreneng Cave was the large volume of water transported by the underground river. The flow exceeded the small drainage capacity of the underground river in Ngreneng Karst Window (Fig. 6). A large amount of Cempaka-induced rainfall significantly increased the volume of water that had to be transported or drained by Bribin Underground River. The manager of Bribin Dam affirmed this condition. Normally, the water level at the dam was 36 m, but on November 28, 2017, it rose to 64 m. Therefore, the water pump machine at Bribin Underground River II or Sindon had to be turned off. The water input was greater than the distribution capacity of the underground river passage, causing water to rise through the karst window and then recede after a certain period. A simple scheme of this mechanism is presented in Fig. 7.

for ten days over a maximum area of 26.4 ha. The groundwater flood in Ngreneng Karst Window occurred because the water flowing through the conduit tunnels exceeded the distribution capacity. As a result, the water rose through the karst window and created a lake on the doline. The diffuse flow that filled the tunnels first rose into the surface. Therefore, the lake water was initially clear. However, after three days, the water from the conduit channels started to emerge and made the lake water murky.

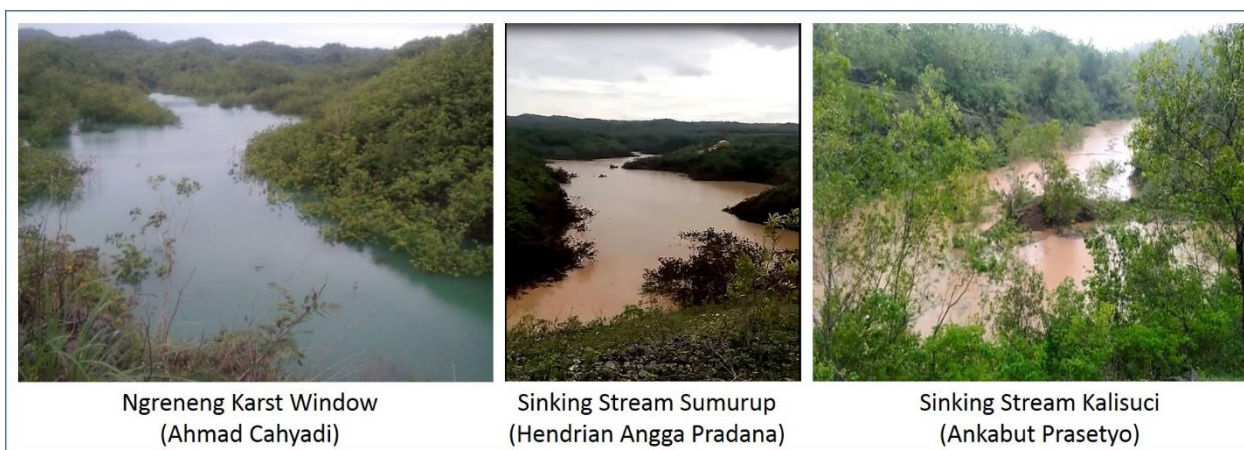
Fig. 8. The Differences between the Indundations around Ngreneng Cave, Sumurup Cave, and Kalisuci Cave

The groundwater flooding in Ngreneng Karst Window was unique because the overflow was clear or not murky. This condition is different from the flooding in Kalisuci Cave and Sumurup Cave (Figure 8). There are at least two reasons that can explain this uniqueness. First, it is attributable to the main recharge that flows

into Ngreneng Cave and, second, the diffuse flow dominates the drainage mechanism.

In karst hydrology, the recharge of groundwater or underground river is broadly divided into two, namely allogenic and autogenic. Allogenic recharge originates from non-karst regions and enters through surface rivers that flow into underground rivers as sinking streams [12], such as Kalisuci Sinking Stream and Sumurup Cave. Kalisuci Sinking Stream, for example, is an outlet of Jirak River that flows from Ponjong District and some regions in Semanu District [12-14]. Water that flows on the surface is murky because it mixes with eroded soils [15]. Different conditions occur if the water recharge is autogenic, i.e., rainwater seeping through cracks in karst areas and gravitationally descending into an underground river [16-18]. The filtering process by the soil, cracks, and rock cavities purifies the water that enters the underground river [7]. Although Ngreneng Karst Window has both autogenic and allogenic systems [12], the discharge capacity of its diffuse flow is considerably large [10]. Consequently, clear diffuse discharge is dominant, which was the same case as the large autogenic recharge at November 30, 2017. The allogenic flow pushed the diffuse flow that had already filled the underground river passage during the flood. In other words, the water rising to the surface and inundating the base of karst basin was diffuse flow. It was also evidenced by the color change that began to occur after four days. The allogenic flow entered later and made the water inundating Ngreneng Karst Window murky.
