Case Study for Road Safety Audit of Aurangabad City

Since RSA is performed to ensure safety, it will also check that design of road components such as road junctions must be planned as per traffic safety guidelines. In present investigation, Beed Bypass Road passing through Aurangabad city was considered. Two road junctions, MIT chowk and Deolai chowk were selected for further investigation. The number of accidents which had occurred in past at these two black spots were studied in detail. Reasons for accident were investigated in scientific manner. Different remedial measures to avoid further accidents were also found and applied in model study to ensure its trustworthiness.

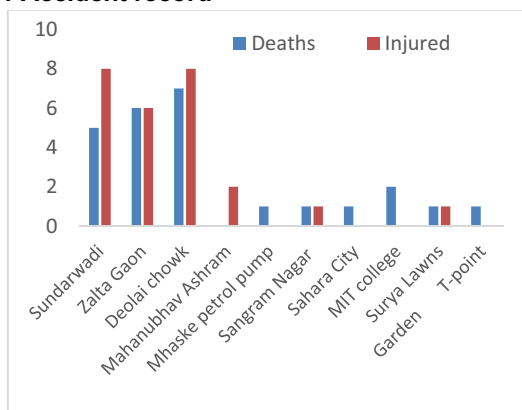
Fig. 3 Number of Injured & deaths at accident locations.

Fig. 3 showed different location along the stretch of Beed Bypass road where number of accidents occurred, were recorded. Corresponding injured and deaths also recorded. This data was made available from past records. It was observed that maximum accidents have occurred at Sunderwadi, Zalta gaon and Deolai chowk junctions. These locations also recorded maximum number of deaths and injured people. For further investigation Deolai chowk which recorded maximum accidents and MIT chowk which was near an educational institution, which may be prone to accident was considered for next investigation.

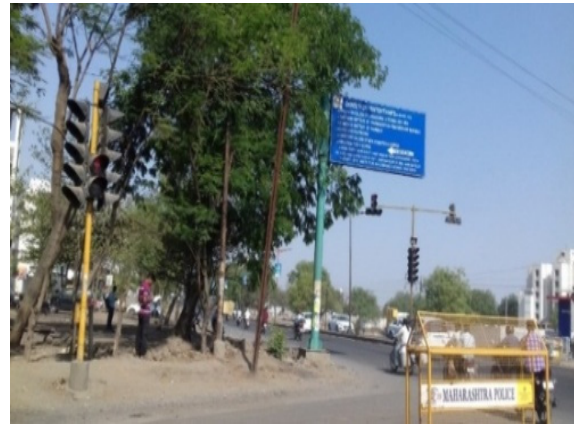
Fig. 4 Sign board post at turning obstructs vehicles

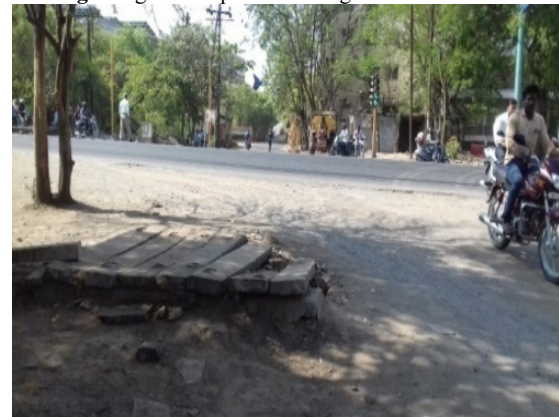
Fig. 5 Open Gutter on road side

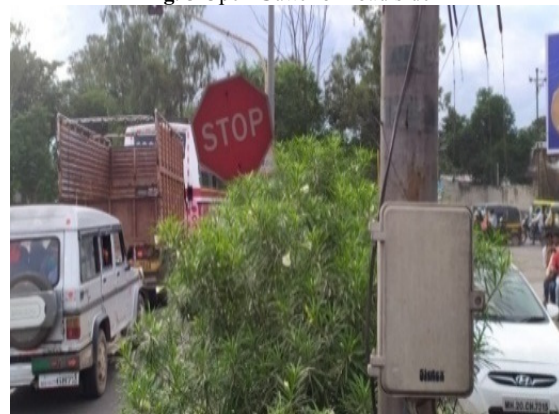
Fig. 6 Road Sign hidden behind plants

14. Plantation at the junctions should be removed so that approaching vehicle can see the clear view of traffic.
15. Branches of trees projecting over the road at a height less than 7 m should be removed.
16. Pot holes and ruts should be repaired.
17. Traffic rules should be strictly followed.

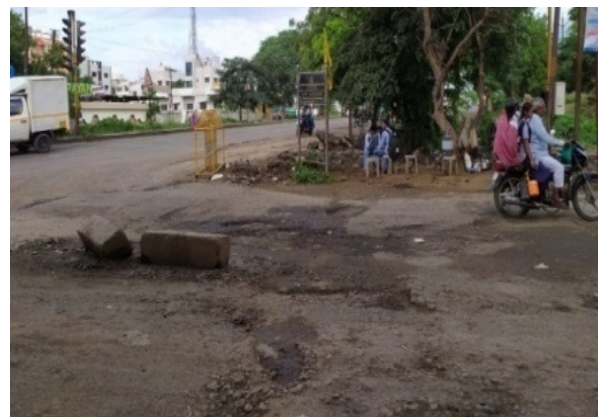
Fig. 7 Pot holes at MIT chowk

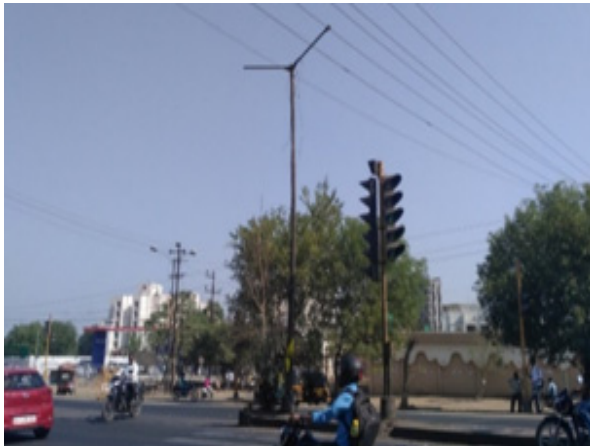
Fig. 8 Street Light not working at MIT chowk

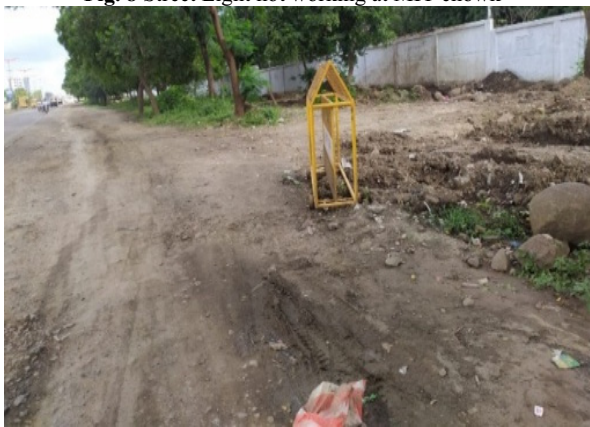
Fig. 9 Uneven Service Road at MIT chowk

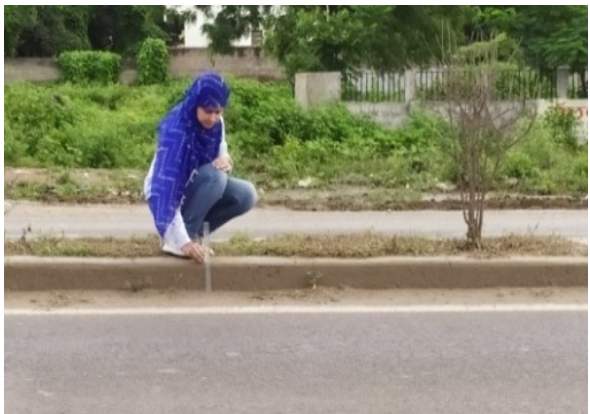
Fig.10 Insufficient Median Height

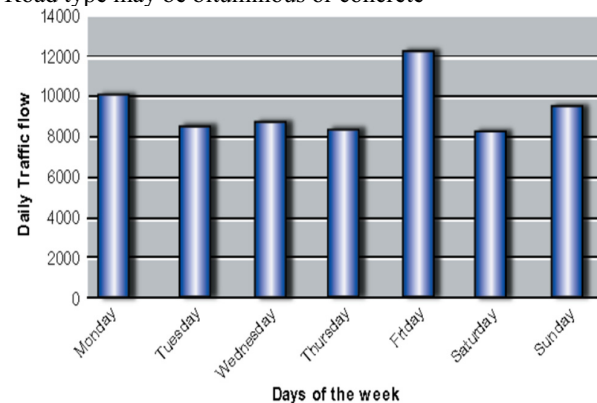
Fig. 11 Daily traffic flow Beed bypass road.

Daily traffic flow on Beed bypass road is represented as bar chart as shown in fig.11 in passenger car unit (PCU).

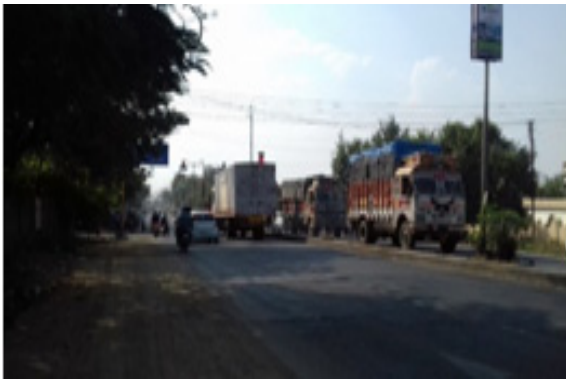
Fig. 12 MIT chowk

MIT chowk is near an institutional area so there is presence of large number of students in day time. Also, at the junction, there is falling gradient which eventually make the vehicle reach the junction at high speed. Sufficient Set back distance (SBD) is not available while taking right turn from MIT college. All these factors lead to accidents. Fig.12 shows photograph of MIT chowk taken on investigation day.

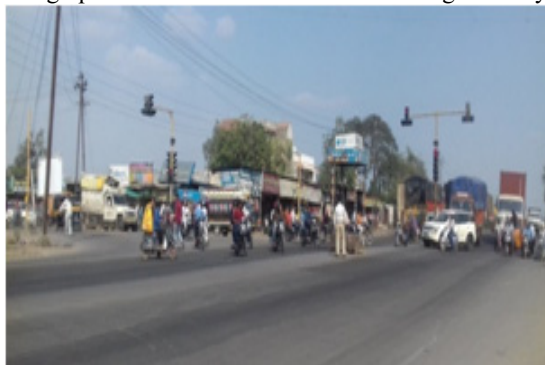
Fig.13 Deolai Chowk

Deolai chowk is one of the most crowded junctions in the Aurangabad city. Many accidents had occurred at this chowk. Small vehicles like two wheelers were involved in accidents. The road going towards Shivaji Nagar has a railway crossing and whenever this road is closed for the crossing of train then the traffic on this road gets diverted to the Deolai chowk making it more difficult for regular traffic at the chowk. Fig. 13 shows photograph of Deolai chowk taken on investigation day.
