# Hard and soft measures for earthquake and tsunami disaster mitigation

Junji Kiyono<sup>1\*</sup>

**Abstract.** A destructive earthquake struck the Kobe region on January 17, 1995, and a massive earthquake and tsunami struck eastern Japan on March 11, 2011. We present an overview of the casualty aspects of the 2011 Tohoku earthquake compared with those of the 1995 Kobe earthquake. In the Tohoku disaster, some water gates and seawalls saved some villages from the tsunami effects, though some did not. Based on these examples, we discuss the efficiency of soft and hard measures and consider their respective merits and demerits. The main causes of death in the Kobe and Tohoku EQs were, respectively, collapsing buildings and drowning in the tsunami. Although the time to death was very short in both cases, people often have more time to evacuate in the case of an interplate earthquake leading to a tsunami. Basic countermeasures against tsunamis include such hard measures as water gates, seawalls, and embankments. Soft measures need to be implemented in areas where hard measures are insufficient

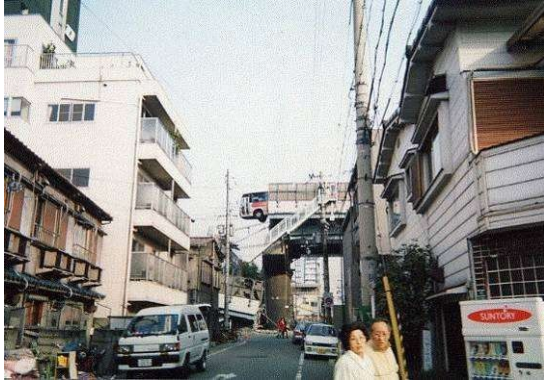
**Fig. 1.** A bus hangs over the edge of the collapsed highway

A destructive earthquake struck the Kobe region on January 17, 1995. Most kinds of earthquake damage to buildings, houses, lifelines, railways, roadways, and harbours occurred. Figs. 1 and 2 indicate the damage to a highway viaduct, which became one of the symbolic scenes of the Kobe earthquake. Fig. 3 shows that the rate of collapsed and severely damaged houses was significantly different according to whether the buildings were

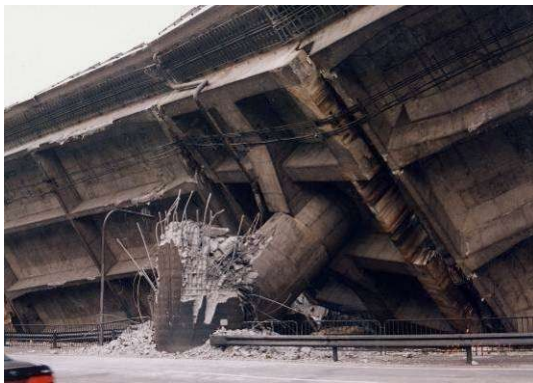
**Fig. 2.** Collapsed pillar of a highway viaduct caused by shear failure

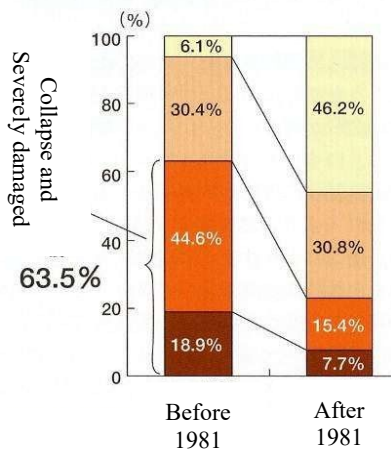
**Fig. 3.** Histogram representation of the proportion of structural damage according to the construction year— before and after 1981)

constructed before or after 1981[2] the year when the seismic code for building construction was revised. This figure indicates that severe damage leading to casualties could have been reduced if houses constructed before 1981 had been strengthened according to the provisions of the revised code.

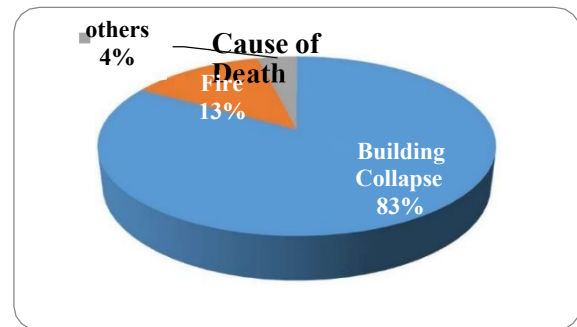
**Fig. 4.** Pie chart illustrating the causes of death in the 1995 Kobe earthquake [2]

Fig.2 shows a classification of the causes of death [2] in the

1995 Kobe earthquake (Kobe EQ). Over 80% of deaths were caused by collapsing buildings. This fact became the basis for promoting the strengthening of buildings. However, the causes of death in the 2011 Tohoku earthquake (Tohoku EQ) were quite different from the Kobe EQ, as shown in Fig. 5 [3]: more than 90% of the deaths were due to drowning.

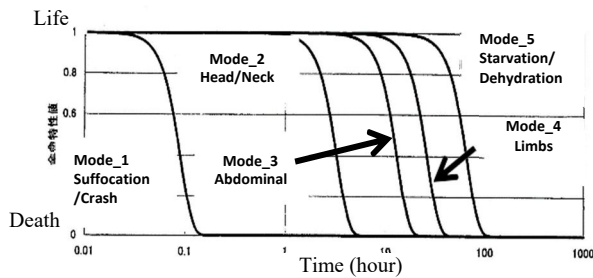
**Fig. 6.** Graph indicating the time leading to death after being trapped in a collapsed house [4]

The time leading to death after being trapped in a collapsed building is classified according to the injured part of the body, as indicated in Fig. 6 [4]. In this figure, the horizontal axis represents time (hours) on a log scale, and the vertical axis is an index value between 0 (death) and 1 (survival). For example, a person survives only for a period of several minutes if they are trapped and suffocated or are crushed by the debris (mode 1), but can survive for several days if they become trapped without sustaining any injury. In the Kobe EQ, as noted, most of the victims were killed by collapsed houses (Fig. 5), which falls in the category of mode 1, and those deaths occurred in buildings that predated the code revisions (Fig. 3). That is why the government promoted the introduction of hard measures, such as the strengthening of houses.

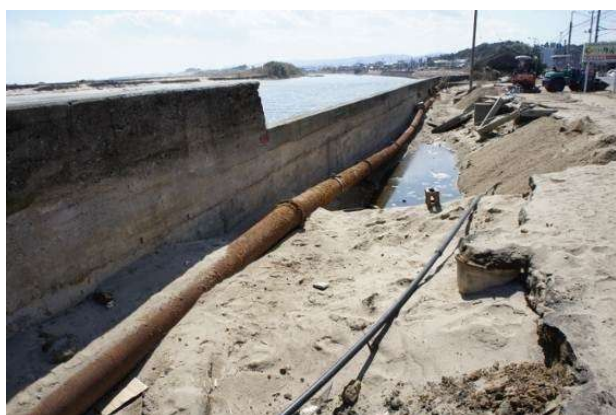
**Fig. 9.** Damaged pipe behind a seawall

Several scenes showing the damage caused by the tsunami appear in Fig 9–14. The extreme power of the tsunami is evident in the damage to buildings, harbours, lifelines, railways, roadways, industry, and agriculture.

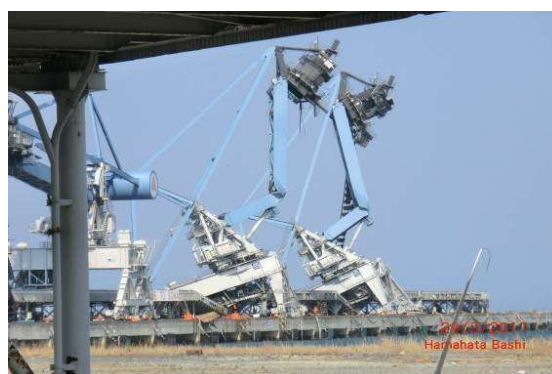
**Fig. 13.** Buckled crane arm (Soma)

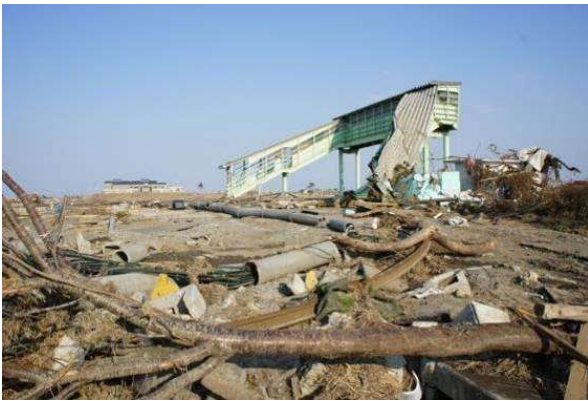
**Fig. 14.** Damaged railway station (Shinchi)

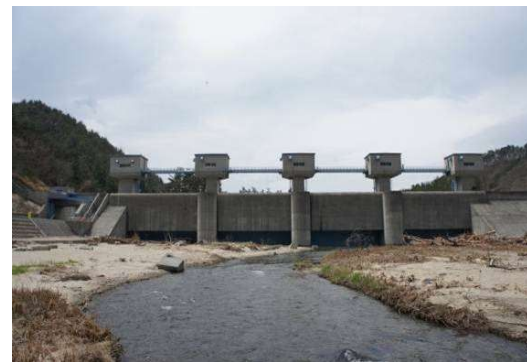
**Fig. 16** Fudai water gate (downstream side)

The Fudai watergate was constructed in 1984 at a distance of about 300 m from the coast (Figs 16 and 17). The height of the gate is TP+15.5 m and the total crest length of the four gates is 205 m. The village itself is located several

hundred meters inland from the coast. Fudai experienced tsunamis associated with the 1896 Meiji Sanriku and 1933 Showa Sanriku earthquakes, which had magnitudes of 8.25 and 8.1, respectively<sup>5</sup>). In 1896, the tsunami struck the village and casualties were severe: 1,010 people were killed. In the Tohoku EQ, the tsunami height was estimated as 20 m, and so the tsunami exceeded the water gates and run-up. Fortunately, no fatalities were reported in the village after the Tohoku EQ.

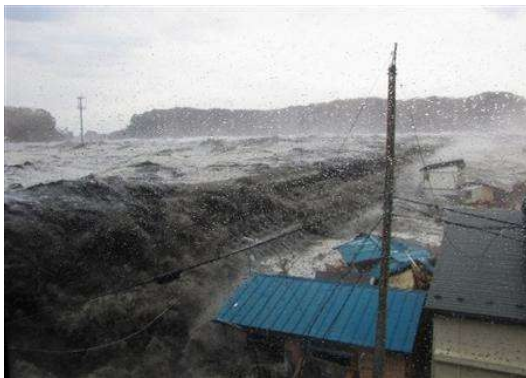
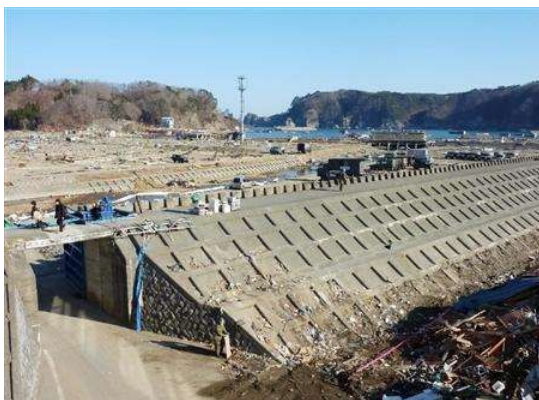
(a) During Tsunami

(b) After Tsunami (Fig (b) courtesy of Mr. Hatayama, from Sankei New:<http://sankei.jp.msn.com>)

**Fig. 20.** Tsunami sweeping over the 10 m high seawall at Taro

With the Tohoku EQ, a tsunami of over 10 m in height struck Taro, and many residents expected the seawalls to protect them. The tsunami swept over or destroyed the seawalls Fig. 20.

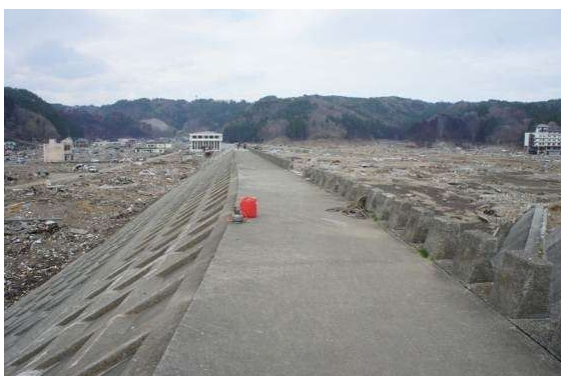
**Fig. 21.** The tsunami washed houses away in Taro

Fig. 21 shows the town after the tsunami. In all, 1,609 houses were destroyed in this area. The total numbers of dead and missing people<sup>8</sup>) for the whole of Miyako, which comprises six districts including Taro, were 417 and 195, respectively, as of June 17, 2011 [4].

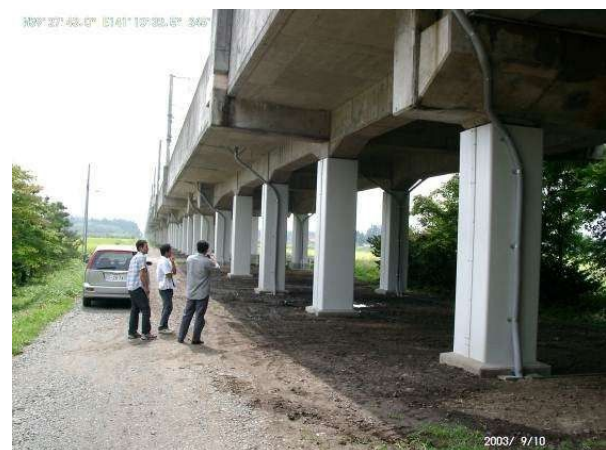
**Fig. 22.** Strengthened viaduct columns after 2003 Sanriku-minami-earthquake

One example of a successful system combining soft and hard measures is an alert system used by Japan’s railways called the Urgent Earthquake Detection and Alert System (UrEDAS) [9]. This system includes data-acquisition, decision-making, and electricity shutdown processes. Japan Railways East reported that at the time of the Tohoku EQ, five Shinkansen trains were running between Fukushima and Iwate prefectures at speeds of around 270 km/h; however, all the trains successfully decelerated and stopped quickly before the main tremor through the UrEDAS system [10]. In the 2003 Sanriku-minami earthquake, many columns of the Tohoku Shinkansen viaduct were severely damaged and retrofitted using steel plate Fig. 22. The bridge columns of the Tohoku Shinkansen sustained severe damage in the Tohoku EQ Fig. 23; however, the retrofitted columns suffered no damage at all.

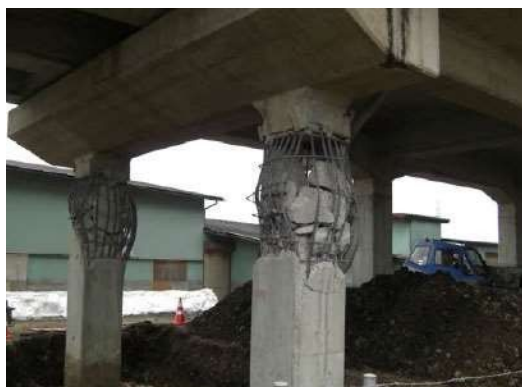
**Fig. 23.** Damaged viaduct columns of the Tohoku Shinkansen line after the Tohoku earthquake (photo courtesy of Dr. Takahashi, DPRI, Kyoto Univ.)
