Study on the Leakage Damage Mechanism and Repair Technology of Shangmaji Weir

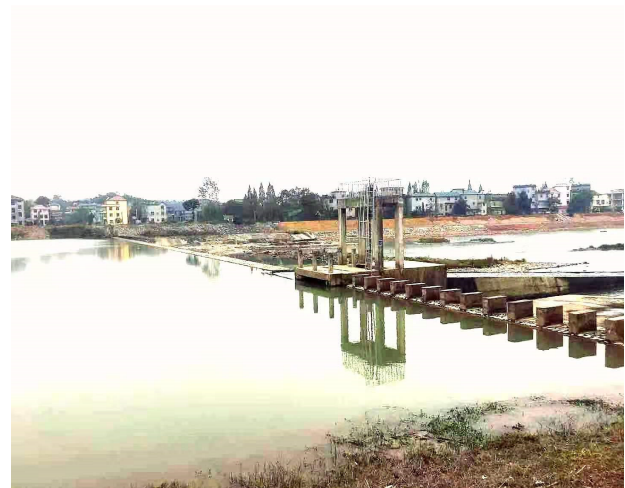
survey data shows that the water intake is 1.8m wide and 1.4m deep. It is only lined with concrete and has no anti-seepage measures (Figure 1). Therefore, when the water flows through the water intake, it is easy to seep to both sides. Under the long-term water infiltration, the weir will also leak and damage.

Fig 1. Leakage at the intake

(2) For the anti-seepage treatment of the water intake, because it is necessary to ensure the amount of water diversion, it is not suitable for large-scale thickening repair, so a relatively simple anti-seepage plan can be adopted, that is, laying geomembrane. Geomembrane is a coiled material, which is convenient for transportation, convenient for construction, and short construction period. At the same time, the cost of using in an anti-seepage system is 30% or more lower than that of a traditional reinforced concrete anti-seepage structure. And the geomembrane has strong acid and alkali resistance, anti-aging, anti-ultraviolet abilities, and can be used quickly in various complex environments and is durable. Geomembrane can be used together with non-woven fabrics. Non-woven fabrics have a rough surface and can generate greater friction with the contact surface to ensure that the geomembrane and the protective layer are in a good and stable state.
