Problems of thermal protection of two-layer external walls with hinged facade systems

Khakass Technical Institute of Siberian Federal University, Construction department, 655017, Abakan, Khakassia, Russia

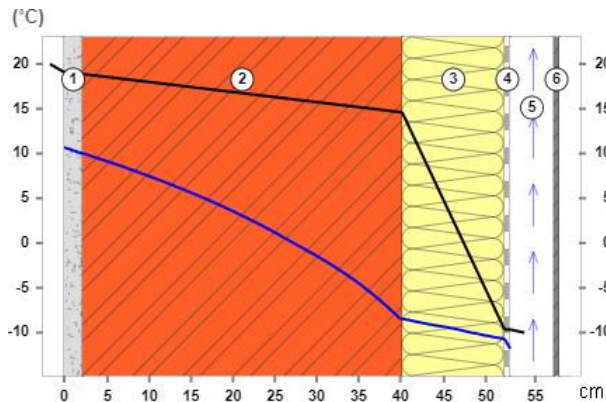
Fig. 1. Temperature distribution in the outer wall with a hinged ventilated facade using a moisture-windproof membrane

In the work, a heat engineering calculation of the external fence was carried out using hinged facade systems with the use (Fig. 1) and without the use of a moisture-windproof membrane (Fig. 2). The properties of the materials used in the outer wall are presented in the Table. 2.

Calculations have shown that the moisture-windproof membrane does no affect on the formation of a condensation plane in the outer wall. In the works [17–19] it is noted that the speed of air movement in the air gap within the range of up to 30 m is insignificant, which reduces the likelihood of mass emission of insulation fibers.

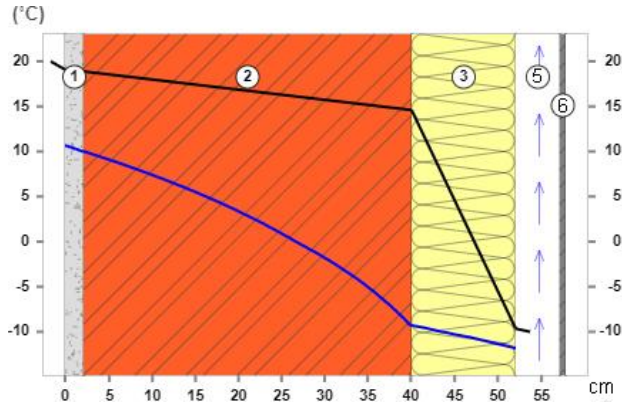
Fig. 2. Temperature distribution in the outer wall with a hinged ventilated facade without a moisture-windproof membrane

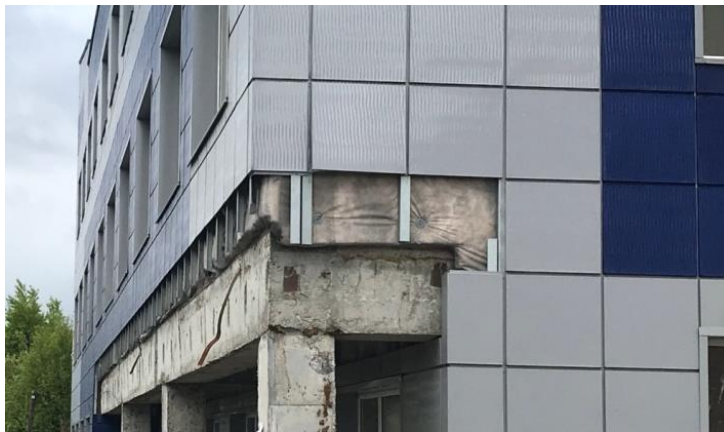
Fig. 3. Contamination of the moisture-windproof membrane during operation

During the operation, the vapor permeability of the membrane will decrease due to its contamination (Fig. 3).

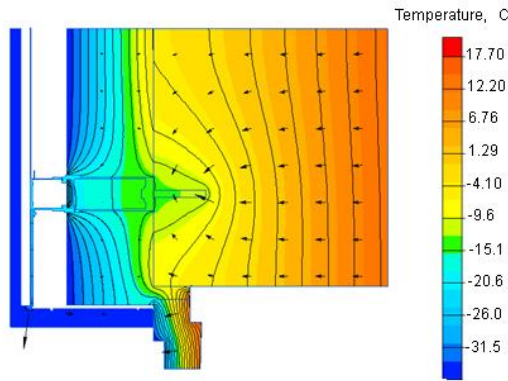
Fig. 4. Junction of the window frame to the wall with a hinged ventilated facade (horizontal section)

Most facade systems have metal ties. Previous studies have shown the effect of heat-conducting inclusions on the thermal protection of buildings. [14, 15] Calculation of the temperature fields of external walls with hinged facade systems for the climatic conditions of Abakan is shown on Fig. 4, 5.

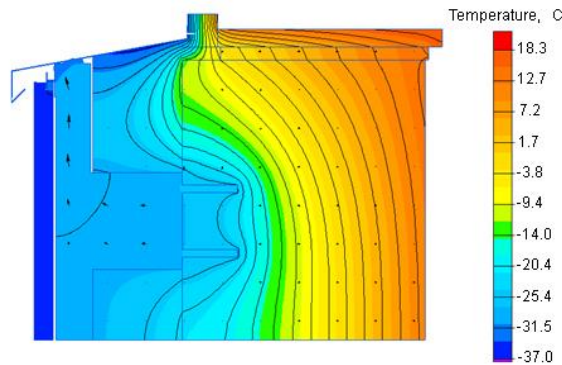
Fig. 5. Junction of the window frame to the wall with a hinged ventilated facade (vertical section)

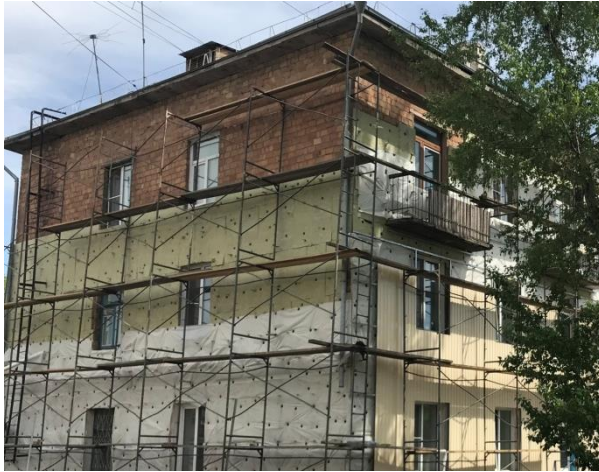
Fig. 6. Defects in the installation of hinged facade systems

Fig. 6 shows façade defects - gaps between heat-insulating plates.

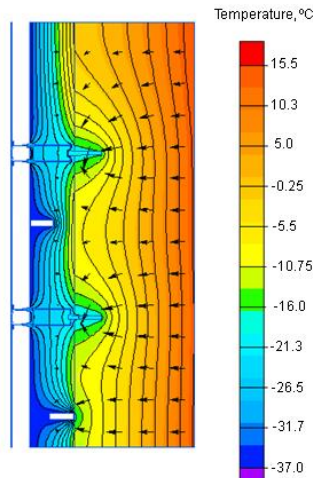
Fig. 7. Temperature field of the outer wall with a curtain ventilated facade with installation defects

Fig. 7 shows the temperature field of the external wall, taking into account the gaps between the heat-insulating plates.

You can see on Fig. 7 the displacement of the temperature isolines in the presence of voids and cracks at the joints of the insulation.
