Implementation and evaluation of the underwater crack repair in the hollow concrete block of the gravity wharf

Abstract. Concrete block quay wall is the most popular type of structures in the gravity wharf. The concrete block can be generally categorized into two types: solid and hollow concrete blocks. Compared to the solid concrete block, the hollow concrete block can reduce the usage of concrete significantly and increase the resistance to sliding and overturning. This paper studied the application of hollow concrete blocks in the gravity wharf of Qingdao Port. It was discovered that in the application, the main problem was the crack development in the hollow concrete blocks. The paper first analysed the reason of crack development in the structure by conducting laboratory model tests. It was found that the contact conditions between two hollow concrete blocks was the key of the crack development. In order to improve the performance of the structure of hollow concrete blocks, an effective scheme, which can repair the cracks in the underwater environment and increase the bearing capacity of the gravity wharf, is proposed. The scheme contains two main procedures. The first step i

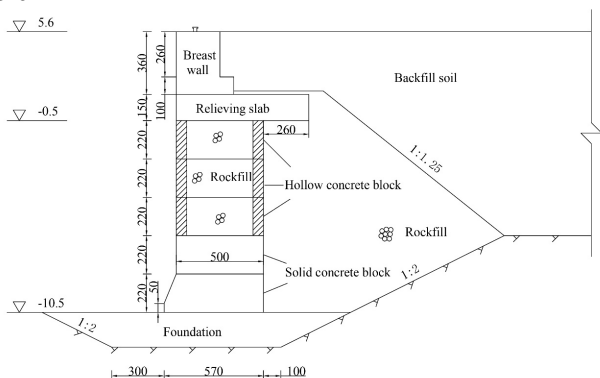
The 52nd wharf in Qingdao Port was constructed from the early 1980s and went into service in 1986. It is a gravity wharf built of hollow concrete blocks. The cross-section of the 52nd wharf is shown in Fig. 1. It can be seen from Fig. 1 that there are three layers of hollow concrete block overlying two layers of solid concrete blocks. The hollow space of the concrete block was initially filled with rocks in the construction period. The diameter of the rock is from 15 cm to 20 cm, and the porosity of the rockfill is approximately 30%-40%. On top of the hollow concrete blocks, it is the relieving slab and the breast wall. The final elevation of the wharf is 5.6 m.

Fig. 1. Cross-section of the 52nd wharf in Qingdao Port (length unit: cm, elevation unit: m).

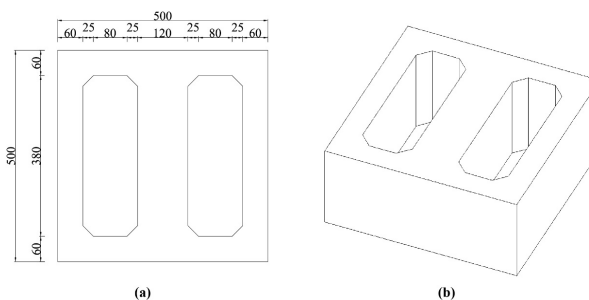
The length of each hollow concrete block is 5 m, the width is 5 m and the height is 2.2 m. There are two holes in the block. Fig. 2 shows the geometry of the hollow concrete block. The positions of the two holes are symmetrical and each hole is 3.8 m long, 1.3 m wide and 2.2 m high. The concrete grade is C20.

Fig. 2. Geometry of the hollow concrete block, (a) top view; (b) 3D view.

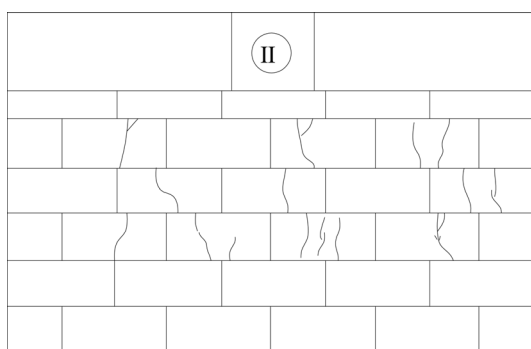
Since the cracks posed a serious threat to the stability of the gravity wharf, it was necessary to find out the reason of crack development. From the appearance of the cracks (Fig. 3), it was found that most of the cracks were approximately vertical and close to the middle part of the hollow concrete block. It was postulated that the main reason for the cracks may be because the block surface was not smooth. This induced that the contact between two hollow concrete blocks became point contact rather than the supposed plane contact. The point contact worsens the supporting and loading conditions of the hollow concrete blocks.

Fig. 3. Appearance of the cracks in the hollow concrete blocks observed by underwater inspection.

The roughness was caused by the production of the hollow concrete blocks. At that time, there were no regulations concerning about the flatness of the surface of the hollow concrete block. Normally, the regulations for solid concrete blocks were used for the hollow concrete blocks, which was ± 1 cm allowed for the surface irregularity. Moreover, in practice, the irregularity (± 1 cm) could be magnified due to the manufacturing technology for such a large concrete block (5 m \times 5 m \times 2.2 m). Fig. 4 shows the possible point contact between different blocks. The contact of two hollow concrete blocks changes from plane contact to point contact. In this situation, the stress conditions of the hollow concrete blocks are much worse than that assumed in the design process.

In order to increase the bearing capacity of the gravity wharf and stop the development of the crack in the three layers of hollow concrete blocks, a scheme had been proposed. The proposed scheme contained two procedures. First, the crack observed in the surface of the hollow concrete block needed to be mended in order to stop the further development of the crack. Second, grouting was taken to reinforce the structure. Cement mortar was injected into the void of the rockfill in the holes of the hollow concrete block. Then, the rockfill and the three layers of hollow concrete blocks could be bonded together and became a whole. The difficulty in the proposed scheme was the underwater construction environment. The mending material should be able to solidify underwater and the cement mortar should be resistant to disperse underwater.

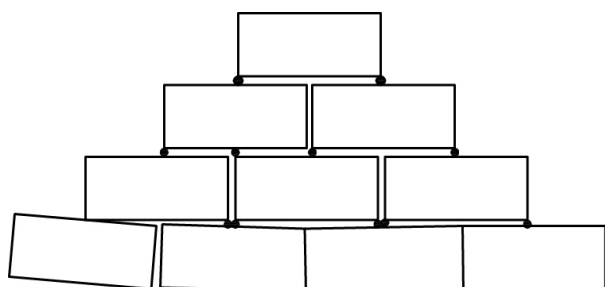
Fig. 4. Possible contact conditions of the hollow concrete blocks.

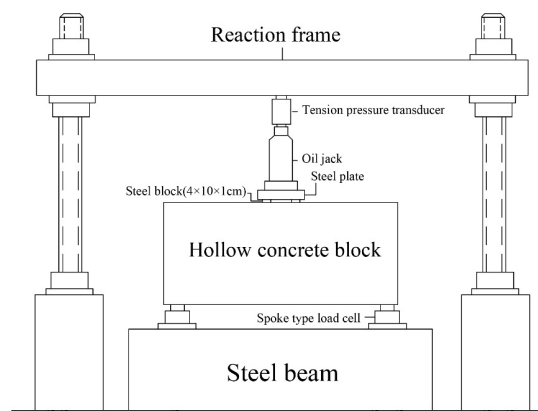
In order to verify the postulation, model tests had been undertaken. In the model tests, the geometric scale was 1:5, which meant the size of the model was 100 cm \times 100 cm \times 44 cm and the two holes in the model block

were both 26 cm \times 76 cm. The concrete grade of the model was also C20. Therefore, based on the principle of similarity, the scale of concentrated loading was 1:25. To investigate the performance of the hollow concrete blocks under the possible contact conditions (shown in Fig. 4), different model tests had been done. Fig. 5 is the sketch of the model test apparatus. In those model tests, the supporting conditions and the location of the concentrated forces applied on the model blocks were different.

Fig. 5. Sketch of the model test apparatus.

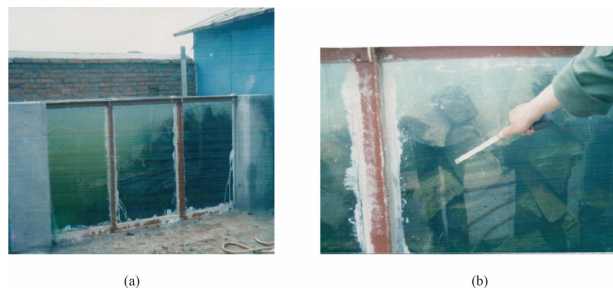
To investigate the effect of the grouting technique, laboratory tests were undertaken first. In the laboratory tests, a model box was made, which had a length of 3.8 m, a width of 2.75 m and a height of 1.33 m. The model box was filled with rocks which had the same size as the rock used in the gravity wharf, i.e. 15-20 cm. Then, the box was filled with water. These built a similar condition to the field (see Fig. 8).

Fig. 8. Model box used in the laboratory tests, (a) model box and (b) conditions of the rockfill.

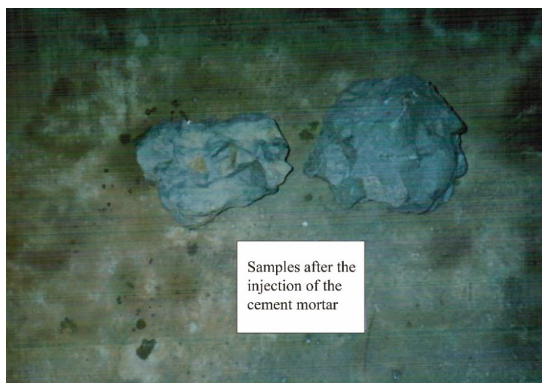
The pressure of the squeeze pump was 0.2-0.4 MPa. It can be found from Fig. 9 that the diffusion area of the grouting was around 70 cm from the pump line. After the test, it was observed that the cement mortar had filled up the gaps among the rocks and connected the rocks together. Fig. 10 showed the samples taken after the injection of the cement mortar. It had proved that the rocks bonded together underwater.

Fig. 10. Samples taken from the model box.

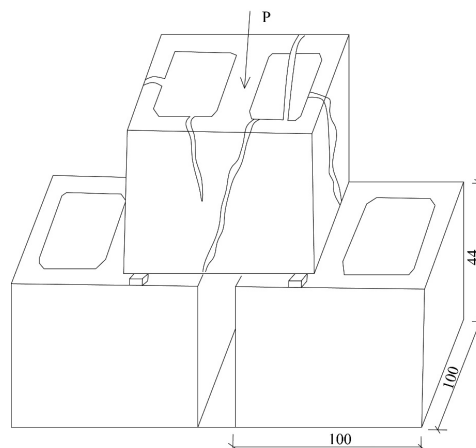
Later, the effect of the grouting on the reinforcement of the concrete blocks had been studied. The model block 3 used in the model test had been taken and placed on top of two unbroken model blocks (see Fig. 11). The supporting conditions of the model block 3 were the same as Fig. 6 (a).

Fig. 11. Model blocks placement for the laboratory test (unit: cm).

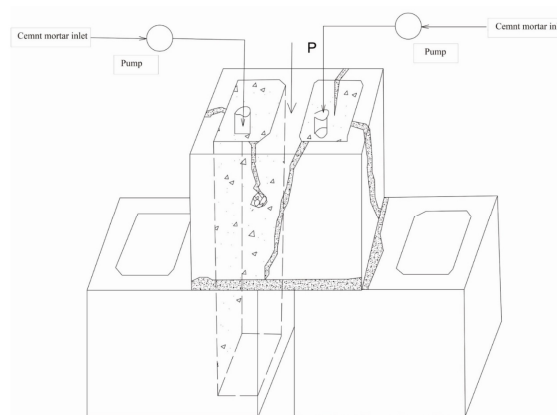
Then, the proposed scheme was used to fix the model block 3. First, the mending material was used to fill up the cracks. Then, the grouting technique was used to reinforce the whole structure. The setup of the injection of the cement mortar was shown in the following Fig. 12.

Fig. 12. Injection of the cement mortar into the rockfill of the model block.

After the injection, the structure was cured by water for the first 7 days. Concentrated load was applied to the structure after 10 days and 20 days. The loading position was the same as model block 3 in the model tests, i.e. the middle of the block. In the 10th day, the concentrated load was 200 kN, and there were no new cracks emerged in the upper block. Compared to its previous bearing capacity (115 kN in Table 3), the strength of the model block increased significantly. In the 20th day, the concentrated load increased to 295 kN, three new cracks emerged in the upper block, whereas the old cracks did not develop again, shown in Fig. 13. The test results proved that the bearing capacity of the model block reinforced by the proposed scheme had increased 153%, which was a significant improvement.

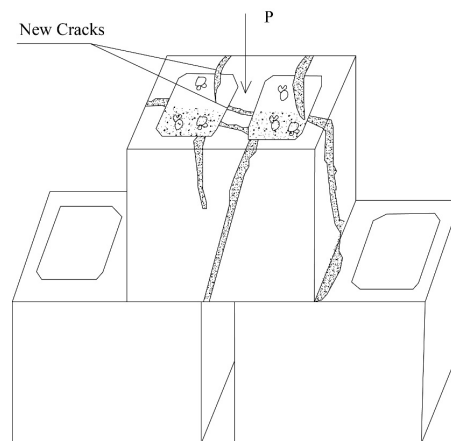
Fig. 13. New cracks emerged in the upper block.

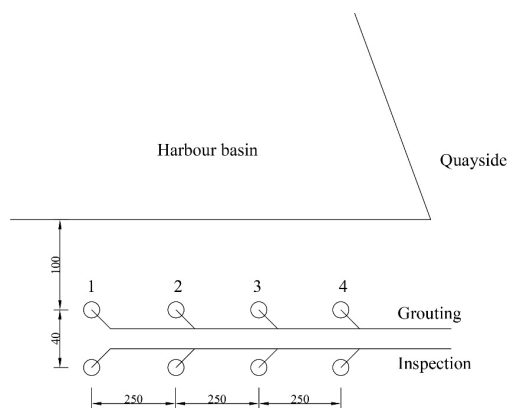
In order to examine the in-situ effect of the proposed scheme, field tests had been done as well. In the gravity wharf, a small area was chosen to conduct the field tests. This area had a span of two hollow concrete blocks. Eight holes were drilled first, four of them were for the grouting and the other four were for inspection (Fig. 14). The diameter of the drill holes was 9-12 cm, and the depth of each drill hole was 12 m. The proposed scheme was used in the field to reinforce the hollow concrete blocks. In the inspection hole, DR-501 nuclear density gauge (produced in the U.S.) was utilized to measure the density of the rockfill before and after the injection of the cement mortar.

Fig. 14. Drill holes for the field test.

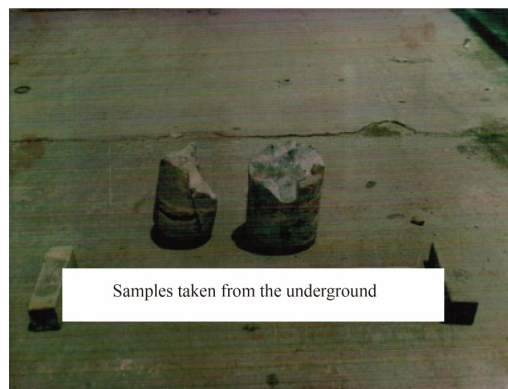
Half a year later, two samples were taken from the wharf. One was taken from 5.5 m deep to the ground, the other one was from 8.5 deep, shown in Fig. 16. It can be observed from the appearance of the samples, the cement mortar bonded to the rocks tightly. The two samples were shaped to conduct tests of compressive strength. The size of them were $\Phi 12.8 \times 10$ cm and $\Phi 10.8 \times 7.5$ cm. The results were 43.9 MPa and 20.4 MPa, respectively.

Fig. 16. Samples taken from the 52nd wharf.

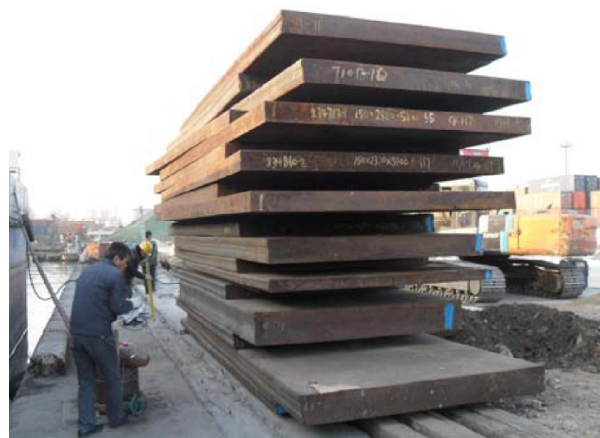
Since there were needs of increasing the capacity of the wharf, the old crane had to be replaced by three new bridge cranes. The three new bridge cranes would apply larger loads to the underneath gravity wharf. To check the capacity of the structure, pile load test was conducted (shown in Fig. 17). The pile load was up to 463 kN/m, which simulates the exact load after the upgrade of the wharf. Under such a heavy load, the old cracks did not further develop and there were no new cracks emerged.

Fig. 17. Pile load test in the gravity wharf in 2010.
