Improving the Reliability of the Scraper-Bunker Peat Harvester

Abstract. Cases of failures of peat scraper-bunker harvesting machines are analyzed. It has been proven, that the main cause of failures is the stumpiness of the peat deposit. When interacting with the stump, there is a sharp increase in the load on all elements of the transmission of the machine, which leads to their temporary exit from the working state. The first element, that the stump encounters is the machine's elevator bucket. As a result of interaction, the bucket gets damaged in the form of ruptures, incipient and developed cracks. Proposals are formulated to increase the reliability of the scraper-bunker peat harvester by installing a simple tracking device at work of the bucket elevator and improving the design of the elevator bucket itself. It is noted, that due to the initiation and development of cracks in the zone of welded seams, buckets must be subjected to flaw detection at least once a year, during pre-season maintenance.

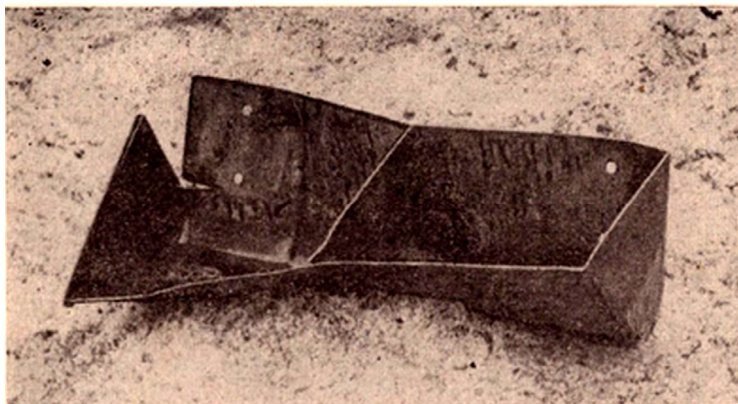
Analysis of the above data shows the following. Such malfunctions, as jamming of the bucket elevator, breakage and deformation of buckets, open circuit of the bucket elevator and malfunctions of the safety clutch for engaging the bucket elevator can be attributed to a separate group of malfunctions, caused by a sharp increase in loads in the bucket elevator drive [8], due to stumps stuck between elevator buckets and machine metal structure in the area of the scraper. When investigating the operation of the first set of machines on deposits with a stump of $S = 1.5\%$, these malfunctions totaled 73 %, or 103 out of 141 malfunctions. The second set of machines, working on deposits with a stump of $S = 3\%$, was subjected to heavy loads, and this group of faults was 78 % here, or 127 out of 163 faults. Thus, the largest number of malfunctions of the scraper-bunker machine of the MTF-43 type is caused by stumps, entering the scraper and jamming them between the elevator buckets and the machine's metal structure, which, without a doubt, even in a single case, can lead to significant deformation of the buckets, accompanied by the initiation and development of cracks in their body (Figure 1). On the other hand, the calculation of the mean recovery time and the mean square deviation from the mean recovery time at the level of tenths showed no difference for machines operating in deposits with a stump of 1.5 and 3%.

Fig. 1. Deformation of the bucket of the scraper-bunker machine with rupture and the development of cracks due to a single hit on the stump.

However, it was required to increase the strength of the elevator buckets, which was done by the specialists of Pindstrup LLC. As the main material in the manufacture of the bucket, a corrugated flooring 4 mm thick made of hot-rolled steel grade St 3 was used, and along the scooping edge of the bucket, a reinforcing rib of a bent profile from the same corrugated flooring was welded (Figure 3).

Nevertheless, the analysis of the operation of the machines shows, that since cracks nevertheless arise and develop in the welded seams of the ladles, which must be repaired in

a timely manner, the design of the ladle should be subjected to further modernization with periodic control [11], at least once a season using ultrasonic flaw.

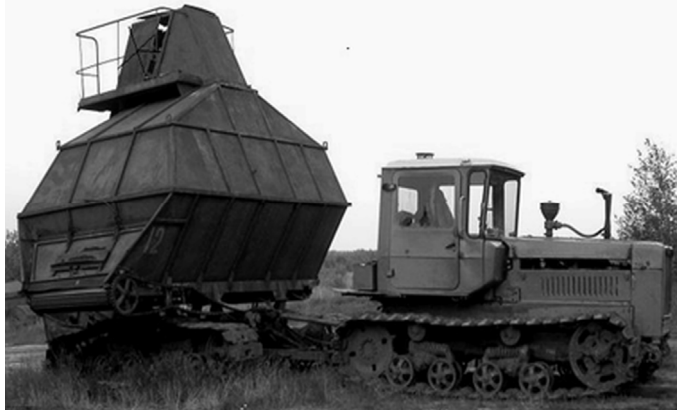
To solve this problem, two machines MTF-43 and MTF-41 with an enlarged hopper were equipped with impellers mounted on the upper driven shaft of the bucket elevator drive (Figure 2).

Fig. 2. A scraper-bunker machine with a bucket elevator, equipped with a tracking impeller.

During the operation of the bucket elevator, the impeller made a rotational movement and the driver of the tractor, looking back, saw this. When the bucket elevator jammed, the impeller stopped, and the driver, noticing this, had to stop, get out of the tractor cab and eliminate the malfunction. The study of the operation of machines with a control impeller showed, that the average time for detecting jamming of a bucket elevator is 18 seconds with a standard deviation from the mathematical expectation $\sigma = 10$ seconds. At the same time, peat losses are on average 2.2 m^3 from one jam with a standard deviation from the mathematical expectation $\sigma = 1.05 \text{ m}^3$.

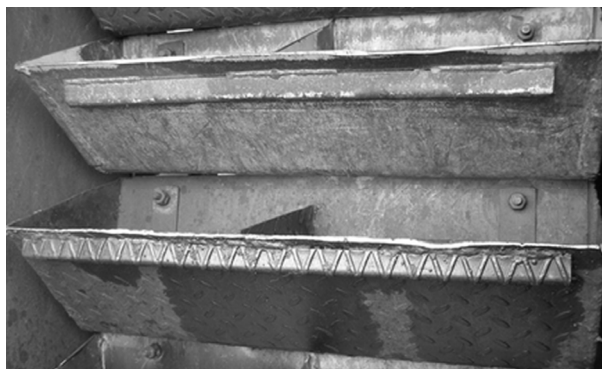
Fig. 3. Elevator buckets made of corrugated flooring at Pindstrup LLC.
