# Analysis and Treatment of Flue Duct Vibration of 1000MW Generator Set with High Load

**Abstract.** In view of the serious flue duct vibration problem of the outlet of a 1000MW unit with a load of 80%BRL and above, combined the vibration test with the calculation of the acoustic standing wave frequency, the cause of the flue duct vibration was analyzed and determined. A modification plan is proposed to install clapboards to change the standing wave frequency of the flue duct and keep it away from the measured resonance frequency. After the clapboards are installed, the flue duct vibration frequency of the induced draft fan outlet is dispersed from the two main frequencies of 61.3Hz and 61.4Hz before the clapboards were installed to 6.88Hz~204Hz; the maximum amplitude of the flue duct is reduced from 105.0 $\mu$ m to 12.6 $\mu$ m, and the problem of the flue duct vibration is fundamentally solved. This case provides a new idea for solving the problem of vibration of the flue duct in the large-scale power station boiler.

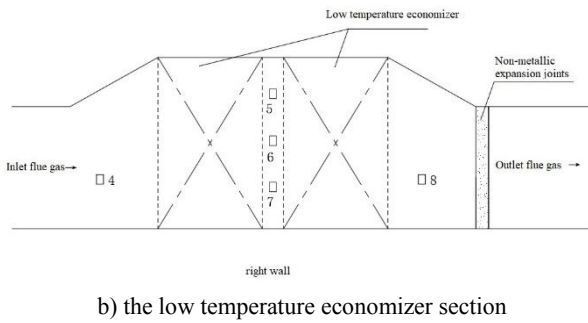
**Fig. 1.** The vibration test position between the outlet of the induced draft fan and the inlet of the FGD.

The main design parameters of the boiler is in table 1. To find the vibration causes of the flues from the outlet of the induced draft fan to the inlet of the desulfurization, the vibration test of the flue on the right side of this section was conducted with using SK4432 vibration test analyzer when the unit brings 920MW~930MW load. The test positions is on the measuring hole flange of the flue or on the outer wall of the flue after removing the insulation layer of the flue, which is showed in detail in fig.1, and the results of the test is in the table 3 and and fig.2.

a) the induced draft fan outlet horizontal section

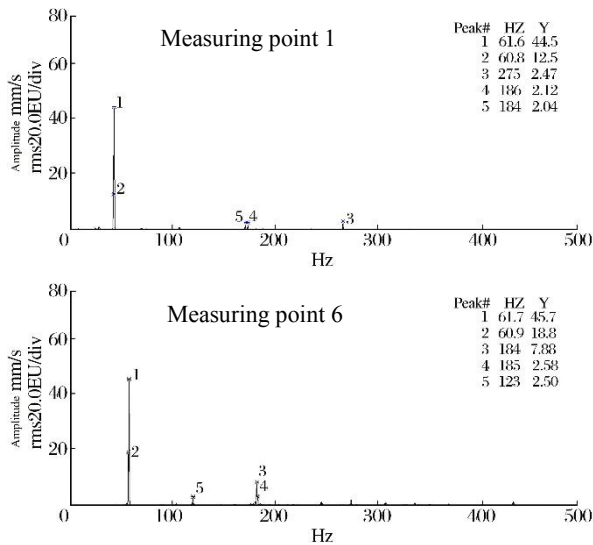
**Fig.2.** The typical amplitude superimpose in vibration test

According to the vibration amplitude of each part, it is judged that the vibration is mainly concentrated at the outlet of the induced draft fan and the body of the low temperature economizer with the 80% ECR above unit load. The flue vibration frequency falls between 61.3Hz and 61.4Hz, and the maximum amplitude at test position

7 reaches 105μm with the unit load between 920MW and 930MW.

Combined with the dynamic superposition and increase of the vibration amplitude during the test process, it is judged that the large vibration of the flue at the outlet of the induced draft fan was caused by flue resonance.

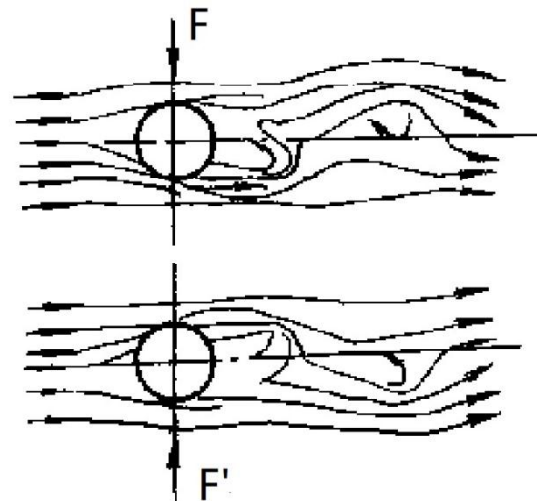
**Fig. 3.** The karman eddy current

The problems of flue excitation or resonance is partly caused by the integral multiple relationship between the natural acoustic frequency of the flue and the periodic shedding frequency of the Karman vortex generated by the flue gas flow subjected to the hot surface tube bundle (light pipe), the excitation of such vibrations can be attributed to unstable vortex shedding due to the lateral flow of fluid across the sides of a cylinder, which is showed in fig.3; and partly caused by the loose installation or worn of the support or diversion device of the flue.

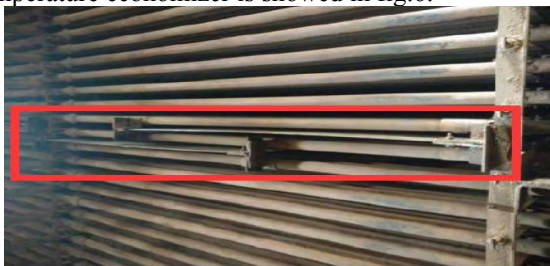
**Fig.6.** The clapboards' installation at the low temperature economizer on site.

Considering that the width direction of the flue is too long, the actual clapboards' installation at the low temperature economizer is shown in fig.6.

Adopt the solution described in 3 to install the clapboard on the horizontal section of the induced draft fan outlet and the low temperature economizer flue, the flue duct vibration frequency of the induced draft fan outlet is dispersed from the two main frequencies of 61.3Hz and 61.4Hz before the clapboards were installed to 6.88Hz~204Hz; the maximum amplitude of the flue duct is reduced from 105.0μm to 12.6μm, which is shown in table 3.

Due to the vibration frequency and vibration amplitude measurement results of the induced draft fan outlet flue before and after the installation of the integrated clapboard, the problem of the flue duct vibration is fundamentally solved.
