Considerable cracking in the foundation slab in a multi-storey underground garage

Marek Maj*, Tomasz Kowalik and Andrzej Ubysz

Wroclaw University of Science and Technology, Wybrzeże Wyspiańskiego 27, 50 370
Wrocław

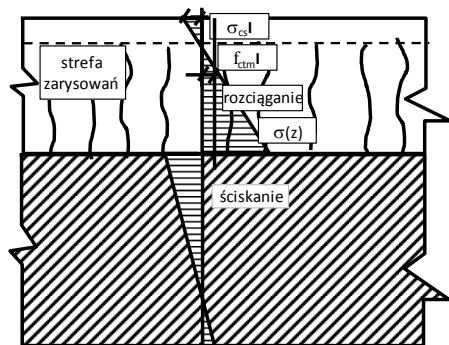
The floor, laid on a foundation slab made much earlier, is itself subject to contraction due to drying out. It has the same components of contraction that previously occurred in the slab. In the foundation slab, free contraction is restrained by the structural reinforcement, while in the floor, the contraction is blocked by its cooperation with the slab. The contact surface of the slab and the floor is not smooth, and it is additionally filled with a bonding layer. During the drying out of the floor and its contraction, this kind of connection causes an additional system of internal forces close to the surface of the slab and the floor, namely squeezing the slab and stretching the floor (Fig. 4). The resulting contraction stresses are to be transferred through the co-polymer fibres added to the concrete.

Fig. 4. Distribution of stresses in two slabs; the lower slab is older and the upper slab is younger and still maturing
