Seismic capacity evaluation of the damaged reinforced concrete building during Palu earthquake 2018

Fajar Nugroho^{1,2*}

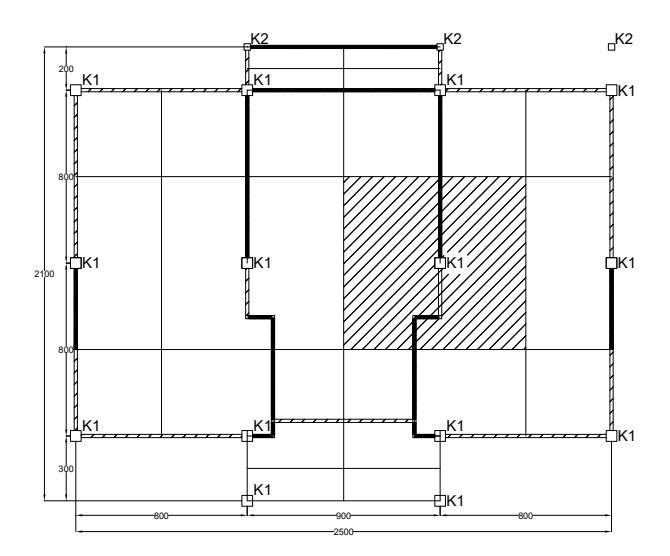
Fig. 5. Floor Plan and Floor Area of the Dean Building

Another detail information on the building structure that required for calculation such as column size, column detail, reinforcement quality is obtained from detailed engineering design (DED) drawing of the Dean Building. Fig. 5 shows the first-floor plan of the building.
