# Analysis of school damage due to Lombok earthquake on August 2018

**Abstract.** The Lombok earthquakes on 5 and 19 August, 2018 have caused fatality and damage buildings including houses and schools. It was reported that the Lombok earthquake had caused damage to at least 606 schools in West Nusa Tenggara. Following the earthquake, the field survey was carried out in a few days to collecting data of damaged schools in Lombok. The global positions of surveyed schools were recorded during the survey to identify the geological and seismicity condition surrounding area. The data were analyzed to understand the cause of the damaged. The damage pattern of the schools is also analyzed and then compared to the other related studies. The damage on the schools in Lombok Island generally has a result of insufficient quality of the building materials. Further, understanding the earthquake resistant building for earthquake prone areas is the most basic knowledge to be informed to the Local Government who has authority to manage the schools. This study suggests for establish Local formal rule of related to minimal requirement for earthquake resistant school building following the microzonatio

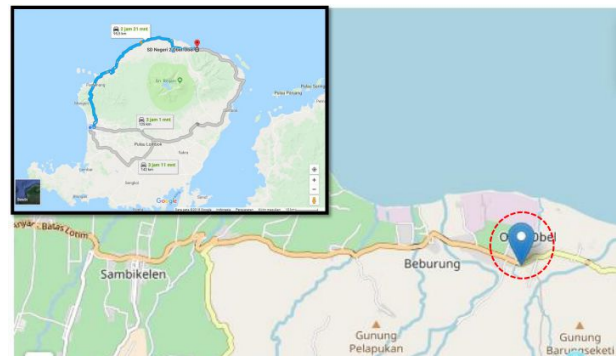
**Fig. 4.** Location of SD 02 Obel-obel.

The main structure of observed building of SD Negeri 02 Obel-obel (Fig. 4) is made of brick masonry wall. This building is used for reading class. The main structure of the building may also be categorized as confined wall (Fig. 5).

This building is still firmly standing but it suffered from detail damage. It can be categorized as light to medium damage. First, the connection between the wall and the confining reinforce (RC) concrete was cracked (Fig. 6). It seems there is not enough steel bar to connect the walls and the main RC columns. Second, the overlaps main steel bar is to short. It is at least 40 time of the main bar diameter. Since then, the joints of perimeter beam and column was pulled out during the earthquake.

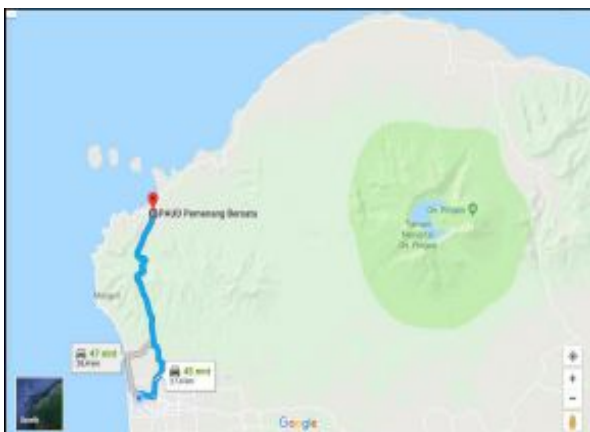
**Fig. 7.** Location of Paud Terpadu PB.

The main structure of observed building of Paud Terpadu Pemenang Bersatu (Fig. 7) is made of brick masonry wall. This building is used for reading class. The main structure of the building may also be categorized as confined wall (Fig. 5).

This building is still firmly standing but it suffered from detail damage. It can be categorized as light to medium damage. First, the connection between the wall and the confining reinforce (RC) concrete was cracked (Fig. 6). It seems there is not enough steel bar to connect the walls and the main RC columns. Second, the overlaps main steel bar is too short. It is at least 40 times of the main bar diameter. Since then, the joints of perimeter beam and column was pulled out during the earthquake.

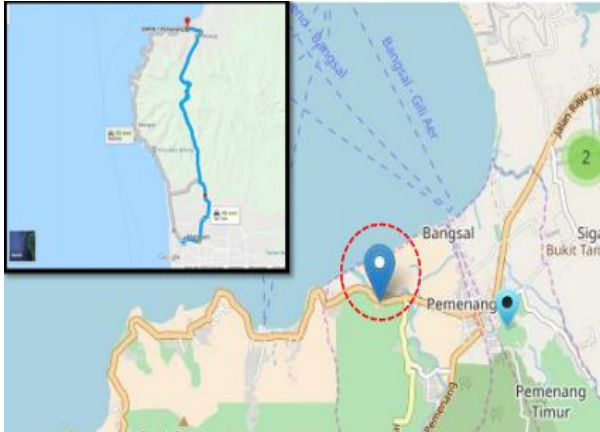
**Fig. 10.** Location of SMP N 01 Pemenang.

The structure of observed building of SMP Negeri 1 Pemenang (Fig. 10) is made of confined brick masonry wall. The building is used for learning classes. The building collapse badly in one side (Fig. 11). The rest of the building can be said still firmly standing even it suffered from small detail damage. This building relatively new building which can be seen from the

material used. It uses the light formed steel for roof construction and uses light metal roof material as well. The side damage indicates the low quality of material and its connection. The wall - roof connection just only 'simple touch' each other. Structurally it is considered to be No Connection at all.
