Implementation of earthquake mitigation at the engineering faculty, university of mataram

Teti Zubaidah^{1,2*}, Rosmaliati^{1,2}, Cipta Ramadhani^{1,2}, and Dwi Ratnasari^{1,2}

Abstract. After the 2018 Lombok earthquakes, buildings within the Engineering Faculty of the University of Mataram (FT Unram), were severely damaged and there have been no comprehensive treatments. Facilities to support earthquake mitigation, such as signs for evacuation routes and assembly points (temporary evacuation sites), are still minimal, and even if they are available many of them are not designed and placed properly. Some parts of the buildings have been partially renovated, meanwhile, there are new buildings constructions that have not been investigated related to disaster mitigation. Anticipating the re-occurrence of big earthquakes in Lombok, it is very necessary to carry out activities for implementing earthquake mitigation at FT Unram. The activities are divided into three stages, namely *first*: conducting direct reviews for inventory and documentation of all vulnerable points, followed by making of maps and building plans; *second*: determining the proper locations of assembly points, creat

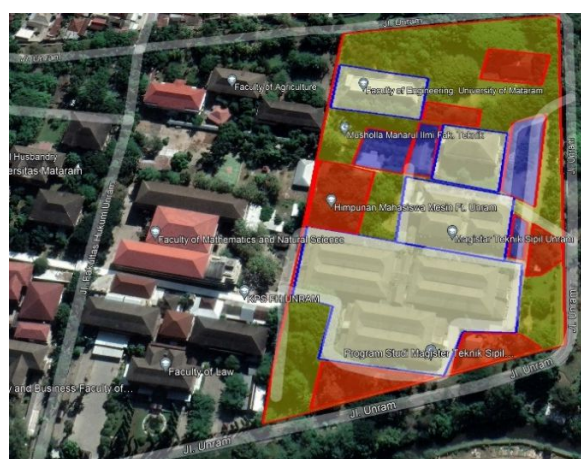
Assembly points and evacuation routes are proposed based on the Evacuation Plans in Fig. 19. The buildings and surrounding closest areas are considered not to be used for assembly points [8]; they are marked as areas with white colors. Permanent obstacles including a wind power turbine, a large power transformer, and semi-permanent buildings are considered not possible for assembly points; they are marked as areas with red colors. Temporary obstacles including parking areas are also considered not suitable for assembly points; they are marked as areas with blue colors.

Fig. 19. Evacuation plans of FT Unram, showing all available free space areas (green) which can be used as assembly points, while buildings (white) and permanent- (red) and temporary- (blue) obstacles are considered not suitable for assembly points. The map was generated by using Google Earth Pro [7].
