Assessment and retrofitting of nursing faculty building of Andalas University, Padang, Indonesia

Abstract. The Faculty of Nursing building is one of the administrative buildings at Andalas University. This building was designed by a planning consultant and began construction in 2013. However, during the construction period, it was found that the concrete quality was very low, that is $f_c'=14.32$ MPa, so that the construction could not be continued because it was not in accordance with the planning quality, $f_c' =22.39$ MPa. Therefore, it is necessary to evaluate the feasibility of the building structure before the construction is continued. In the structural analysis, the loads applied are dead loads, live loads, and earthquake loads. The analysis was carried out using the application (*software*) ETABS. Based on the analysis results, it was found that the capacity of columns and beams of the building are not strong enough to withstand the loads acting on the structure. The inter story drift also does not meet the permit limit requirements according to the New Indonesian Earthquake Code, SNI 1726:2019. Therefore, it is necessary to retrofit (strengthen) the structure of the Nurs

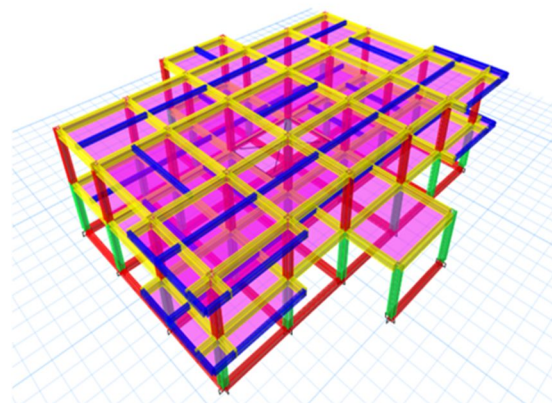
Fig. 5. Modeling of Structure

Analysis of the Nursing Faculty Building structure, Andalas University, was carried out using 3D structural modeling in the ETABS program. Columns and beams of the building structure are modeled as frame elements, while the slabs are modeled as slab elements.

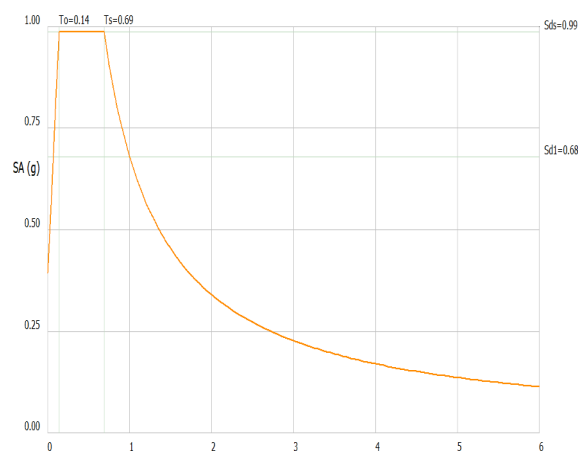
Fig. 6. Earthquake Response Spectrum Design of Padang City

These tables are dynamic earthquake data obtained from the Puskim PU application. From these data, a graph of Earthquake Response Spectrum Design of Padang City was obtained, as shown in Fig. 6.
