Assessment of underground mining influences in the area of historic church building

Piotr Strzalkowski¹, Roman Ścigala¹ and Katarzyna Szafulera¹

¹ Silesian University of Technology, Faculty of Mining and Geology, 2 Akademicka Street, 44-100 Gliwice, Poland

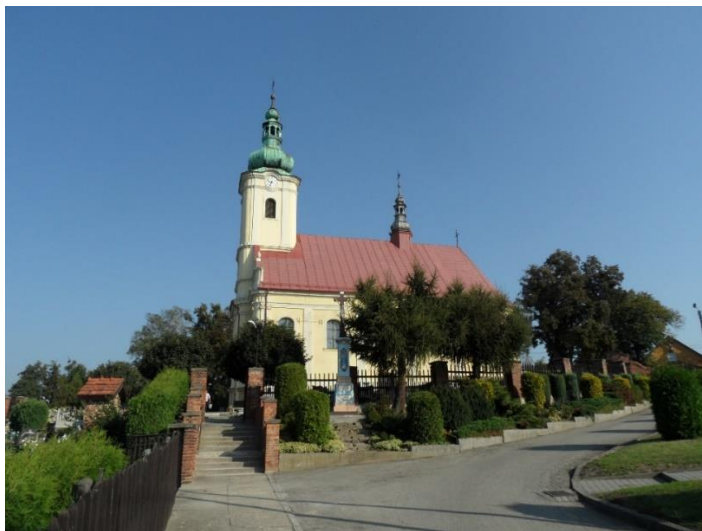
Fig. 1. General view of the church building.

The church dedicated to Saint Michael Archangel is a free-standing object without basement. It covers an area of approx. 450 m² and its cubic capacity is approx. 71100 m³. It has been built in the years 1793-1799 on a hill with an elevation of approx. 9m, in a late baroque style. The church is a single-nave building with small extensions at the northern side, in which utility rooms, a vestibule and a vestry are located - Fig. 1.

The form of the building is compact, the floor projection is rectangular, elongated, divided at one side. The total length of the church is 30.5 m. The width of the object is variable and ranges from 14.3 to 17.7 m. The height of the building is approx. 20 m counting from the ground surface to the roof ridge, while the height of the tower is approx. 38 m.

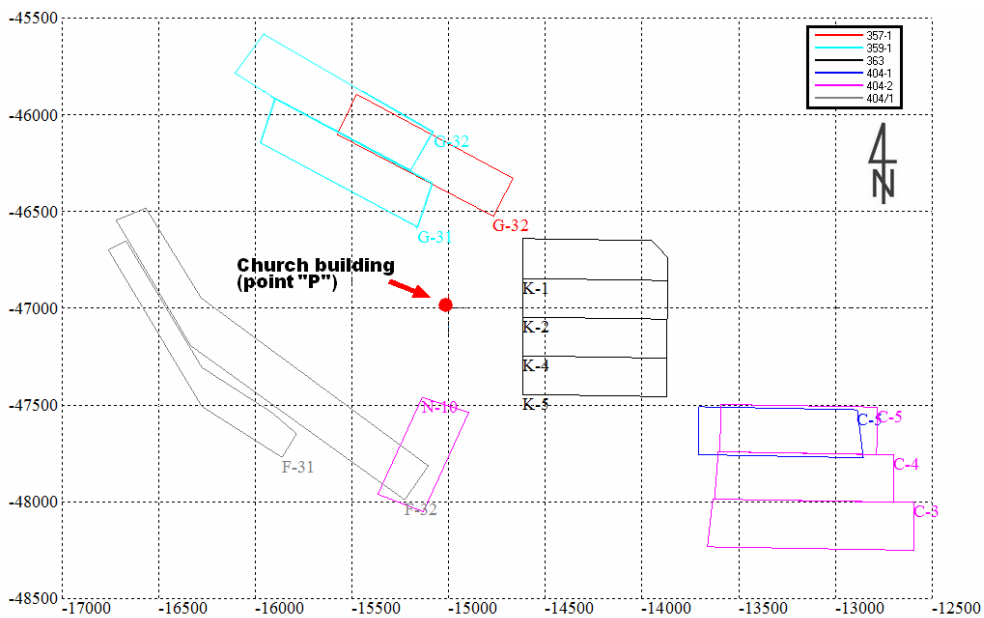
Fig. 2. The sketch of longwalls location in relation to the church building.

In the area of the church building, mining exploitation is conducted and planned in the coal seams: 357/1, 359/1, 363, 404/1, and 404/2. The basic data concerning the mining and geological conditions has been presented in table 1. Fig. 2 presents a sketch of the locations of longwalls in relation to the church building.

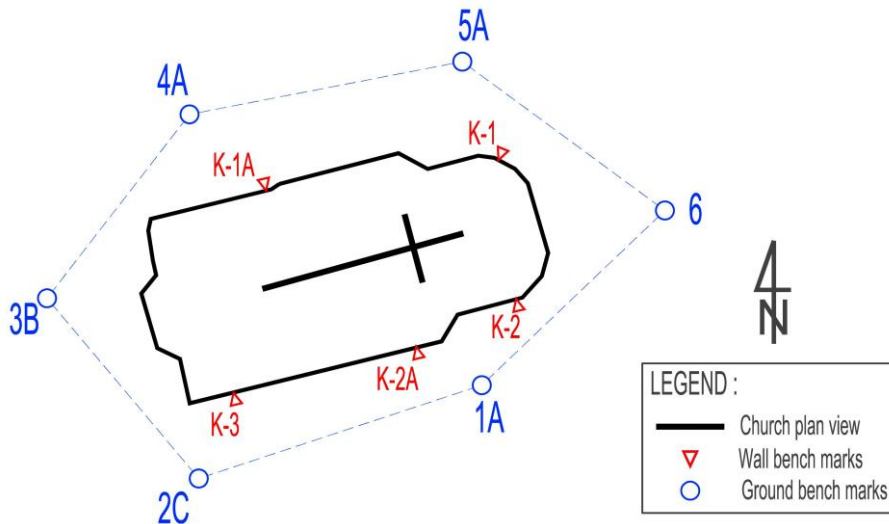
Fig.3. Location of measuring points in the neighborhood of the church building

To monitor the effects of mining exploitation in the area of the church, geodetic measurements were conducted for ground points and wall bench marks located on the church foundations. The ground bench marks with numbers from 1A to 6 were located around the church building. Location of control points is shown in fig.3. The first measurement was conducted on 12.08.1992. The measurements were conducted depending on the intensity of the effects of mining exploitation in intervals ranging from one quarter to one year. Until June 2018, a total of 65 measurements have been taken.

Additionally, three wall bench marks: K1, K2 and K3, have been placed in 1992, subject to measurements with similar frequency as the ground points. In October of 2001, two additional bench marks, K1A and K2A, were placed on the foundations of the church building.

Analyzing the results of measurements conducted for the ground bench marks around the church (points 1A - 6) and the wall bench marks located on the foundations (points 11/463 K1, K2, K3, K1A, K2A), it should be concluded, that the subsidence of the surface caused by mining exploitation in the years 1992-2018 proceeded systematically at a constant intensity. The maximal subsidence was measured in June 2018 at the 5A bench mark, reaching -806 mm, while the maximal subsidence measured for the foundation of the building reached -728 mm in the K2 point. In the years 1992 - 2018, the movements of the rock mass registered using the bench marks in the area of the building have been observed to decrease in three periods: in December 2000, August 2006 and June 2017. Between June 2017 and June 2018, slight increases in subsidence of the bench marks located on the building have been observed.
