Flexural performance of RC columns with FRCC jacketing

Marta Del Zoppo, Costantino Menna, Marco Di Ludovico^{*} and Alberto Balsamo

Department of Structures for Engineering and Architecture, University of Naples Federico II, Italy

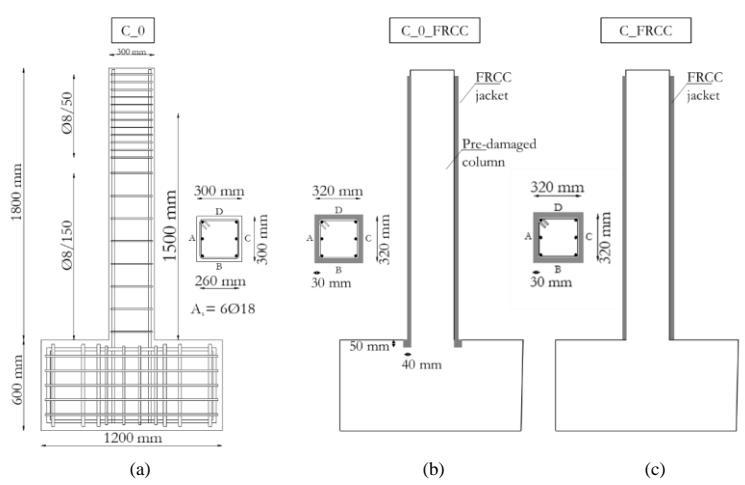
Fig. 2. Specimens grometry and strengthening configurations for C_0_FRCC (b) and C_FRCC (c).

The strengthening technique consisted in applying a thin layer of FRCC (total thickness of 30 mm) to the full-scale RC columns after the complete removal of the concrete cover (20 mm of thickness) from the existing concrete surface, slightly enlarging the cross-section about 20 mm per side. The resulting cross section dimension was 320 mm x 320 mm. The jacketing procedure consisted of different steps: after complete concrete cover removal, the concrete surface was wetted up to complete saturation; then, a wooden formwork was constructed around the perimeter and along the full length of the column in order to allow fresh FRCC pouring. Given the highly performing bond properties of both FRCC materials, no bonding agent or primer was employed at the FRCC-inner concrete interface.

The experimental program consisted of two full-scale RC columns investigated under three configurations: (i) bare RC column, named C_0; (ii) repaired RC column with FRCC_a jacketing after pre-damage, named C_0FRCC; (iii) strengthened RC column with FRCC_b jacketing without pre-damage, named C_FRCC. A summary of the experimental campaign is reported in Figure 2. A further distinguishing feature among C_0FRCC and C_FRCC specimen configurations is the jacketing anchorage to the foundation block. Indeed, in the case of C_0FRCC the jacketing is anchored to the foundation by means of a socket in the foundation that increased the bond surface, as visible in Figure 2b. Conversely, in the other specimen, no anchorage was provided between jacket and foundation, as depicted in Figure 2c.

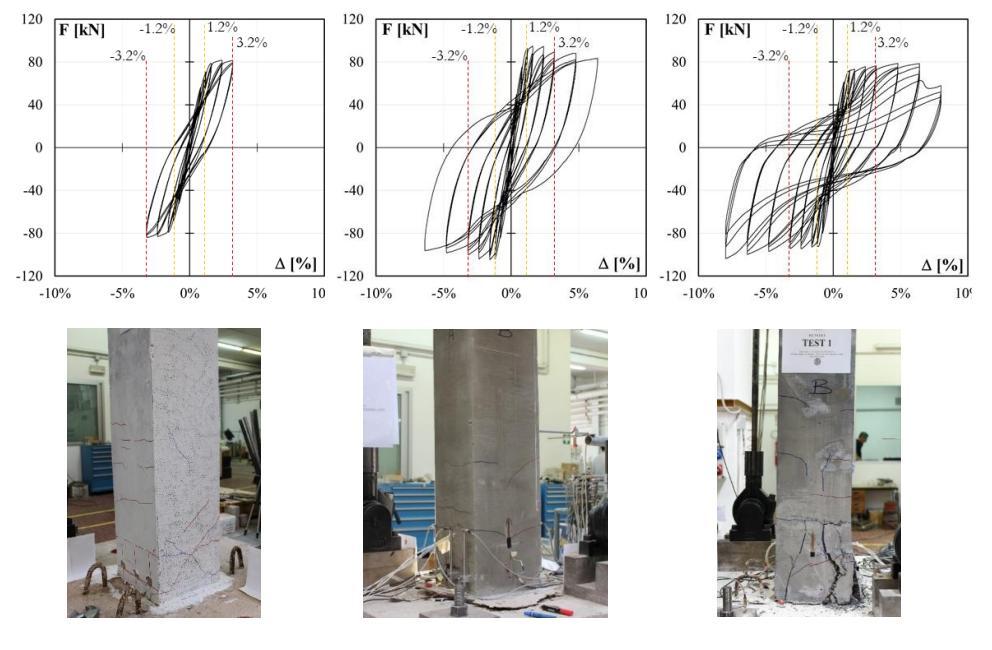
(a) (b) (c) **Fig. 3.** Experimental behavior of specimens C_0 (a), C_0_FRCC (b) and C_FRCC (c).

The lateral force-drift relationships, $F-\Delta$, derived from the experimental tests for the three configurations investigated are reported in Figure 3, along with the damage pattern at failure. Results for C_= and C_0_FRCC were already presented in [7].

As aforementioned, the test of specimen C_0 was stopped at a drift ratio of 3.2%, to allow the repair of the specimen (Figure 3a). At this level of drift, the specimen achieved the flexural yielding, but no failure mechanisms were observed up to the end of the test.

The pre-damaged and repaired specimen, C_0_FRCC, had a flexural behaviour up to a drift ratio of 6.4%. Then, the test was arrested for safety reasons and the conventional failure, defined as a strength degradation up to 80% of peak force, was not achieved (Figure 3b). The anchorage system induced a rigid rocking behaviour, activating a sliding surface inside the foundation block. At the end of the test, the FRCC jacket was lightly damaged, with very small and isolated flexural and shear cracks. However, the anchorage system provided also a slight increase of strength and stiffness with respect to bare specimen C_0, working as flexural strengthening.

Conversely, the specimen C_FRCC achieved a sudden drop of lateral capacity for a drift ratio of 6.4% (Figure 3c). This was related to the crushing of the FRCC jacket that caused the overall failure of the specimen. In this case, the absence of anchorage between the jacket and the foundation block did not allowed significant increase of lateral capacity. The failure of the jacket and the observed asymmetric response of the specimen in the positive and negative load directions were probably related to small asymmetries of the jacket thickness developed during the casting process.

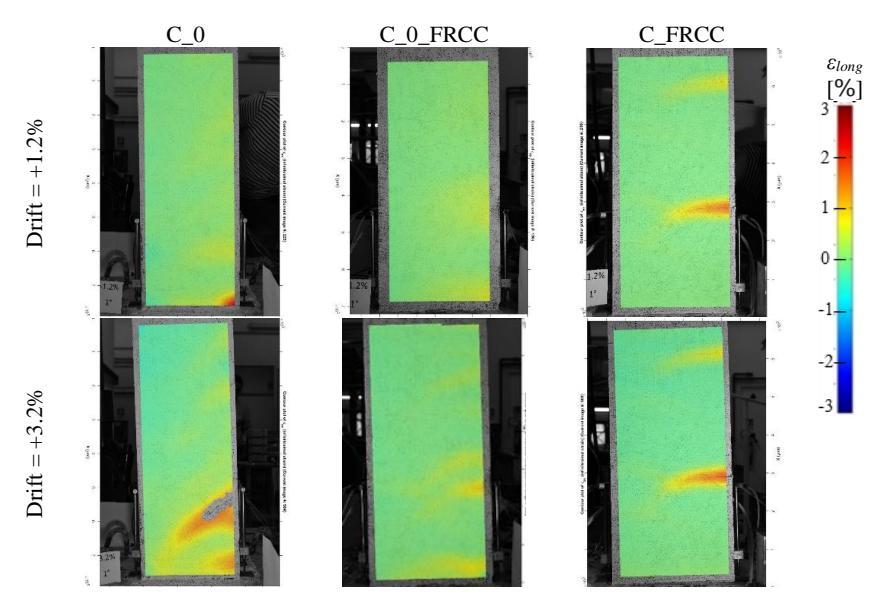
Fig. 4. Longitudinal strain fields from DIC (positive strain values correspond to tensile strains).

The longitudinal strain fields recorded by using the DIC at drift ratios of 1.2% (i.e. yielding) and of 3.2% were reported in Figure 4 for the three configurations investigated for both positive and negative load directions.

The plot of longitudinal strains was helpful for understanding the behaviour and the resisting mechanisms of the specimens. Looking at bare specimen C_0, the compressive struts involved in the resisting mechanism to shear were clearly visible at a drift ratio of 1.2%. Tensile strains (i.e. yellow in legend) were distributed along inclined lines, according the truss analogy resisting mechanism for shear actions, defining the compressive struts. It's interesting to note how the strain distribution resulted different among the three different configurations at this drift level. The bare RC column exhibited multiple tensile strain concentration lines along the tensile strains in wider areas of the specimen with just two main concentration zones. Among these, a higher level of tensile strain appeared in the specimen C_FRCC at a height of 300mm from the base section in the positive load direction.

The aforementioned tensile zones developed in flexural cracks for greater drift ratios, as visible in Figure 4 for a drift ratio of 3.2%. In the positive load directions, where the tensile strains overcame the concrete/FRCC tensile capacity (i.e. red in legend), cracks developed following the principle tensile direction.

In the case of C_0_FRCC, the magnitude of strains concentration is definitely lower with respect to C_0, with tensile strains lower than 1.5%. The tensile strains aligned along the tensile principal direction were still visible, but the strain value was reduced due to the rocking behaviour developed by the jacketed specimen that probably caused a strain release. By this, the most part of the deformation was related to the rigid rotation along the sliding surface inside the foundation block. Very few small cracks were developed on the FRCC jacket.

Conversely, a single large crack opened in the positive direction on specimen C_FRCC, due to the strain-softening tensile behavior FRCCs which dissipated energy by a single macrocrack, leading to a very limited damage if compared to C_0. Similarly to specimen C_0_FRCC, the magnitude of strains was slightly lower than that recorded for C_0 as well as the damage distribution, due to the strain release caused by the rocking behaviour at the base-section.
