# An effect of humid climate on micro structure and chemical component of natural composite (*Boehmeria nivea-Albizia falcata*) based wind turbine blade

**Abstract.** In this work, wind turbine blade NACA 4415 is fabricated from natural composite of *Boehmeria nivea* and *Albizia falcata*. The composite fabrication method used is hand lay up method. The aim of the work is to investigate an effect of humid climate of coastal area on micro structure and chemical composition of composite material of the blade. The wind turbine is tested at Pantai Baru, Bantul, Yogyakarta for 5.5 months. The micro structure scanning is performed with Scanning Electron Microscope (SEM) and material component is measured with Energy Dispersive X-ray spectrometer (EDS). The samples are tested before and after the use within 5.5 month at the location. The results show that composite material inexperienced interface degradation and insignificant change of micro structure. From EDS test, it is observed that Na filtration reduces C and increases O in composite material after 5.5 months.

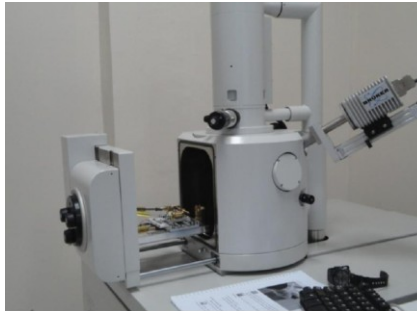
**Fig. 1.** Scanning Electron Microscope (SEM)

Wind turbine blade NACA 4415 is fabricated from natural composite of *Boehmeria nivea* and *Albizia falcata*. The composite fabrication method used is hand lay up method. The wind turbine is tested at *Pantai Baru*, Bantul, Yogyakarta for 5.5 months. The micro structure scanning is performed with Scanning Electron Microscope (SEM) and material component is measured with EDS. The samples are tested before and after the use within 5.5 month at the site. The SEM unit used in this work as shown in Figure 1.

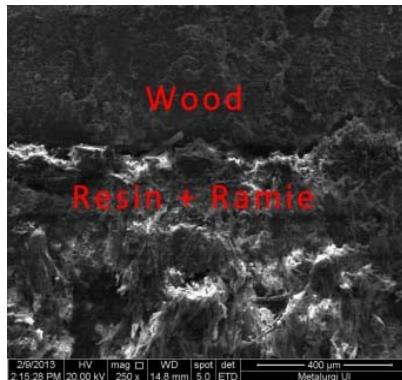
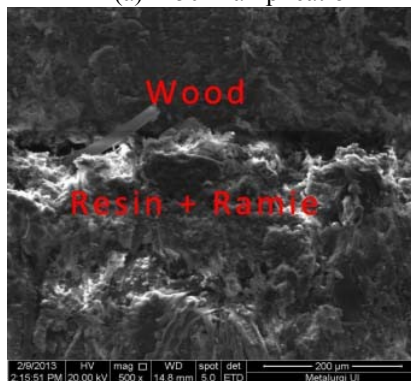
**Fig 2.** SEM photo of composite before used as wind turbine blade

Figure 2 presents photo of cross sectional area of 2 layers composite from the SEM test. The interface between Sengon wood core, resin, and ramie fiber indicated has good bonding due to polar resin used. SEM photo of cross sectional wind turbine after 5.5 months installed at Pantai Baru shown in Figure 3.

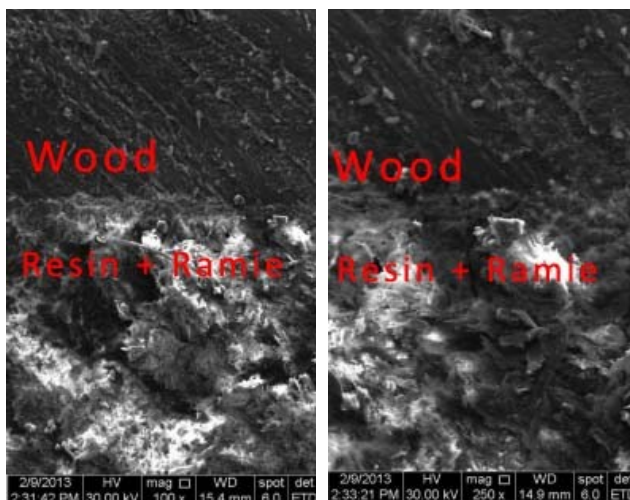
**Fig.3.** SEM photo of composite after 5.5 months

After 5.5 months, the micro structure of the composite inexperienced degradation. It indicates that the method of lay hand up is good enough for composite wind blade fabrication.

From EDS test, it is observed that Na diffusion reduces C and increases O in composite material after 5.5 months. The results of SEM test show that composite material inexperienced interface degradation and insignificant change of micro structure. It can be concluded that hand lay-up method give good performance of composite blade for encountering the effect of humidity on composite material.

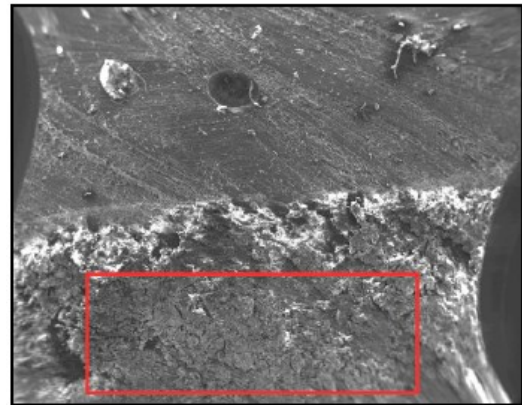
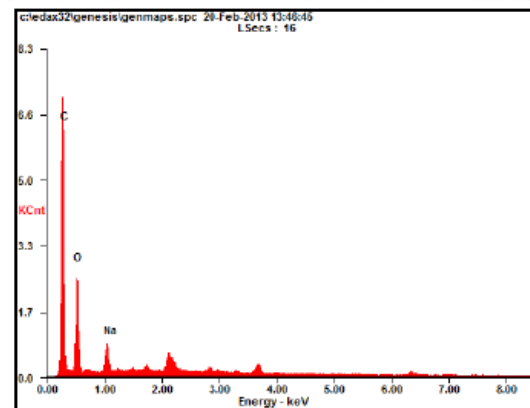
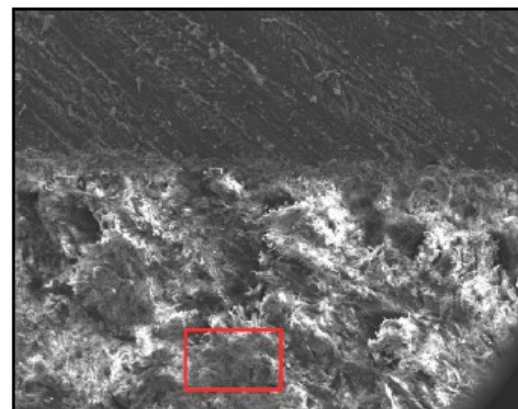
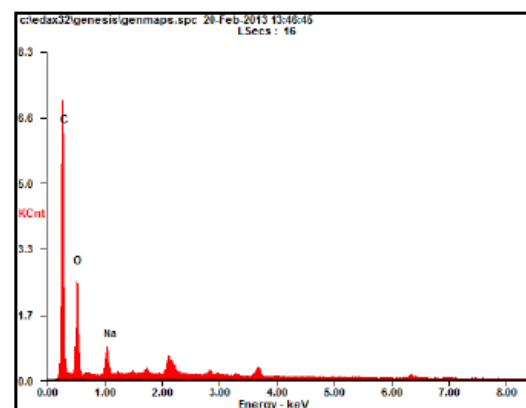
**Fig. 4.** SEM & EDS test of resin-ramie fiber of the composite before and after field test

(a) SEM & EDS test of resin-ramie part before field test

(b) SEM & EDS test of resin-ramie part after 5.5 months field test

Figure 4 shows the results of SEM and EDS test of resin and ramie part of composite wind turbine blade. Meanwhile, Table 1 show chemical component of (C, O, Na) of resin-ramie part before and after field test.

Wood is mostly composed by three elements, Carbon, Hydrogen and Oxygen. These elements come from CO<sub>2</sub> in the air and from H<sub>2</sub>O from the ground. However, the wood also contains other elements such as Nitrogen, Phospor, Kalium, Calcium, Magnesium, Silikon, Alumina and Natrium. After 5,5 months installation of model, EDS test is conducted. The test result indicates that Carbon decreases by 4.01%, while Oxygen increases by 7.85%. This phenomenon is caused by high humidity at observation site, about 69.98%. This high humidity increases a diffusion of oxygen air into the propeller material.

Component	Before being used (Wt%)	After 5.5 months (Wt%)
C	59.90	54.95
O	35.77	44.13
Na	4.33	0.91

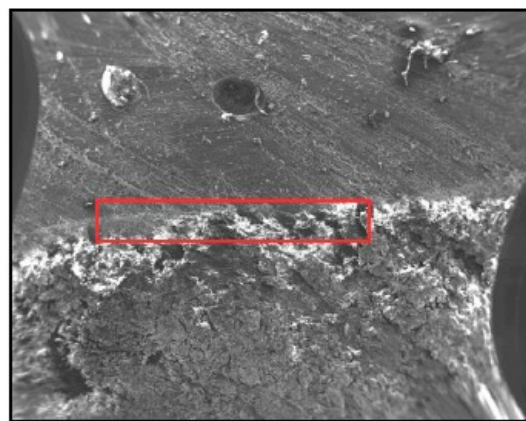
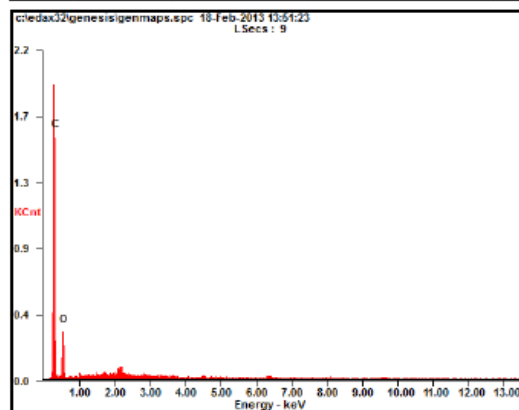
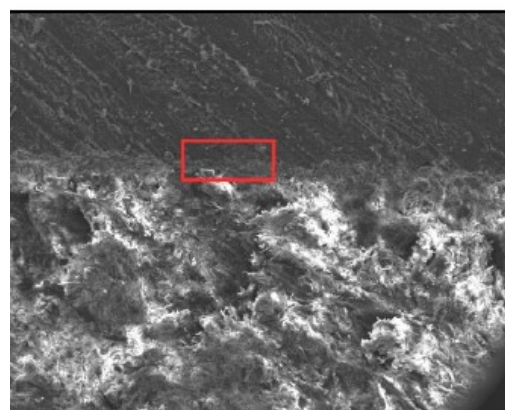
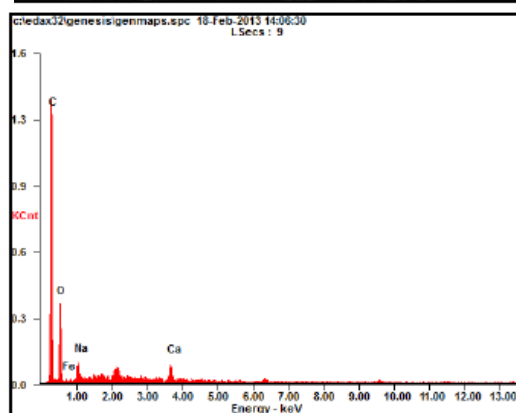
**Fig. 5.** SEM & EDS test of interface between wood and resin-ramie before and after field test

(a) SEM & EDS test of interface between wood and resin-ramie before field test

(b) SEM & EDS test of interface between wood and resin-ramie after 5.5 months field test

After being tested for 5.5 months at Pantai Baru-Bantul-Yogyakarta, EDS test shows that Carbon (C) content in composite decrease 4.01%, Oxygen (O<sub>2</sub>) increases 7.85%. This is due to high humidity of the site during the field test. The humidity at the site during 5.5 months test is about 69.98%. In high moist air, oxygen content in the air infiltrates to composite wind turbine blade.

Figure 4 and Table 2 show the results of SEM and EDS test of wood resin-ramie interface of composite wind turbine blade before and after the field test.

Component	Before being used (Wt%)	After 5.5 months (Wt%)
C	59.69	55.68
O	36.17	44.02
Na	4.14	1.30
