# The Impact of the Rock Mass Deformation on Geometric Changes of a Historical Chimney in the Salt Mine of Bochnia

**Abstract.** There are many ways of the geometry measurement of slim objects, with the application of geodetic and photogrammetric methods. A modern solution in the diagnostics of slim objects is the application of laser scanning, with the use of a scanner or a scanning total station. The point cloud, obtained from the surface of the scanned object gives the possibility of generating not only information on structural surface deformations, but also facilitates obtaining the data on the geometry of the axis of the building, as a basic indicator of the characteristics of its deformation. The cause of the change in the geometry of slim objects is the impact of many external and internal factors. These objects are located in the areas of working or closed underground mines. They can be impacted by the ground and they can face the results of the convergence of cavities. A specific structure of the salt rock mass causes subsequent convergence of the post-exploitation cavities, which has the influence on the behaviour of the terrain surface and the related objects. The auth

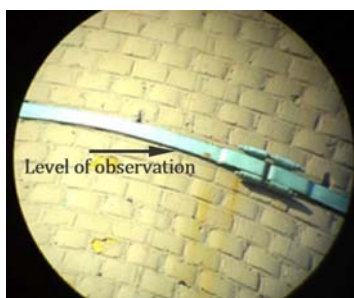
**Fig. 1.** Rings equipped with screw locks making the marked observation levels 4 Analysis of the deformation of the terrain surface in the region of the chimney

- lower – a flue, of the geometry of a cuboid of base  $6.55 \times 6.55$  m and height 3.8 m;
- central – base of changeable cross-section in the shape a regular octagon made with a proper security of external areas of spherical triangles;
- upper – the covering of changeable circular cross-section (from 2.668 do 1.602 m), enforced by steel rings of the cross-section of  $8 \times 80$  mm consisting of three segments joint with screw locks (Fig. 1), allowing the regulation of the tension power, which, during the inclination measurements with geodetic methods facilitate the identification of the purpose (observation level).

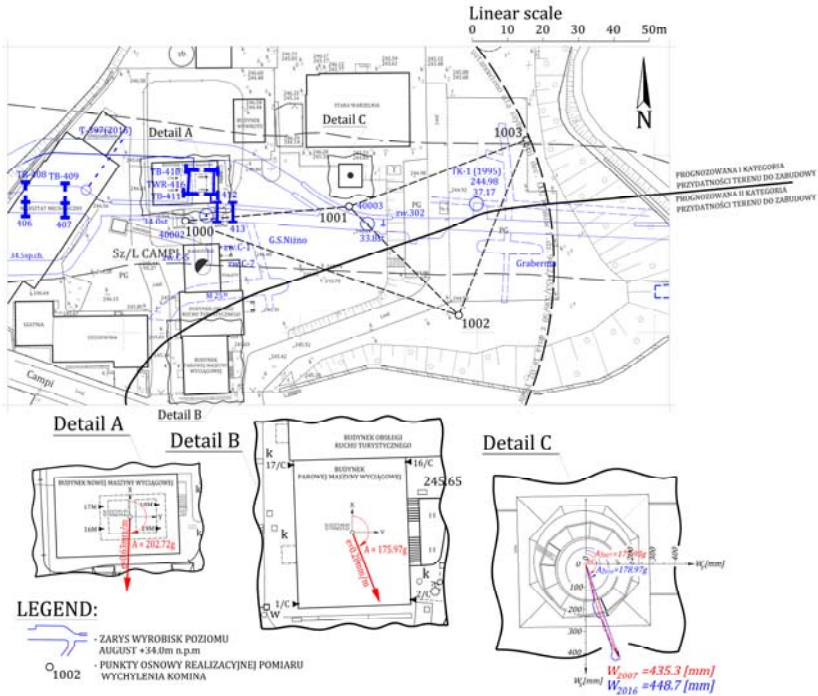
**Fig. 2.** Localization of the measurement stands on the background of situation details on the surface of mining excavations on Level August (the shallowest level connected with Shaft Campi)

change in the vicinity of the chimney the height data of precise levelling network of wall benchmarks (control points) stabilized on the buildings (localized in meridian system) of new hoisting machine and steam machine, were used (Fig. 2). The analysis of the change on the surface of the terrain in the analysed region of placing the industrial chimney was carried out based on the data coming from the Surveying Division in Salt Mine „Bochnia”.

The analysis of the inclinations and subsidence in selected buildings was based on the algorithm described by [7]. To geometrically interpret vertical dislocations, the equation of plane was fit into the measured points (4 points for each object according to Fig. 2), defined by the formula:

In case of the application of the laser scanning methods to define the geometry of the stem chimney from the points of the established control line (Fig. 2), the algorithm of the approximation of circles directly from the selected point cloud (band) was applied on selected levels (in case of the circular cross-section of the construction) described in [5]. Laser scanning actually generates dense point data, which, if properly interpreted and processed allow us making 2D or 3D documentation in the modelling process.

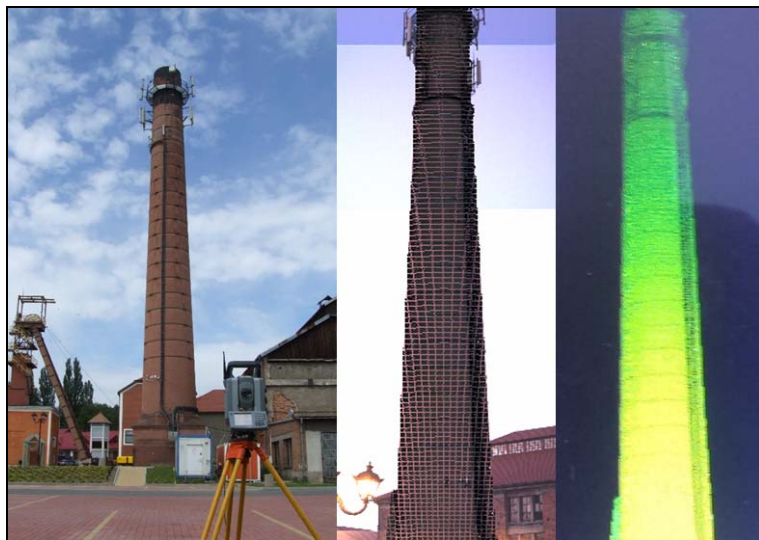
**Fig. 3.** View of the historic chimney – point cloud – the image of the power of the reflected signal (the measurement of the geometry of the chimney with the use of the scanning total station VX Trimble)

Analysis of the coordinates of the centres of circles of subsequent study levels directly allows the determination of the tilt vectors  $W_i$  and their directions in the accepted local or geographic system of coordinates. Multi-point cover of the chimney surface (Fig. 3) provides surplus observations, which increase the accuracy of the results on the stage of the analysis and minimize the influence of human factor (including the aiming error), on the final results of the analysis. One should emphasize that in the above example the mean of the points lying on a certain level in the whole circuit of the chimney's shield is 53 points (we accepted the band of height-attributing of points to cross-section on level  $h = \pm 5$  mm). Basic parameter defining the present geometric state of the slim construction is the resultant vector of the inclination of its stem  $W$  or the inclination of generalized axis  $W_z$  (Table 2). According to the formula contained in [10], the border value of the inclination of the axis of the studied chimney (regarded dangerous) is 2.13 m.
