# Water quality and sustainability of Merdada Lake, Dieng, Indonesia

**Abstract.** The volcanic lakes in Dieng Plateau offer some unique phenomena, which interest not only tourists but also scientists. However, as the land use changes, the lakes are now facing environmental degradation especially from agricultural practices. This research aims to study the impact of agricultural practices on the environmental degradation of the lakes especially the water quality and analyze the sustainability of the lakes to support water needs. Merdada Volcanic Lake, one of the lakes in Dieng Plateau was selected as the focus of this research. Method conducted on this research are fields survey to collect the physical parameters temperature and conductivity also chemical parameters like pH, Nitrate, BOD, phosphate, and coliform. A complementary data was acquired using interviews method for defining the sustainability of the lake. Based on observation, water level of the lake is gradually decreased, especially during the dry season. At the same time, the agricultural practices in the surrounding area led to soil erosion, which involved surface runoff that transporting sediments into the lake. This

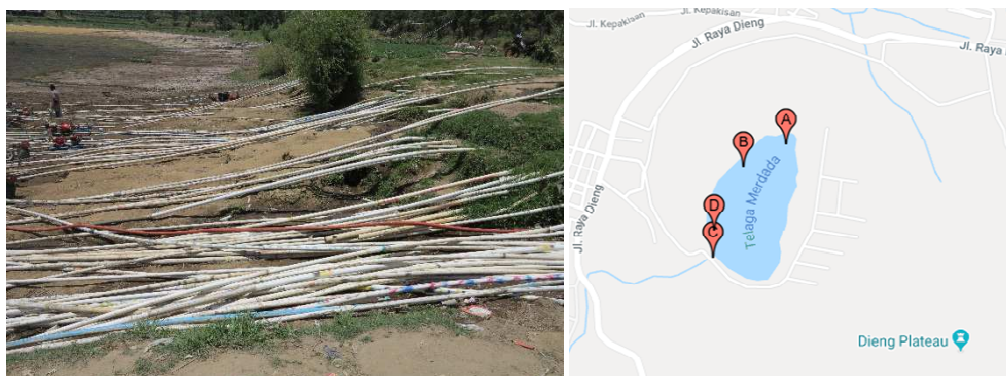
**Fig. 3.** Water decreases extremely by over pumping activities, the picture was taken in 2015, a dozens water pump together take up water for cultivating (left). Samples location for water quality analysis taken from western part of the lake (right).

shown in Figure 3 (left) clearly showed how farmer tries hard to use water lake for irrigation even the water almost drain. However, many farmers depend on the availability of water from Merdada Volcanic Lake because of no others water source for irrigating accessible for their land. There were more than 100 water pumps with an estimated pumping duration of 3 hours per suction day.

must be highlighted on sample D because its value has large differences than other samples. Sample D expected rice phosphate (0.332 m/L) when other samples has a very small amount of phosphate (<0.02 mg/L). Its indicated that sample D located near inlet from erosion path moving down from the agricultural slope or supposed to be point of accumulating. Coliform measurement also has different value, ranging form 3–11 MPN/100mL. Location of sampling sites and its water quality showed in Figure 3 (right) and Table 2.

The water scarcity endangered Merdada Volcanic Lake, especially in dry season. Water use for irrigation is main cause the water scarcity of the lake. From the interview with farmers, they used different capacity of water pumping, but it can be estimated that average of water discharge is 40 L/min per water pump, similar with 240 L/h—other measurement of water pumping taken from a lake near Merdada Volcanic Lake, conducted in Pengilon and Warna Lake [13]. Pengilon and Warna Lake also have water use for irrigation. During potato cultivation, pumping is done for 3 hours every suctioning day. There were 28 time of suctioning during cultivation. In this case, Pengilon and Warna release 12600 m<sup>3</sup> for irrigation in every cultivating season. By those scenario, Merdada Lake has more water release for cultivation than Pengilon and Warna Lake. On every season water irrigated from Merdada Lake counting about 14976 m<sup>3</sup>. In similar scenario, Pengilon and Warna Lake wasted about 360 liters oil from 120 water pump for every cultivating season. But on Merdada Lake oil wasted counting less than them, about 300 liters oil wasted direct or indirectly to Merdada Volcanic Lake water and influenced to its water quality. However, field observation found that the position of the water pumps, which were exactly on the side of the lake, potentially introduced oil spills into the lake and caused contamination like showed in Figure 3 (left).
