Gravel and boulders mining from mountain stream beds

Keywords: mountain stream, gravel mining, river bed, Carpathians

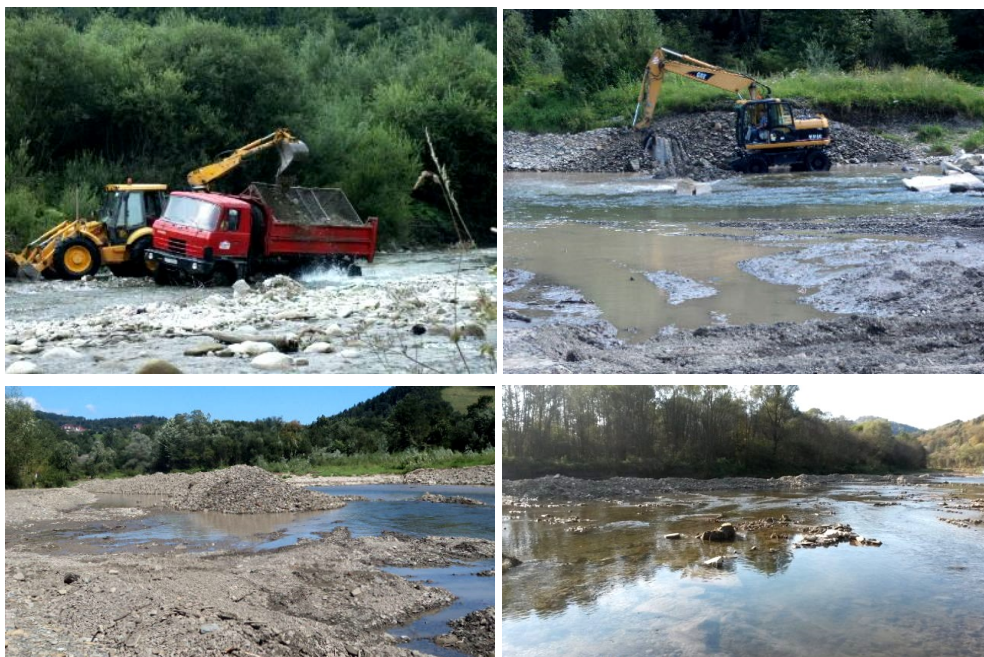
Fig. 1. Illegal gravel mining in Polish Carpathians: excavators and lorries in work and river gravel bed degradation after illegal gravel activity

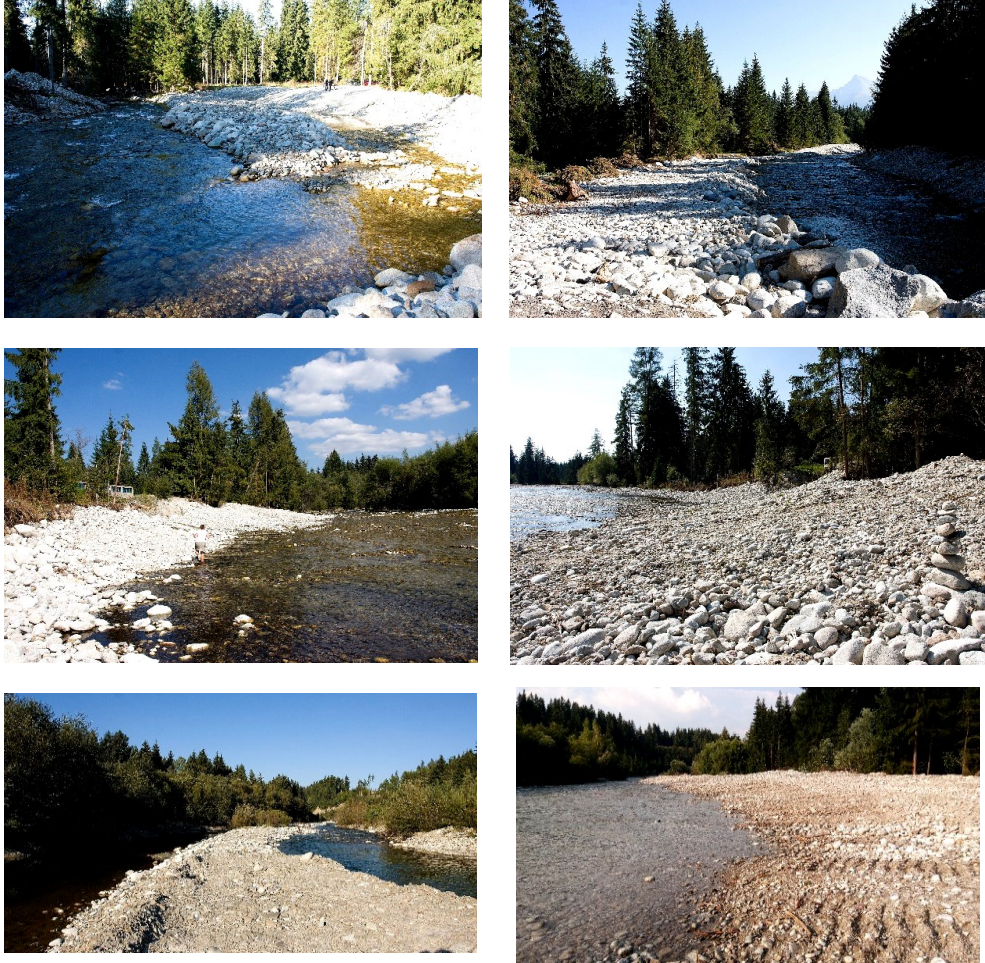
Fig. 2. River gravel bed degradation after illegal gravel activity on Slovakiens rivers.

Nowadays gravel extraction on the Belá River is related with stabilizing works after flood event (5-7 years RI) during summer 2018. Realization of this works were declared according the second and third degree of flood activity in the Belá River catchment and were aimed to protection of private property and citizens' lives. However, according to official documents the main reason was channel overflow what endanger the road operation. These works was aimed to removing of the gravel bar accumulation (46 600 m³ planned in total), moving of the river sediment (24 000 m³ planned in total) and redirection of the channel course (Fig. 2). Practically, along the river length the specific morphological processes typical for the multi-thread Belá River were suppressed to minimum. Individual terrain reconnaissance in August 2018 reveals that total channel improvement overgrew the range of planned works and the channel and bed armouring was destroyed by the operation of heavy mechanisms. On the several river reaches we registered an artificial development of the new channel shape (wide "U") with concentrated water course within shallow low

flow channel and isolated floodplain from the active channels due to 2 m high new artificial banks. This type of river regulation including gravel extraction and gravel replacement were also occurred on the river reaches where the residential area is missing and there was no threat to property rights and lives.

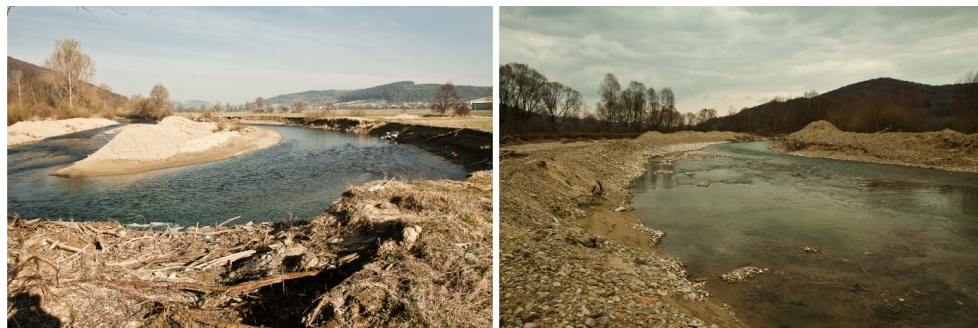
Fig. 3. River gravel bed degradation after illegal gravel activity on Slovakiens rivers.

floodplain area. Nowadays gravel extraction (2002 – 2009) is concentrating to active channel area where the volume of gravel mining is permitted by the mining license up to 1000 m³ per year for one company. This extracted sediment volume is aimed to restrict the sediment supply to the Domaša water reservoir. Channel bed is formed by gravel fraction (from 2 to 64 mm) with average proportion 84,1 % for the Topľa River and 81,8 % for the Ondava River. Average grain size D50 is for the Topľa 33,09 mm (-5,02 Phi) and 35,23 mm (-5,08 Phi) for the Ondava. In addition to gravel extraction both rivers are lateral dynamic with intensive migration of channel. Erosion protection is ensured by channelization and artificial embankment in areas of settlements but in other section was channel modified and straighten to the original state, gravel materials are pre-load in the form of dikes near active channel without reinforcement (Fig. 3, 4).

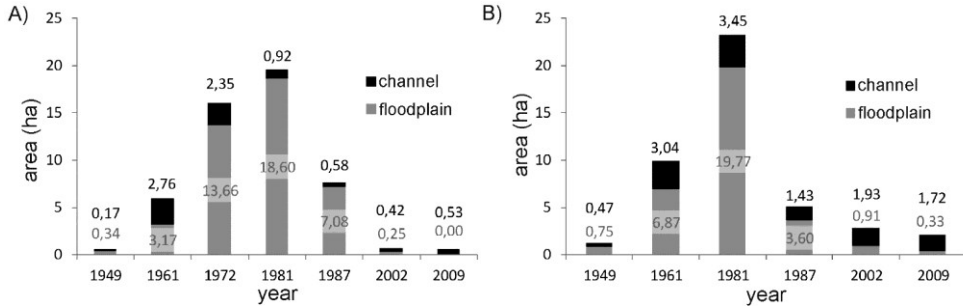
Fig. 5. The gravel pit area identified on the floodplain and active channel for the Ondava River (A) and Topľa River (B) during study time span 1949 – 2009.

The largest volume of gravel extraction, calculated on the basis of the excavation area, took place at both the Ondava River and the Topľa River in 1981, where the gravel pit area represented 19,52 ha on the Ondava River, respectively 23,22 ha on the Topľa River. Their area then decreased dramatically. The largest volume of mining in the study period was on the floodplain area (Fig. 5).
