# Analysis of the features and causes of the contamination in the Shandi River basin

**Abstract:** This study examined the contamination of the surface water in the Shandi River basin in Yangquan, Shanxi province. A total of 11 sampling points (numbered S1-S2, S3-S4, S5-S11) were selected from the upstream to the downstream of the river, and 19 indexes were selected for inspection to identify the causes and features of contaminated water in the basin. The Nemerow Pollution Index was applied to evaluate the quality of the surface water and the overall extent of contamination in the basin. The result revealed that the content of  $\text{Cl}^-$ , As,  $\text{Cr}^{6+}$ ,  $\text{CN}^-$ , and volatile phenols met the grade III water quality standards in China, and the remaining indexes exceeded the standards by varying degrees. The five sources of contamination in the basin negatively affect the environment. The presence of contaminants at the sampling points was in the following order, from highest to lowest:  $\text{SO}_4^{2-} = \text{Mn} = \text{NH}_3\text{-N} > \text{Fe}^{2+} = \text{Hg} > \text{Fe}^{3+} > \text{Cd} > \text{Zn} = \text{F} > \text{COD} > \text{NO}_3^- = \text{NO}_2^

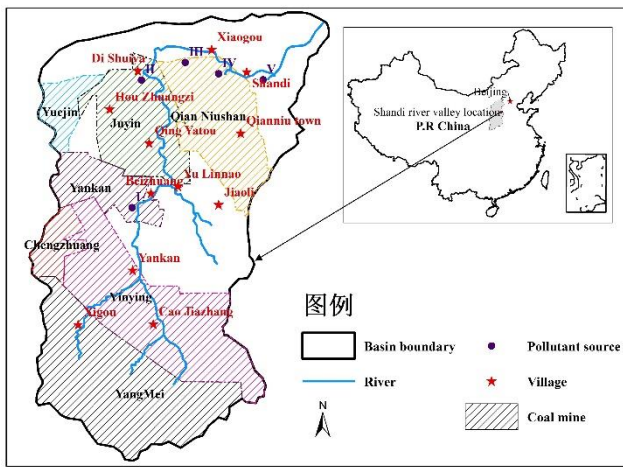
**Figure 1.** Location of Shandi River and the distribution of mining sites and contamination sources

The location of Shandi River and the distribution of mining sites and contamination sources are displayed as Figure 1.

After field studies and investigations were conducted, five sources of contamination were found to cause the contamination in the basin:

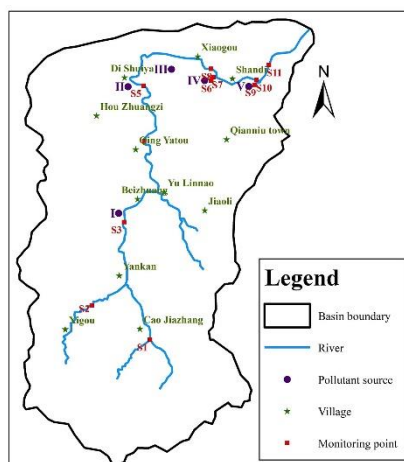
**Figure 2.** Distribution of the monitored sampling points in the basin

According to the hydrogeological condition of the Shandi River basin and the principle of having an even and feasible arrangement of sampling points, 11 sampling points were placed from south to north along the river. The distribution of the sampling points is depicted in Figure 2. The upstream lies to the south of Yankan, the midstream extends from Yankan to Zhainao village, and the downstream is located to the south of Zhainao village. The upstream, midstream, and downstream areas received 2, 2, and 7 sampling points, respectively, with sampling points numbered S1-S2, S3-S4, and S5-S11 in order from upstream to downstream.

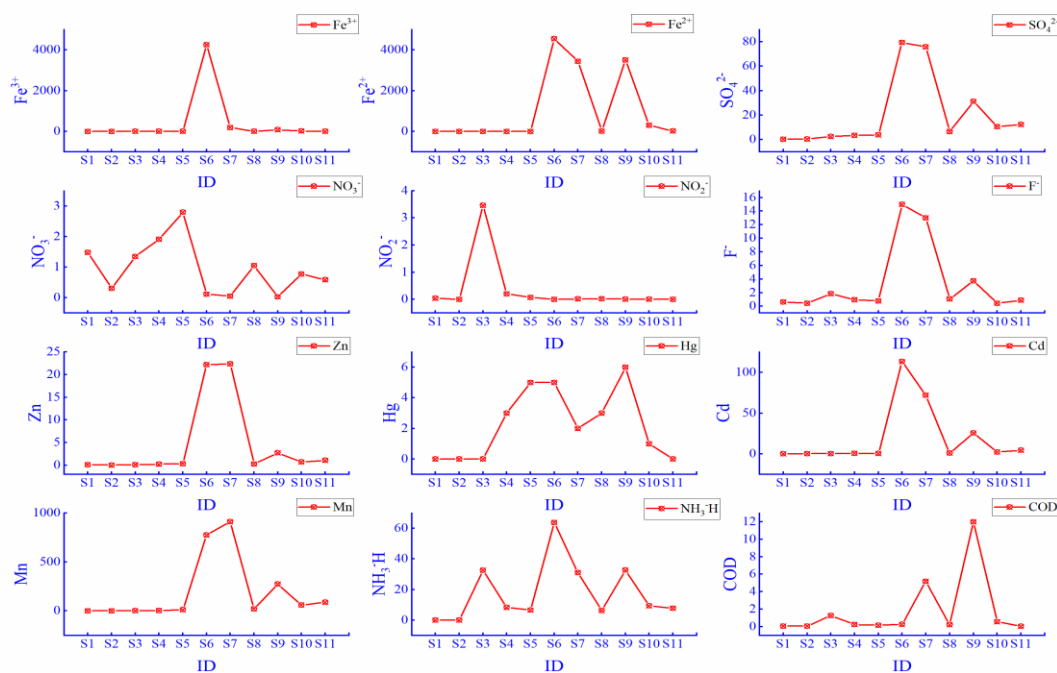
**Figure 3.** Distribution of the contamination indexes

The evaluation of the influence level of each single contamination index was calculated using single contamination indexes. The results demonstrated that the river was not contaminated by Cl<sup>-</sup>, As, Cr<sup>6+</sup>, Pb, CN<sup>-</sup>, volatile phenols, or H<sub>2</sub>S, but it was contaminated by Fe<sup>3+</sup>, Fe<sup>2+</sup>, SO<sub>4</sub><sup>2-</sup>, NO<sub>3</sub><sup>-</sup>, NO<sub>2</sub><sup>-</sup>, F<sup>-</sup>, Zn, Hg, Mn, Cd, NH<sub>3</sub>-N, and COD by varying degrees. The severity of each single contamination index descends in the following listed order: Fe<sup>2+</sup> > Fe<sup>3+</sup> > Mn > SO<sub>4</sub><sup>2-</sup> > Cd > NH<sub>3</sub>-N > Zn > F<sup>-</sup> > Hg > COD > NO<sub>3</sub><sup>-</sup> > NO<sub>2</sub><sup>-</sup>. The proportion of each contamination index at the sampling points is in the order of SO<sub>4</sub><sup>2-</sup> = Mn = NH<sub>3</sub>-N > Fe<sup>2+</sup> = Hg > Fe<sup>3+</sup> > Cd > Zn = F<sup>-</sup> > COD > NO<sub>3</sub><sup>-</sup> = NO<sub>2</sub><sup>-</sup>. This indicated that the content of Fe<sup>2+</sup> caused the highest level of contamination, and the content of SO<sub>4</sub><sup>2-</sup>, Mn, and NH<sub>3</sub>-N had the widest contamination range. The distribution of each contamination index is displayed in Figure 3. Fe<sup>3+</sup>, Fe<sup>2+</sup>, SO<sub>4</sub><sup>2-</sup>, F<sup>-</sup>, Zn, Hg, Mn, Cd, and NH<sub>3</sub>-N had relatively high contamination indexes near sampling point S6. The contamination source analysis showed that S6 was influenced by contamination source IV, which resulted in the high contamination indexes of the factors listed above. The content of Fe<sup>2+</sup>, SO<sub>4</sub><sup>2-</sup>, F<sup>-</sup>, Zn, Hg, Mn, Cd, NH<sub>3</sub>-N, and COD also exhibited increases. The contamination source analysis revealed that S9 was affected by contamination source V, which resulted in high contamination indexes in the factors Fe<sup>2+</sup>, SO<sub>4</sub><sup>2-</sup>, F<sup>-</sup>, Zn, Hg, Mn, Cd, and NH<sub>3</sub>-N, whereas the contamination source of COD remains to be clarified. The outflow of acid mine drainage led to a critical level of contamination at S6 and S9.
