Large-Scale Plate Load Tests to Determine the Collapse Potential at Santorini 150 kV GIS Substation Site

Abstract. Two large-scale plate load tests were carried out at the foundation level of the Santorini 150 kV GIS Substation, where the subsoil was identified as collapsible. The purpose of these load tests was to establish in-situ, the magnitude of the expected settlements due to the collapse of the subsoil structure after inundation, while applying a bearing pressure equal to the maximum expected according to the structural design. After completion of the tests, which are described in detail, the resulting settlements were found to be acceptable, so no soil improvement measures were required and it was concluded that with the design and execution of these innovative load tests, it was possible to measure under actual field conditions the magnitude of settlement due to collapse of the soil structure. This led to a more economical foundation solution, compared to the one that would have been adopted were only laboratory tests taken into account in the calculation of settlements.

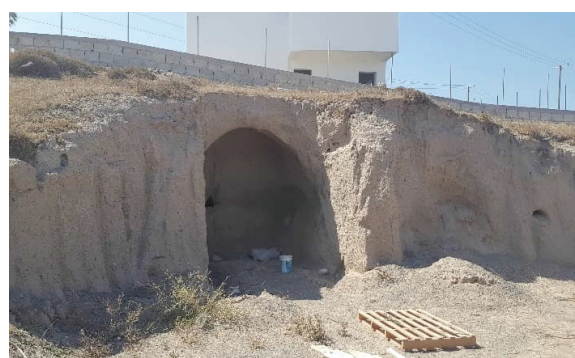
Fig. 1. The subsoil as seen in an open cut excavation in the area of the project.

According to the executed geotechnical investigation at the Santorini 150 kV GIS Substation site ([1]) the subsoil consists of volcanic ash deposits in the form of lightly cemented silty sand of low unit weight and high porosity, which was identified as a collapsible soil (see figures 1 and 2). A soil that, although in a dry state exhibits satisfactory mechanical characteristics, it exhibits a sudden and large reduction of its volume when it gets wet, or even worse when it is saturated with water, due to loss of its apparent cohesion and collapse of its open structure ([2]).

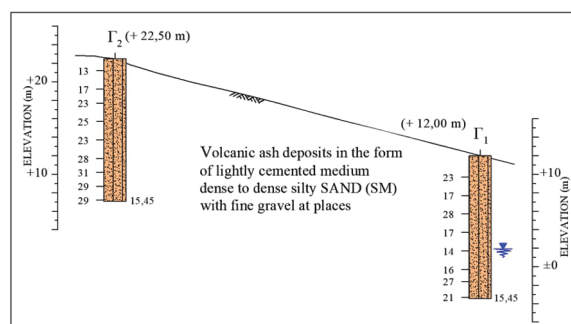
Fig. 2. Typical geotechnical section ([1]).

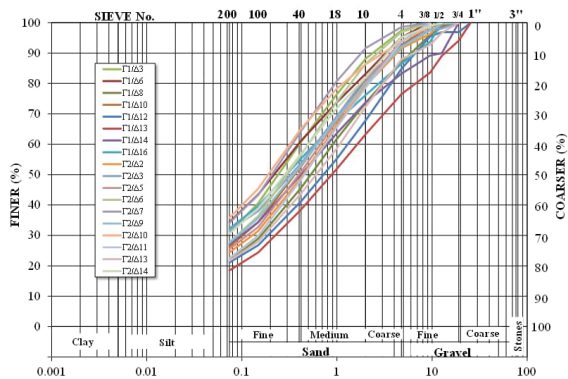
Fig. 3. Grain size distribution of the soil deposits.

According to the executed geotechnical investigation ([1]), the soil consists of lightly cemented medium dense to dense silty sand with fine gravel at places. The grain size distribution of the volcanic ash deposits is presented in figure 3, from which it is observed that there is little variability in terms of gradation. The unit weight of the volcanic ash deposits exhibited a significant variation, ranging between 14.0-21.0 kN/m³ with an average value of 17.0 kN/m³.

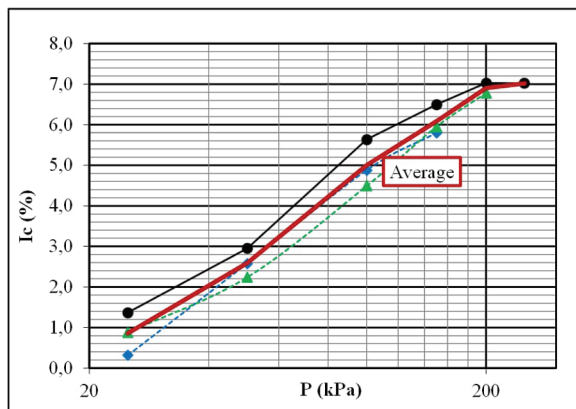
Fig. 4. Collapse index I_c vs. applied pressure P (from laboratory tests).

Given that the collapse index depends on the magnitude of the applied pressure during saturation, multiple collapse potential tests were performed in the laboratory, in order to estimate the collapse potential for various applied vertical pressures. The results of these laboratory tests are summarized in the diagram below (figure 4). From this diagram it is observed that by increasing the applied ground pressure, the collapse index (I_c) increases as well.

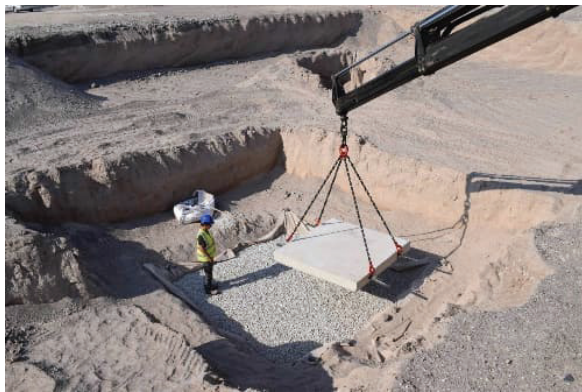
Fig. 5. Preparation for the load test.

A 4.00x4.00 m excavation was formed at the location of each load test, the bottom of which was at the foundation level of each structure (GIS and SVC buildings respectively). A non-woven separation geotextile, weighing 150 gr/m², was placed at the bottom of each excavation and then a layer of 20-40 mm gravel, 0.20 m thick, was placed on the geotextile. This layer facilitated the spreading of water under the loaded slab during the

soil saturation phase. The geotextile was placed in order to separate the permeable gravel layer from the subsoil and to prevent sinking of the gravels into it, especially during the saturation phase. Finally, a square 2.00x2.00 m reinforced concrete slab was placed upon the gravel layer (see figure 5). This slab was designed in such a way that on one hand it would be fairly stiff, but on the other hand it would not be too heavy, so that the initially applied pressure, after its placement on the ground, would not exceed 5 kPa.

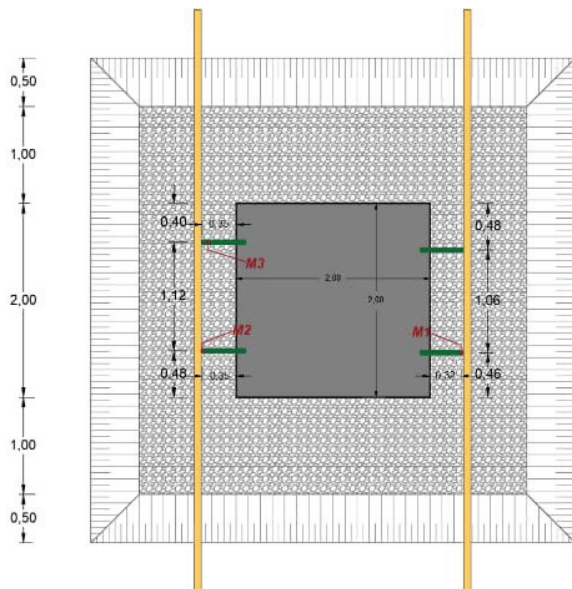
Fig. 6. Layout of the settlement monitoring arrangement.

Monitoring of settlements was carried out with 3 dial gauges of 0.01 mm precision, attached on two wooden beams 6.00 m long (see figures 6, 7 and 8). The choice of wooden beams was made with the purpose of minimizing temperature effects (low thermal expansion coefficient).

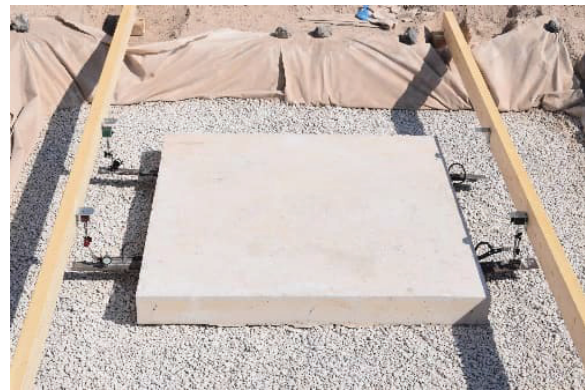
Fig. 7. View of the settlement monitoring arrangement.

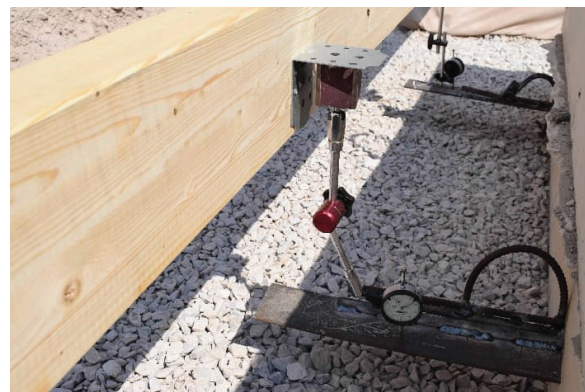
Fig. 8. Close up view of the settlement monitoring arrangement.

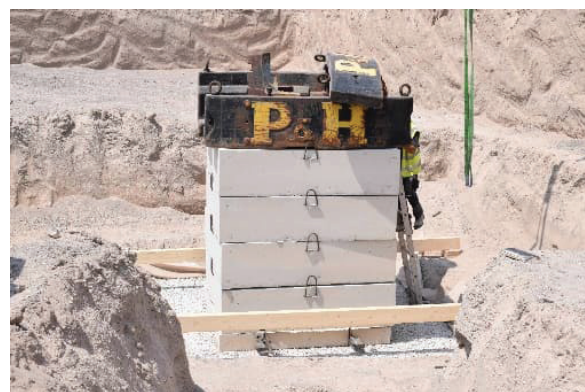
Fig. 9. View of the elements used for the application of the test load.

The test load was applied with 4 precast concrete blocks weighing 48 kN each and 4 steel counter weights of a construction crane weighing cumulatively 104.5 kN, in order to achieve the required test load (see figure 9).

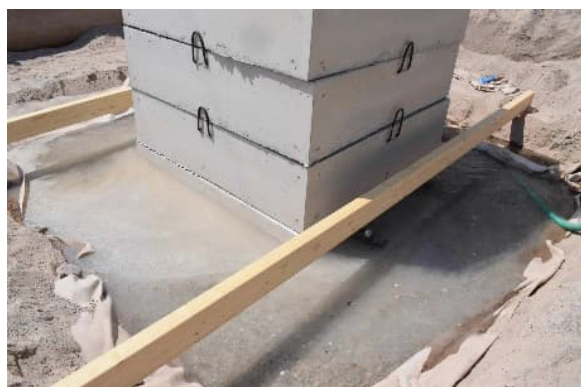
Fig. 10. Inundation of the gravel layer under constant vertical pressure.

During the 2nd phase of the test (saturation of subsoil), the gravel layer was inundated and was kept covered by water at all times with a continuous supply of water from water tank trucks (see figure 10).

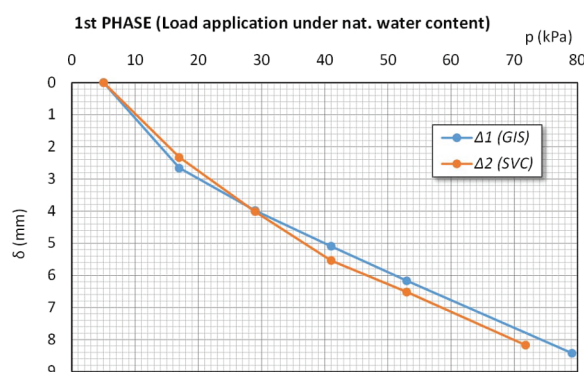
Fig. 11. Settlement vs. applied pressure under natural water content of the subsoil (1st phase of the tests).

The results of the two load tests are presented graphically in figures 11 (1st phase) and 12 (2nd phase).

More specifically, in figure 11 the settlement of the slab as a function of the applied load under natural water content of the subsoil is presented. It is mentioned that the majority of settlements during each loading stage in this phase developed fairly fast. As it can be observed from figure 11, the response of the subsoil was fairly linear, implying that it was far from failure, and there was no distinct difference in behaviour between the two test locations. The estimated subgrade reaction modulus at the maximum applied pressure under natural water content conditions is in the order of $K_s = 10 \text{ MN/m}^3$.

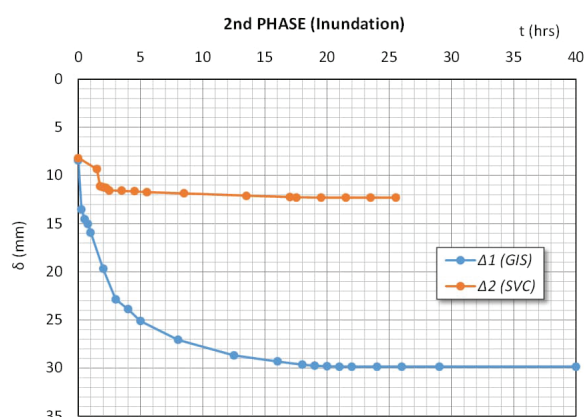
Fig. 12. Time evolution of settlement during inundation under constant load (2nd phase of the tests).

In figure 12, the settlement of the slab as a function of time after inundation, under maintained load (the maximum applied in phase 1), is presented. From this figure the following are observed:

- The phenomenon of additional settlements due to collapse of the soil structure after wetting was confirmed, as expected based on the laboratory test results.
- Most of these additional settlements developed fairly quickly after commencement of the inundation phase (about 55%-75% in 2 hours and 90%-95% in 10 hours).
- The observed increase of settlements due to soil wetting was distinctly different at the two test locations, ranging between 50% for test Δ2 (SVC) to 250% (!) for test Δ1 (GIS).
- The subgrade reaction modulus at the maximum applied pressure decreased from the original value $K_s \approx 10 \text{ MN/m}^3$ to $K_s \approx 2.5\text{-}5.0 \text{ MN/m}^3$.

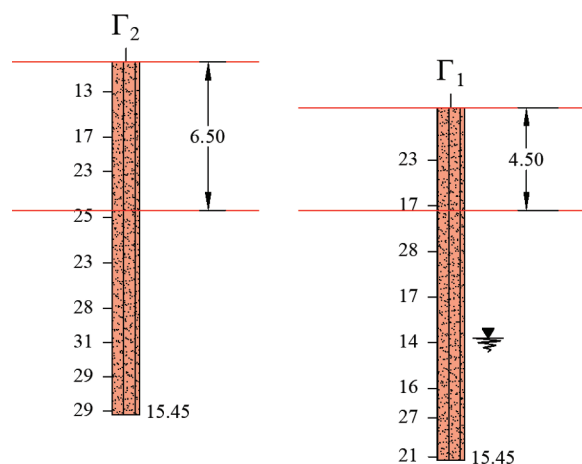
Fig. 13. N_{SPT} values vs. depth beneath load test level at the two test locations.

- The SPT blow count values (N_{SPT}) beneath test level were generally higher (up to twice) in the SVC building (borehole Γ_2 – test Δ_2) as compared to those in the GIS building (borehole Γ_1 – test Δ_1) (see figure 13), denoting a denser soil structure at the SVC building location. This assumption is also supported by the observed lower water infiltration in the SVC area during inundation (25 m^3 in the SVC area as compared to 36 m^3 in the GIS area), which is attributed to a lower void ratio and thus lower permeability.
