# Monitoring and PH Analysis of Tailings from the Effluents of the Cerro De Pasco Mining Company in the Years 2017-2021

**Abstract.** Currently, mining operations in Peru, such as in the province of Pasco, require water consumption for metallurgical mining processes, supply for personnel, among other operations. The purpose of this study is to determine whether the mining company located in Cerro de Pasco has reduced its pH values over the years and whether they are within the Maximum Permissible Limits established by Peru. The impacts of mining activities cause damage to water bodies and the health of the population, so water monitoring is carried out at certain discharge points called cell1, cell2 and cell3, where pH measurements were taken. The results of the monitoring, with respect to the tailings from the mine, are acidic pH values containing suspended solids as well as high concentrations of sulphates and metals. The contributions of the study, which is carried out in the city of Cerro de Pasco located at 4338 m.a.s.l., show practical results as they are used for a diagnosis and analysis for the years 2017-2021 with respect to the mine tailings.

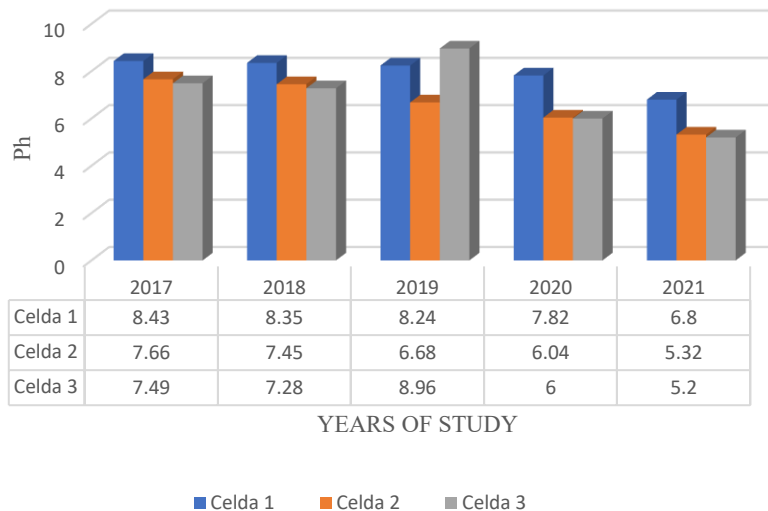
In figure 2 the results of the annual averages of pH according to the drainage classification based on pH and acidity/alkalinity potential of minerals from table 1 the acid values are considered >6, alkaline values are considered < 9 and neutral values from 6 to 9. With respect to the year 2017 the cells have values from 7.49 to 8.43, in the year 2018 the cells have the values from 7.28 to 8.35, in the year 2019 with values from 6.68 to 8.96, in the year 2020 with values from 6 to 7.82 and in the year 2021 only in cell 1 with a value of 6.8 shows that the tailings are neutral class. On the other hand, with respect to the year 2021 in cells 2 and 3 their values respectively are 5.32 and 5.2, showing that the tailings are of acid class.

**Fig. 2.** pH sample from cell 1, cell 2 and cell 3, year 2017-2021.

The annual average pH data for each cell for the study years 2017 to 2020 show that the minimum value is 6 and the maximum value is 8.96 considered neutral tailings as they are within the pH classification range. The values for the year 2021 show that there are two classes of pH with respect to the tailings, since in cell 1 its value is 6.8 considered within the neutral range, unlike cells 2 and 3 whose values are 5.32 and 5.2 respectively, considered as acid tailings (16), the formation of these tailings is caused by chemical oxidation of sulphides, due to acceleration by bacterial activity. On the contrary, in the case of alkaline tailings, it happens as a result of the dissolution of oxides, hydroxides and silicates (17).

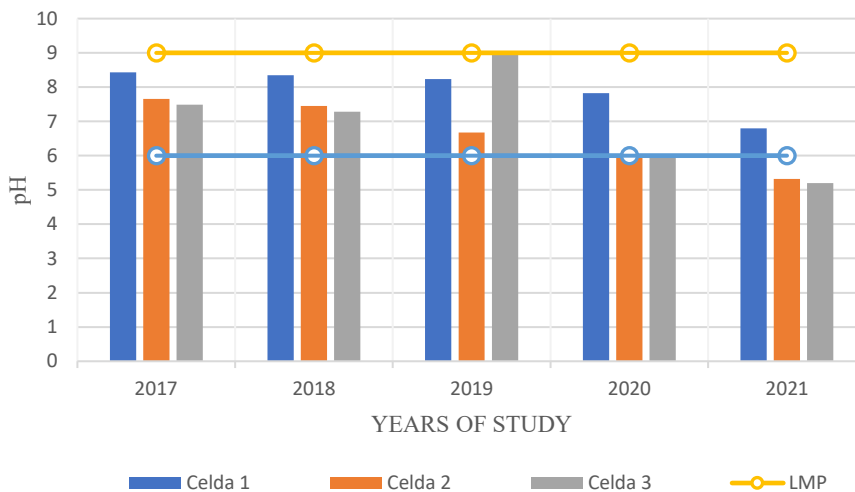
The analysis in Fig. 3 according to the Maximum Permissible Limits for mine tailings discharge with respect to pH its limit for the annual average is within the range 6-9, showing from the year 2017 to 2020 the values of the three cells are within the range. With respect to the year 2021 it is observed that the value of cell 1 remains within the established range unlike cell 2 and 3 that does not exceed the minimum range.

**Fig. 3.** Annual pH analysis using the LMP for discharge of effluents from mining activities.

For the development of revision with respect to the parameters of environmental pollution towards water resources, based on the objective of maintaining the quality levels, the principle of graduality is used, enabling progressive adjustments to these levels for ongoing mining activities. The pH data are within the MPL parameters from the year 2017 to 2020 unlike the year 2021 in cells 2 and 3 the pH value is not within the MPL parameters established in the Supreme Decree N°010-2010-MINAM, meaning that the mining company did not perform adequate treatment in their mine tailings, which would indicate an acidic pH (18).
